# SERVICE BULLETIN

#### FIELD CAMPAIGN SERVICE BULLETIN #: SVC2022-071

BC1200XL Wheel and Tire Assembly Replacement Kit (IK00-3973) In September 2020, owner notifications were sent regarding the abovereferenced product safety recall. We have not received confirmation that all the machines have been updated.

NHTSA SAFETY RECALL NUMBER 20V-085

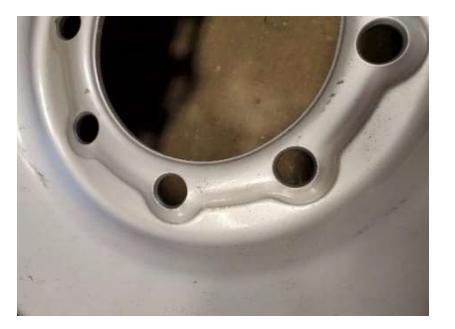
Defective Supplier Wheel Improper Lug Nut Seat and Potential Cracks

Specific wheels (steel rim) with 8-bolt pattern on  $6\frac{1}{2}$  inch (165 mm) circle to be used with 5/8" studs provided by a supplier:

- have an incorrect lug nut contact area causing wheel lug nuts to loosen; and/or
- can develop possible cracks causing the tire to lose air pressure.

Identified by continuously raised lug nut surface

Destroy wheels and tires. When you remove the supplier defective steel rim/wheels, these wheels can never be used or sold for any purpose. The wheels MUST be destroyed:

- Remove the tire from the steel rim/wheel or deflate the tire.
- Torch cut the wheel(s) across the lug nut area.
- Take photo(s) of the destroyed wheel(s) and attach to campaign warranty claim.
- Discard the lug nuts so they can never be used or sold for any purpose.
- The removed used tires may be retained in your used tire inventory or disposed of. The cost of tire removal and disposal is included in the labor hours.

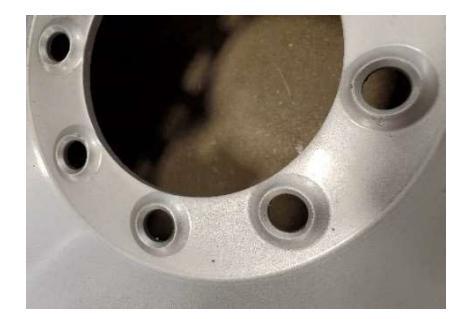
Properly Manufactured Wheel Correct Lug Nut Seat

Identified by raised surface only around lug nut location

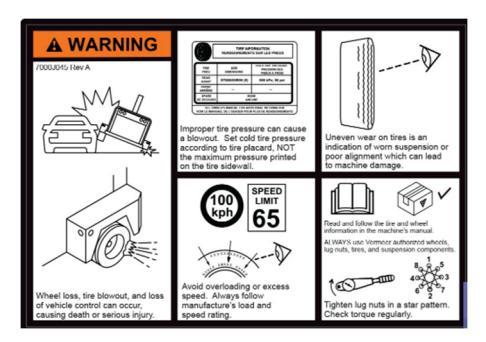
IK00-3973 contains a new safety sign (shown to the right) and updated Operator's Manual and Maintenance Manuals. <u>No</u> wheel/tire assembly is included in IK03- or IK04-3973. See sample owner letter #1 at end of this Bulletin. **This kit must be installed as soon as possible**.
