PORSCHE

Service 75/21 ENU

AMBO – Retrofitting Heating Element for Passenger Seat Backrest (Stop Delivery/Recall Campaign)

Model Line:	Cayenne (9YA/9YB)		
Model Year:	As of 2020 up to 2021		
Concerns:	Heating element for passenger seat backrest		
Information:	Due to an assembly error that has since been corrected, the subject vehicles were assembled without the passenger seat back heating element.		
	This variation from specification can affect the Occupant Classification System as calibrated for this specific vehicle. If warnings are ignored, the front passenger restraint systems may not be activated as designed.		
	In the event of occupant classification system malfunctions, the "Airbag warning lamp" or "Passenger Airbag OFF" lamp will be activated in order to alert the occupants.		
Action required:	Retrofit heating element for passenger seat backrest.		
Affected Vehicles:	Only vehicles assigned to the campaign (see also PCSS Vehicle Information).

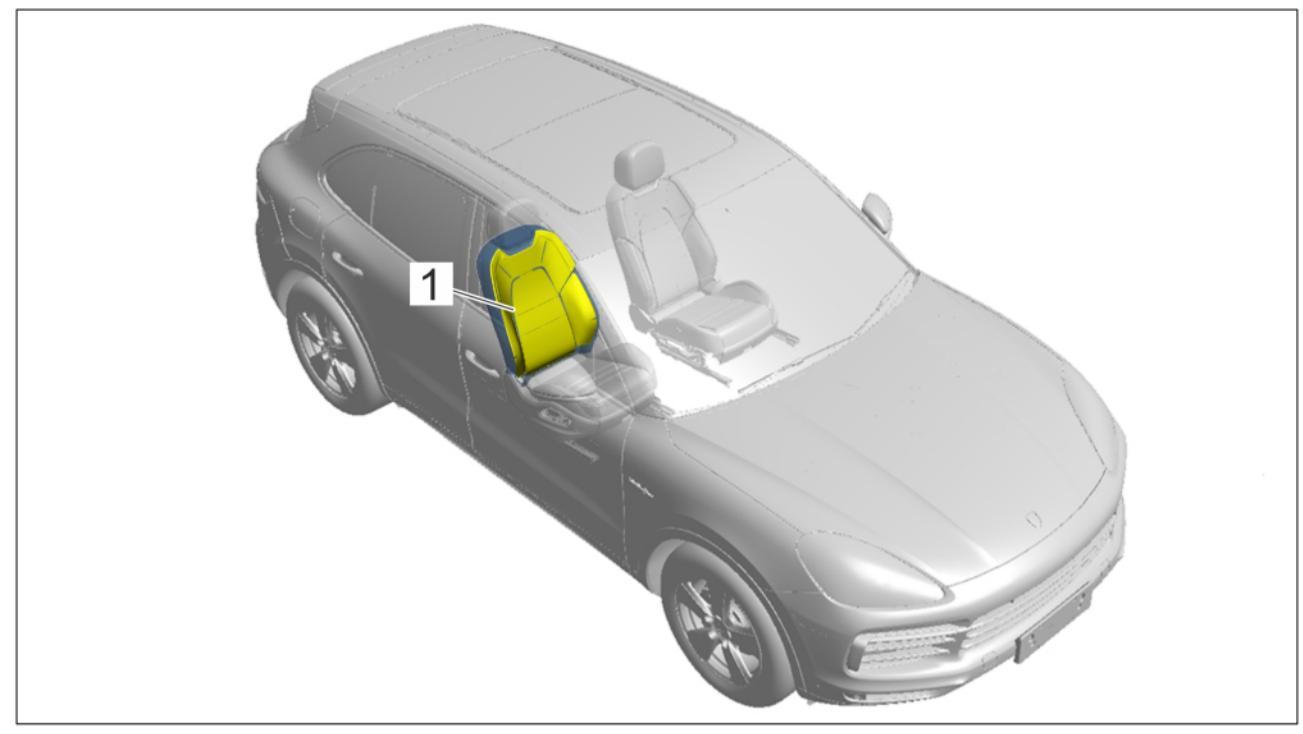
Installation position of heating element for passenger seat backrest

1 – Heating element for passenger seat backrest (retrofitting)

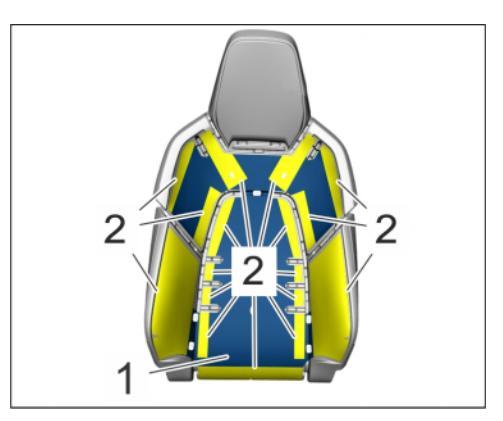
Heating element for front passenger seat

- Work Procedure: 1 Remove the padding from the front passenger seat backrest. \Rightarrow Workshop Manual '741719 Removing and installing padding for front backrest'
 - 2 Remove cover for front backrest. ⇒ Workshop Manual '741919 Removing and installing cover for front backrest'
 - 3 Retrofit the heating element on the front passenger seat.
 - 3.1 Position the heating element \Rightarrow Heating element for front passenger seat-1- on the padding for the front backrest.
 - 3.2 Carefully remove protective film from the backing sheet in the marked area ⇒ *Heating element for front passenger seat*-**2** and press heating element ⇒ *Heating element for front passenger seat*-**1** on firmly.

- 3.3 Press heating element \Rightarrow Heating element for *front passenger seat* **-1** - into the grooves in area \Rightarrow Heating element for front passenger seat -2-.
- Install cover for front backrest. \Rightarrow Workshop Manual 4 '741919 Removing and installing cover for front backrest'
- 5 Install the front backrest padding and make sure that the wire harness for the heating element is routed as specified in the Workshop Manual.

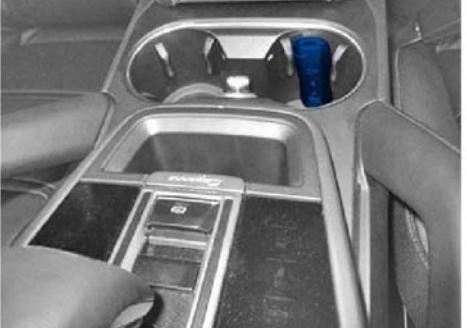
Emergency start tray

- 6.2 **Position** the driver's key in the rear area of the left cupholder in the center console between the holding struts (emergency start tray) in order to guarantee a permanent radio link between the vehicle and driver's key \Rightarrow Emergency start tray.
- Connect 9900 PIWIS Tester 3 to the 6.3 vehicle communication module (VCI) via the USB cable. Then connect the communication module to the vehicle and switch on the **PIWIS** Tester.
- 6.4 Switch on the ignition and open the 'Diagnostics' application on the PIWIS Tester start screen.

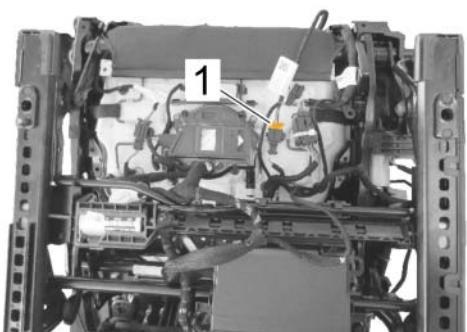
Heating element for front passenger seat

The plug connection for the backrest heating element is located on the bottom of the passenger seat as shown in the illustration \Rightarrow Heating element - electric plug connection -1-.
