Service Bulletin

Subject: Normal Characteristic - "No Active Route" Message Displayed After Touching Navigation Icon

Models: 2013 Cadillac ATS, SRX, XTS Equipped with CUE Infotainment System

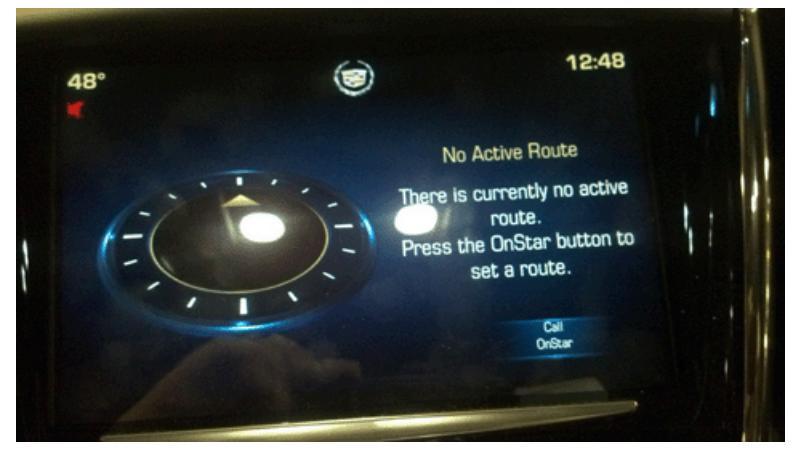
There are different option levels of the CUE system; not all of them are equipped with a navigation system.

The Navigation icon is displayed in both systems, but they function differently dependent on which option the vehicle is equipped with.

Inspect the vehicle build / RPO code for the vehicle to determine if the CUE system is equipped with Navigation feature.

If the vehicle is not equipped with the model-specific RPO code listed above, then it is not equipped with the Navigation function and cannot be upgraded. The vehicle is operating as designed and no repairs should be performed.
