GM Bulletin No.: 12188

SERVICE UPDATE

- SUBJECT: Service Update for Inventory and Customer Vehicles Starter Motor Short Circuit Expires with Base Warranty
- MODELS: 2013 Chevrolet Avalanche, Silverado 2013 GMC Sierra Equipped with 4.8L/5.3L V8 Engine (L20, LC9, LMG)

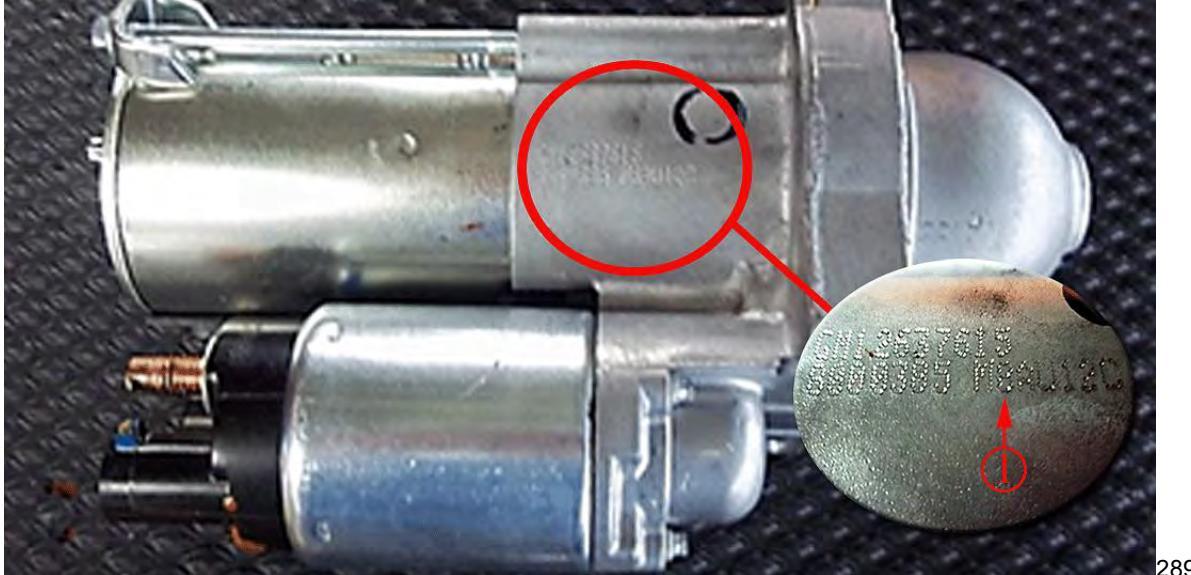
2899929

- 1. Raise and support vehicle. Refer to Lifting and Jacking the Vehicle in SI.
- 2. Locate the starter motor and starter motor date code information.

Note: A flash light and mirror are required to view the starter motor date code.

- 3. Determine if the second digit of the starter motor date code is 8 or 9 (1). The starter motor date code is an alpha-numeric code that begins with the letter "M." Look at the next digit to determine if the starter date code is an 8 or 9 (1).
 - If the second digit of the starter motor date code is NOT 8 or 9, no further action is required. Lower the vehicle. Refer to *Lifting and Jacking the Vehicle* in SI.
 - If the second digit of the starter motor date code is 8 or 9, remove and replace the starter motor with a new starter motor. Refer to *Starter Replacement (V8)* in SI.
- 4. Lower the vehicle. Refer to *Lifting and Jacking the Vehicle* in SI.

This bulletin provides a service procedure to inspect and, if necessary, replace the starter motor on **certain** 2013 model year Chevrolet Avalanche and Silverado, and GMC Sierra vehicles, equipped with a 4.8L (L20) or 5.3L (LC9/LMG) V8 engine. Components within the starter motor may contact and wear through the wiring insulation, causing a short circuit condition. This could cause the starter motor to become inoperative and the customer will not be able to start the engine.
