# 2013 ALTIMA SEDAN; DTC C1197 STORED

NTB13-013

**APPLIED VEHICLE:** 2013 Altima Sedan (L33) APPLIED VINs and DATES: Vehicles built before: 1N4(\*)L3A(\* \*)DC 214030 and February 1, 2013

DTC C1197 is stored in the ABS actuator and electric unit (ABS control unit).

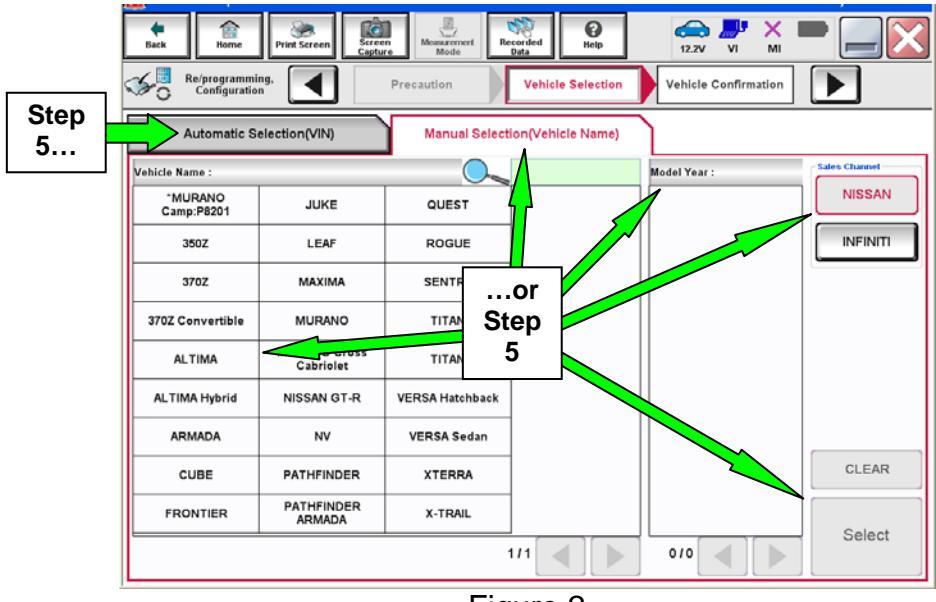
Figure 2

If the following screen appears, select the Automatic Selection(VIN) tab OR

From the **Manual Selection(Vehicle Name)** tab, select **NISSAN, Altima**, **Model Year** (2013), and then **Select**.

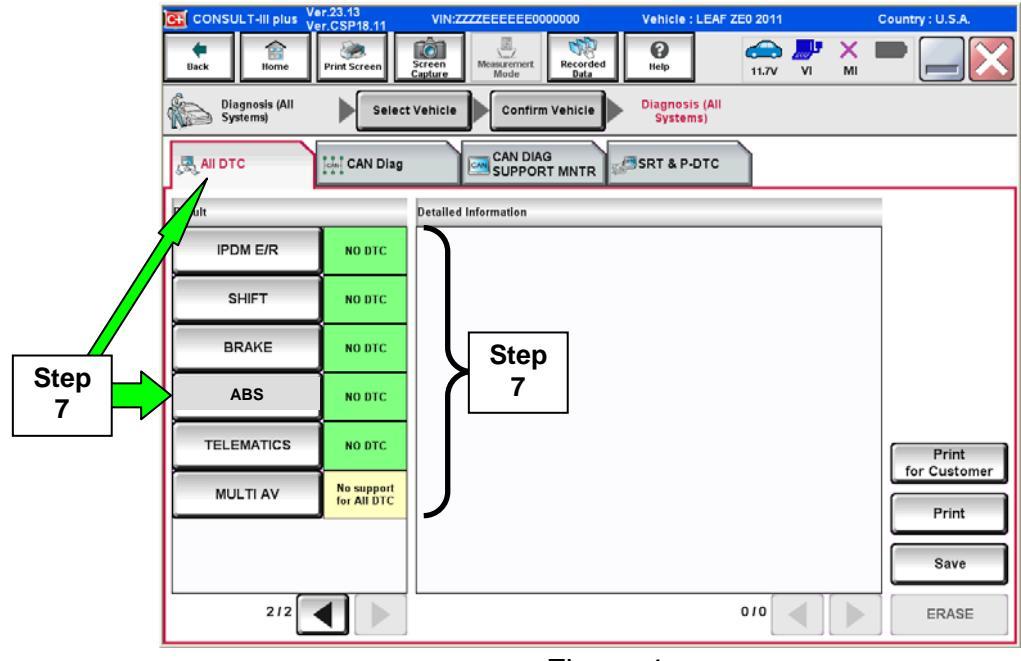
Figure 4

- 7. From the All DTC tab, verify there are no DTCs stored, and then select ABS.
  - If there are any DTCs other than C1197, diagnose, perform repairs, and then erase DTCs **before** continuing. Refer to ASIST for further diagnosis.

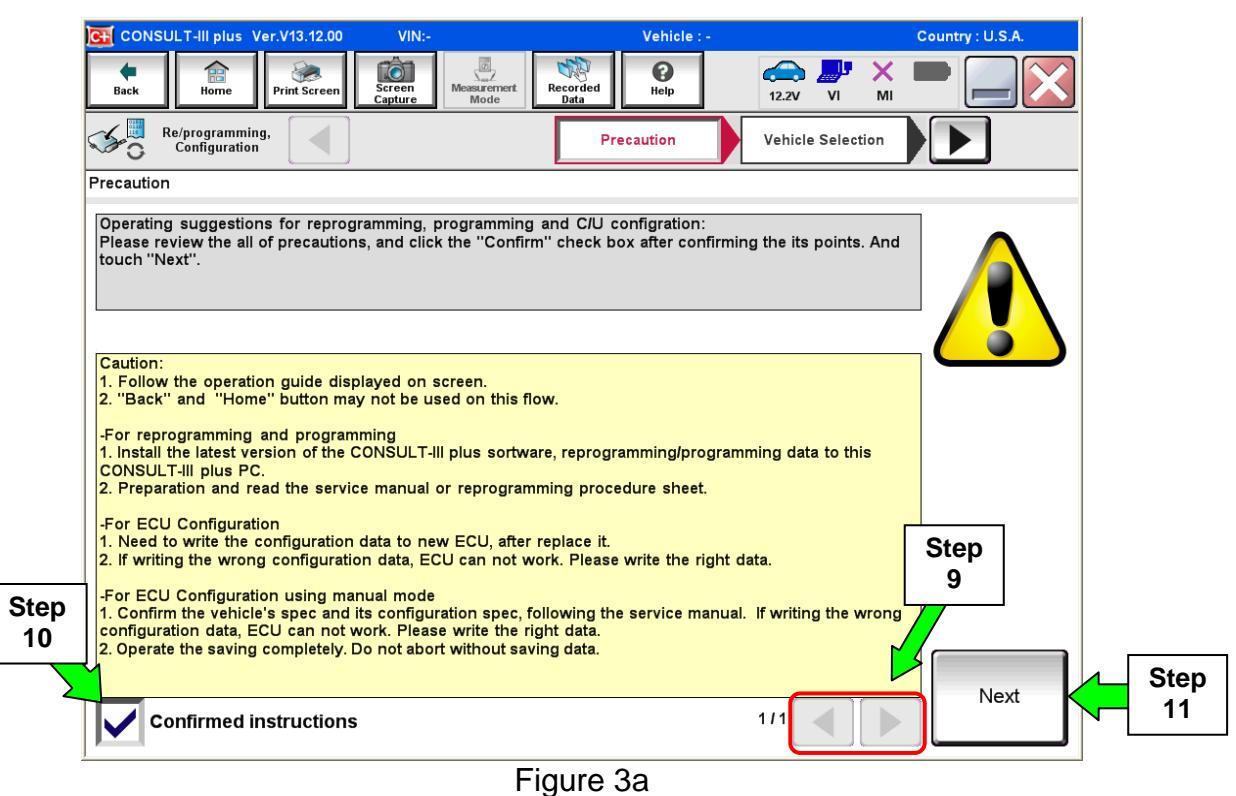
- 9. Use arrows (if needed) to view and read all precautions.
- 10. Check the box confirming the precautions have been read.
- 11. Select Next.

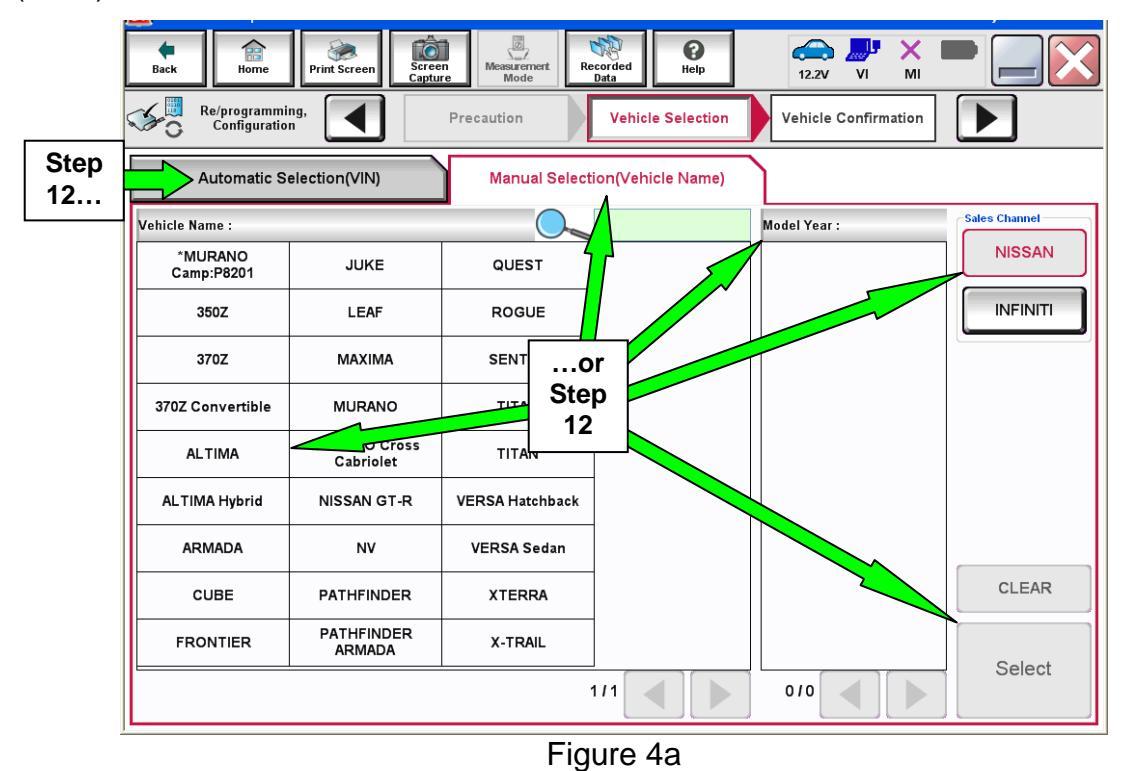
12. If the following screen appears, select the Automatic Selection(VIN) tab OR

From the Manual Selection(Vehicle Name) tab, select NISSAN, Altima, Model Year (2013), and then Select.

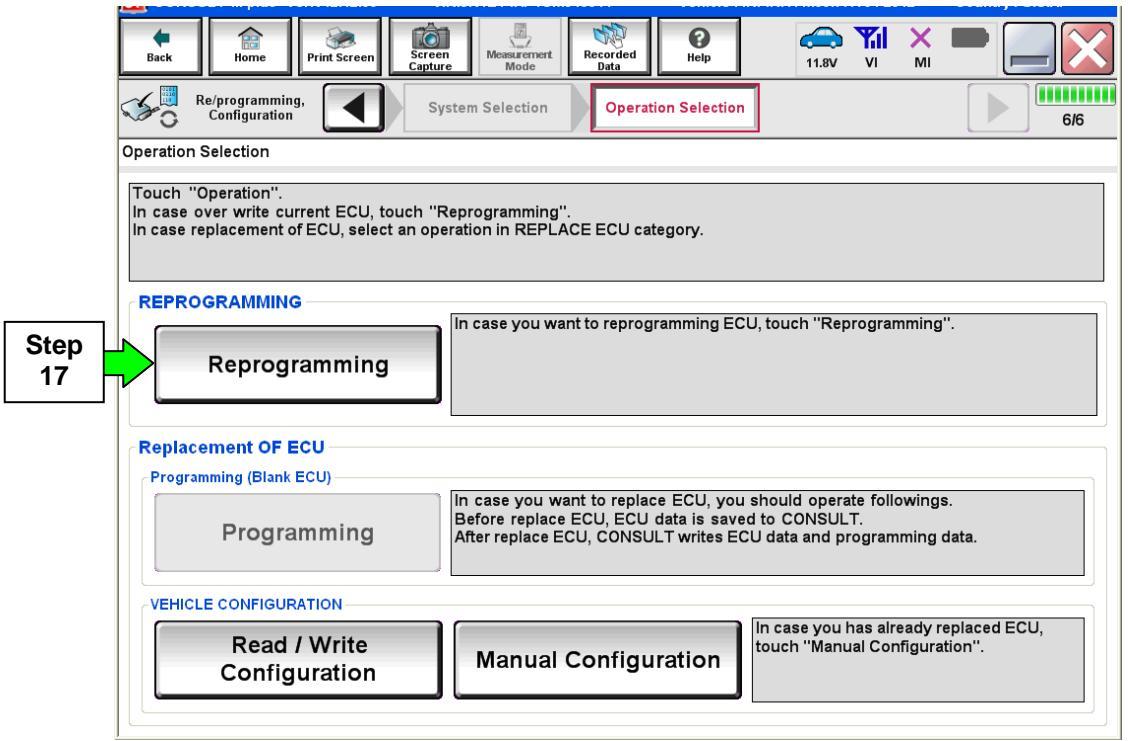
Figure 9a

# 17. Select Reprogramming.

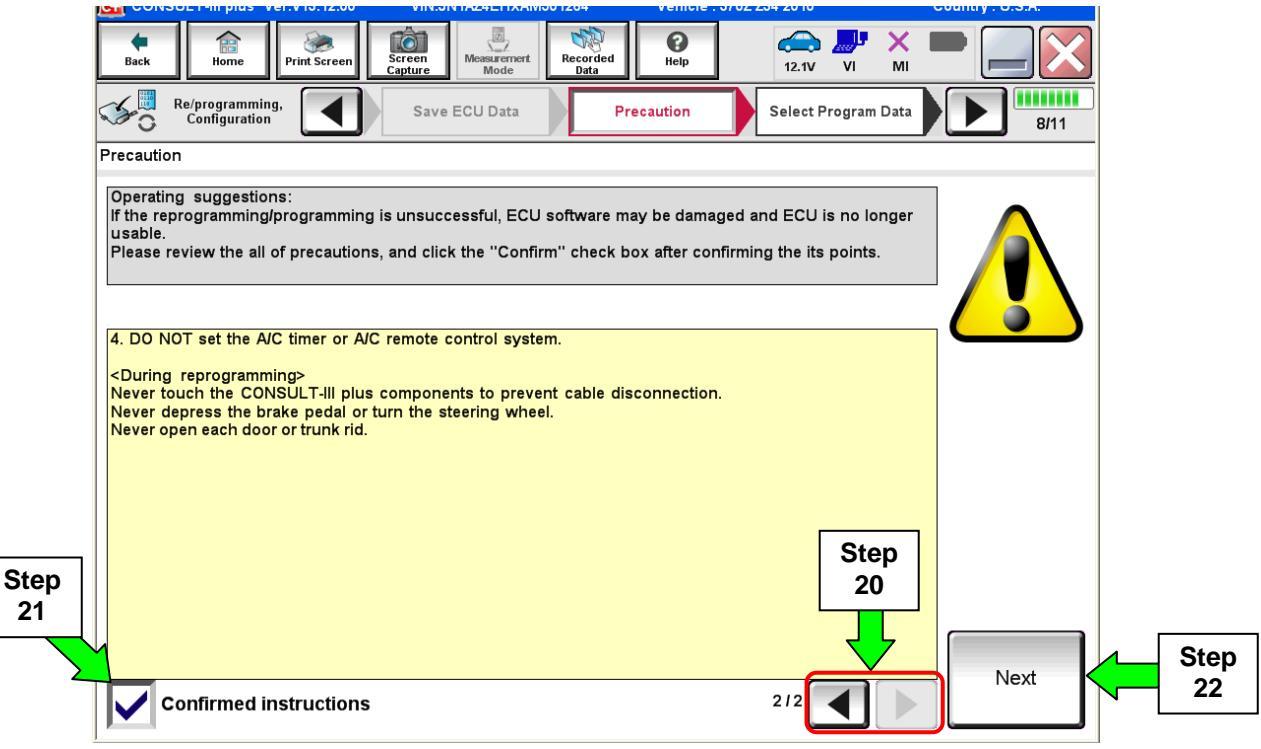
Figure 12a

- 20. Use arrows (if needed) to view and read all precautions.
- 21. Check the box confirming the precautions have been read.
- 22. Select Next.

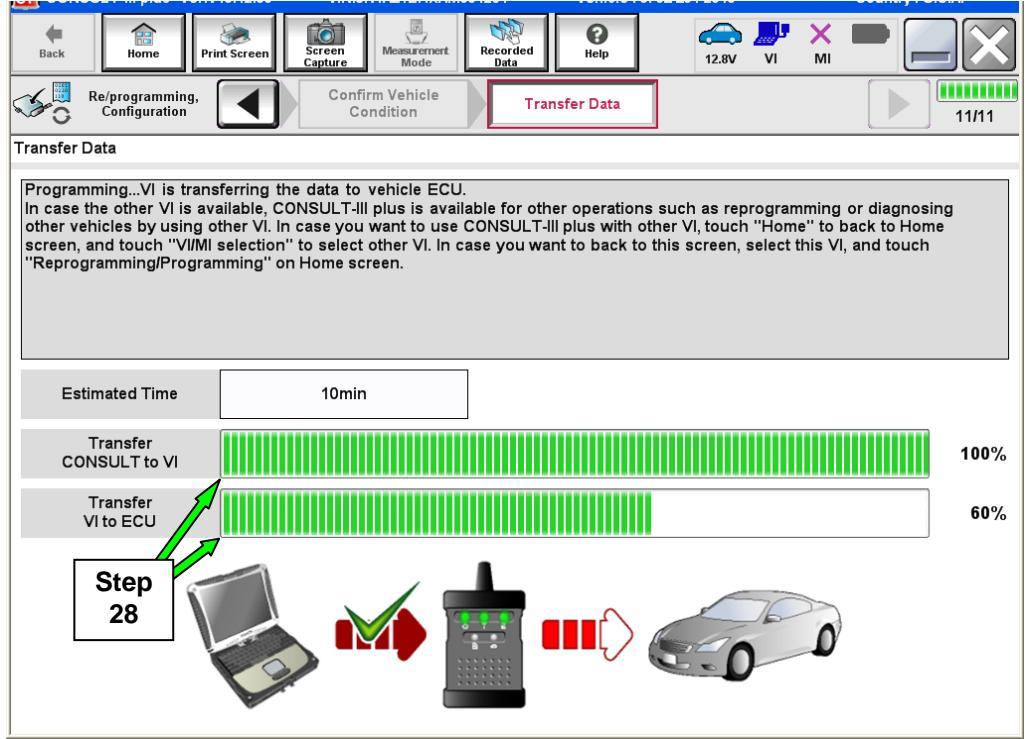
Figure 17a

28. Wait for both progress bars to complete.

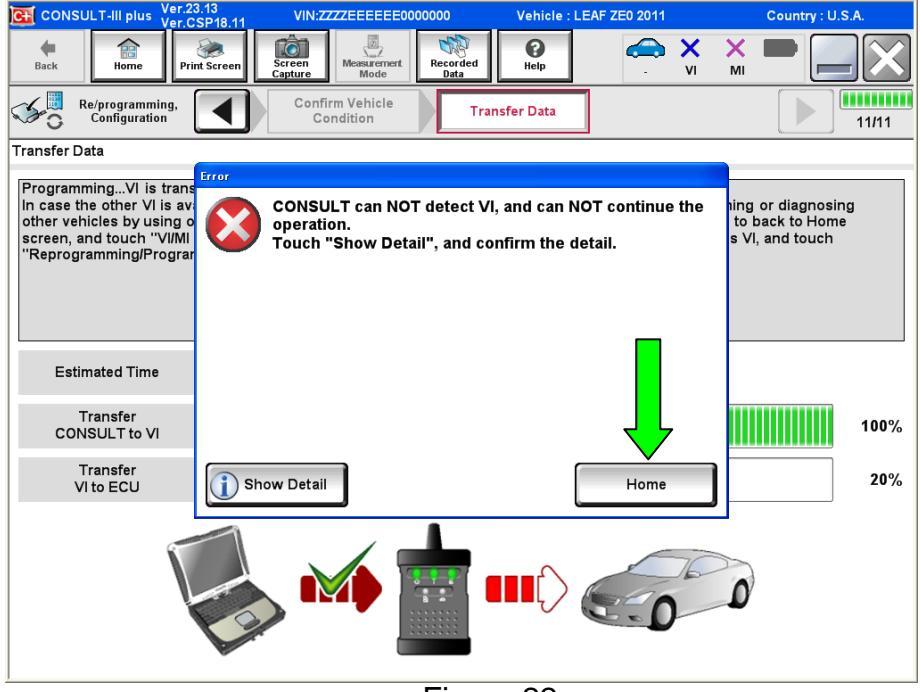
If the screen in Figure 22a displays, select Home, and then select Trouble Diagnosis.
