91 13 10 April 11, 2013 2033079

RNS 315 Hardware Failure

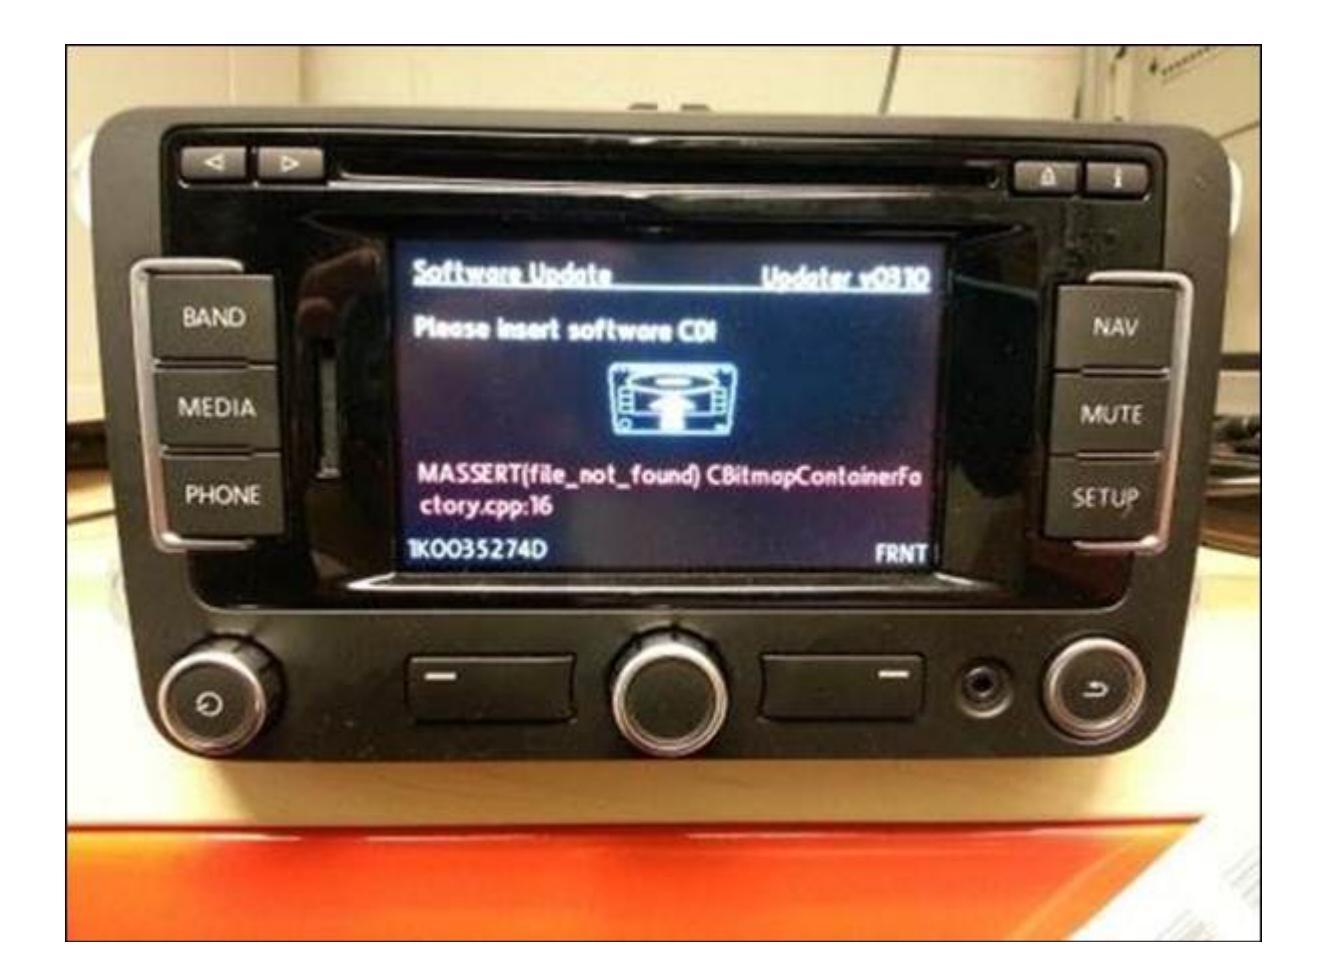
If the message "Please insert software CD" appears, the RNS 315 radio-navigation system must be replaced according to the repair manual.

• Replace the RNS 315 radio-navigation system.
