Tech Tips

TT 61-07-105

2007-2013 EOS – Convertible Top Inoperative, One Side Bar Not Unlocking From Header, Fault 02805 – System Interference

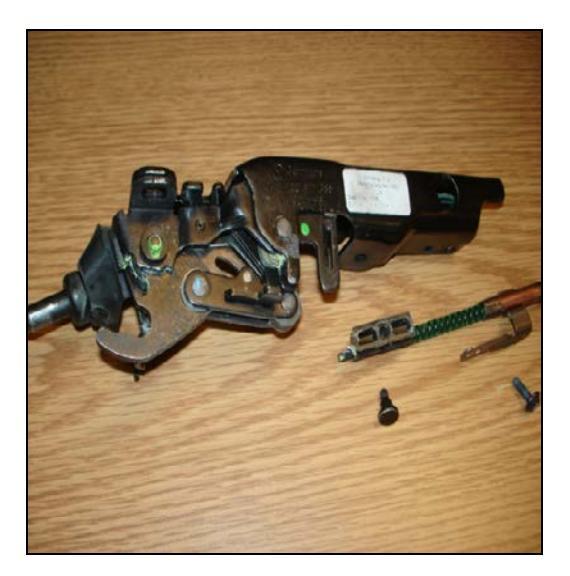
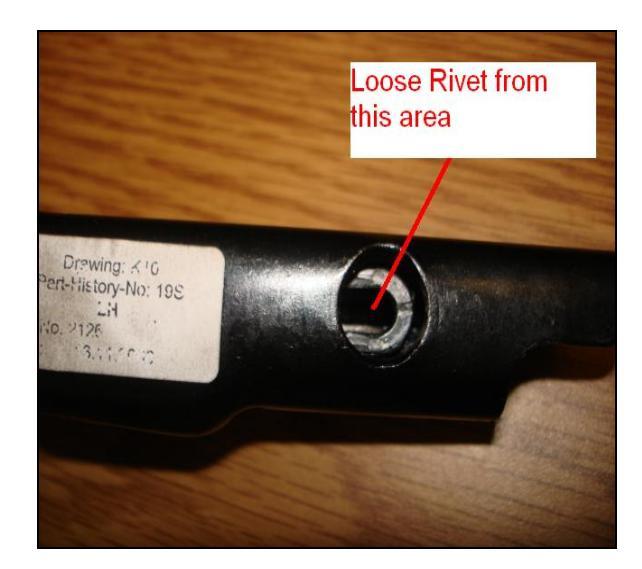
- If the only fault present is 02805 (system interference) or no faults at all, check to ensure the C segment is opening fully.
- If it is, check that the side bars are fully unlocking from the header.
- If only one side is unlocked, run the complete GFF test and document the results. <u>Do not replace</u> <u>any switches at this time.</u>
- Remove the interior trim from the side cover and inspect the locking arm from the C segment ram area to the hook on the header side. If there are any loose components in this assembly, please replace the latch per instructions in ElsaWeb and send the old parts back to the Warranty Test Center (See pictures below for reference of loose components).

<u>IMPORTANT</u>: DO NOT attempt any emergency open or close procedures for this particular concern as other damage may occur which will not be covered under Warranty.
