SPECIAL SERVICE CAMPAIGN COW

ENGINE CONTROL MODULE (ECM) REFLASH

CERTAIN 2013 MODEL YEAR SCION FR-S

UPDATED JANUARY 7, 2013

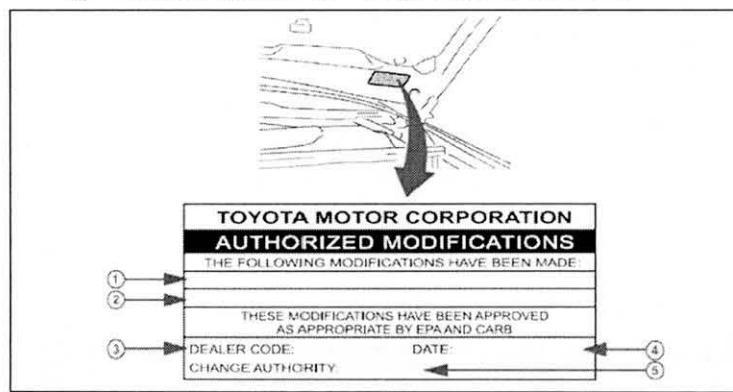
1	Replacement ECM P/N 6AT – SU003-04567 6MT – SU003-04568	
2	New Calibration ID 6AT – ZA1JA00D 6MT – ZA1JA00C	
3	Dealer Code	
4	Date Completed	
5	Campaign Code (C0W)

3. ATTACH THE AUTHORIZED VEHICLE MODIFICATION LABEL

- a) Fill out the label.
- b) Affix the label to the under-side of the hood.
