# VARIANT CODING AFTER HEAD UNIT REPLACEMENT

Model	Production Date Range	
K900 (KH)	2015MY ~

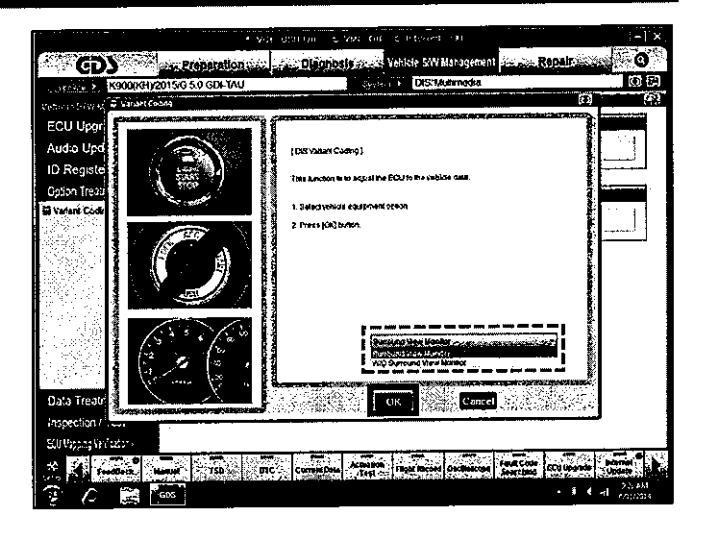
8. Select the system type (with **Surround View** or **W/O Surround View**) from the drop down menu and Click on **OK**.
