Service Bulletin

Subject: Normal Characteristic - Folding Top Side Rails May Not Stow Completely When Lowering Top

Models: 2011 - 2015 Chevrolet Camaro Convertible

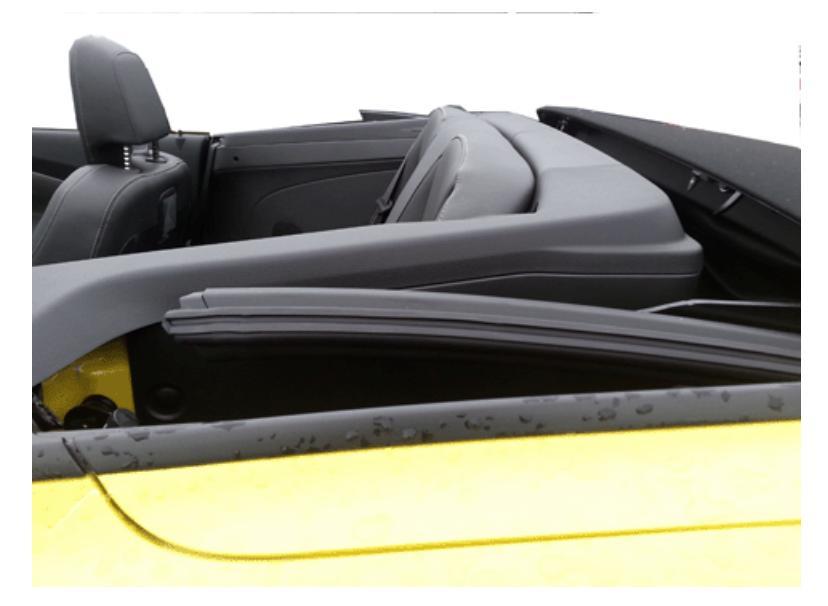
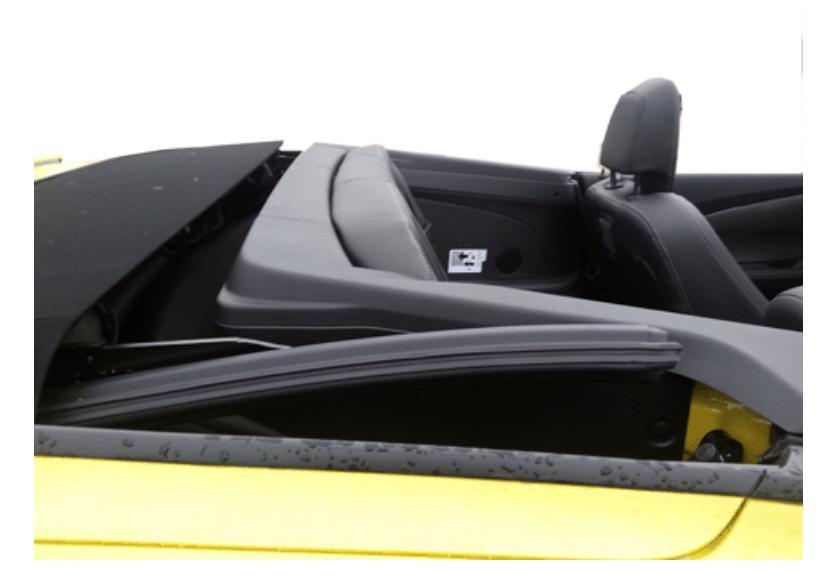
It may be noticed by some customers that when lowering the folding top, the side rails, commonly referred to as the "deer legs", may remain a bit higher than the stowage compartment allows. They may comment that they have to push gently on these side rails to get them low enough to install the tonneau cover. An example of these rails can be seen in the 2 photos below.

This is a normal characteristic for these vehicles, especially for ones with a new folding top. This will improve over time as the material is cycled multiple times but depending on many other factors, (number of cycles, temperature, build variations, etc) the customer may still notice a slight protrusion of these side rails above the side of the body. This is no way affects the quality or longevity of the folding top. All that is required is for the customer to apply slight amount of downward pressure to these rails to get them to fully stow.

Please communicate to the customer this condition is a normal operating characteristic of their vehicle. It will not impact the designed performance or reliability of the vehicle. Please share this information with the customer, including a copy of this message.
