Model(s)	Year	Eng. Code	Trans. Code	VIN Range From	VIN Range To
All Except Routan	1998 - 2016	All	All	All	All

92 15 02 July 22, 2015 **2026253** Supersedes T. B. V921301 dated May 6, 2012 to provide updated cleaning product information and include additional model and model year applicability.

Windshield Wipers Streak or Smear

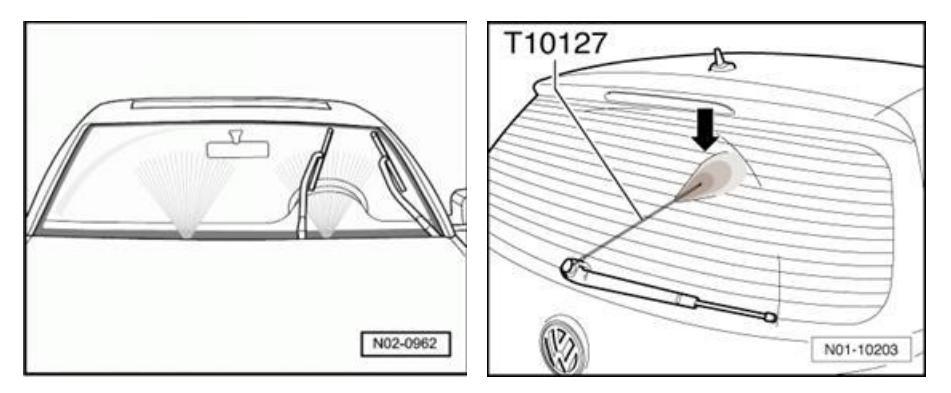
I Note:

DO NOT attempt to wipe or clean windshield wiper edge with cleaning cloth or chemicals. Wiper(s) are manufactured with treated surface that requires no maintenance.

- If the washer(s) need to be adjusted, see Repair Manual Group 92 Windshield Wiper/Washer System in ElsaPro.
- Verify when in operation and after correct adjustment of washer(s) that wipers do not streak and properly clear the windshield.
- To clean the windshield or rear glass, proceed with the following steps:
- 1. Check for foreign matters that need to be cleaned or removed from the glass or wiper(s).
- 2. Clean the glass using 3M[™] Quick Wax and Perfect-It Clay. See the steps outlined below.

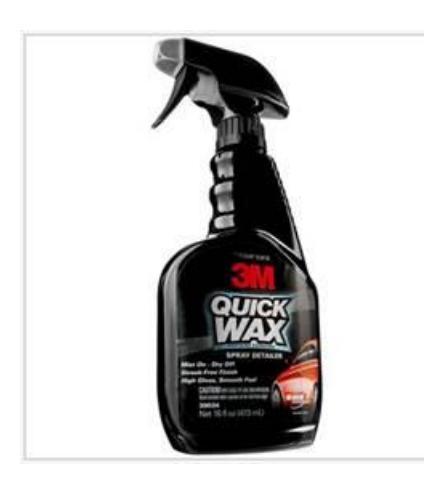
With vehicle exterior (including all glass surfaces) washed and dried and the wiper arms placed in the service position, perform the following:

Apply 3M[™] Quick Wax Part No. 39034 to the windshield or rear glass.

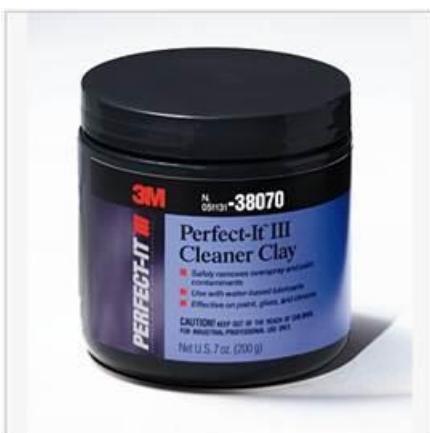
Using 1/3 of a bar 3M[™] Perfect-It[™] III Cleaner Clay Part No. 38070:

- Flatten clay into a small palm size pancake.
- With clay flat between windshield and your hand, rub windshield (with light friction) using a vertical motion (up/down) across windshield.

Ensure glass stays moist with Quick Wax. Clay can be flipped over when dirty.
