Keystone RV Company

## **SERVICE ADVISORY # 15-227**

## Summerland Mini Fuse

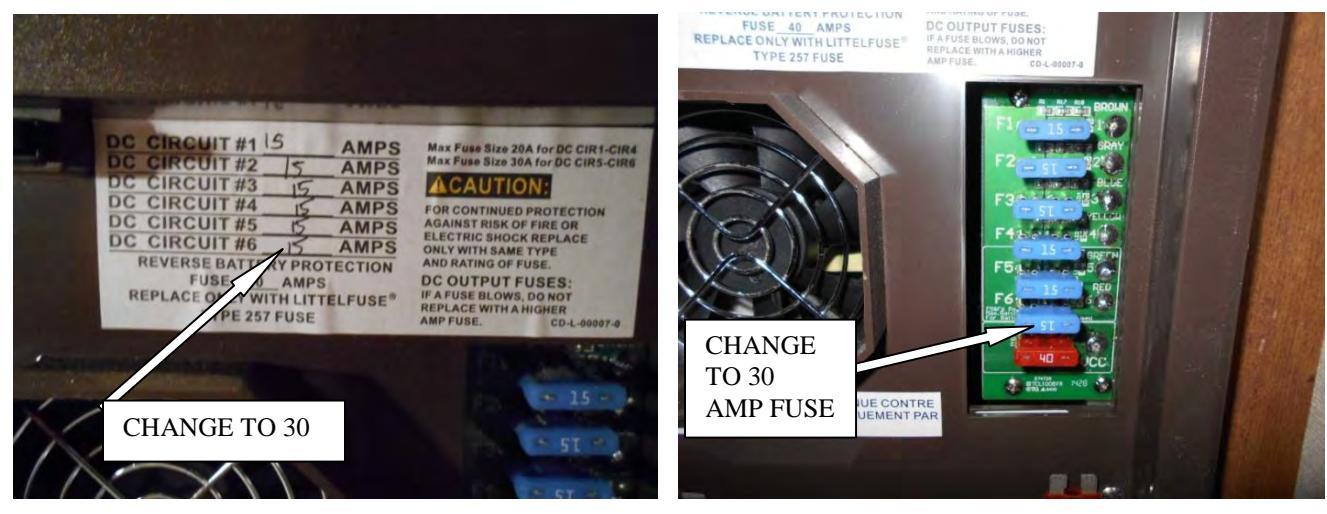
Fig. 1

It has been determined the below listed vehicles were manufactured with an undersized 15 amp fuse placed in the battery charging circuit which should have a 30 amp fuse. The circuit is wired and rated for 30 amp capacity. This advisory explains how to correct.

- **Step 1** Locate the trailer on a level, flat and hard surface. Chock the wheels.
- **Step 2** Locate the fuse panel in the unit. Remove the 15 amp fuse from the number 6 location of the fuse panel. Replace the fuse with a 30 amp fuse. Change the noted fuse size of position 6 on the information label from 15 to 30.
