On some vehicles, customers may complain of an intermittent squeal when coming to a stop. This concern is often due to the brake pads not freely floating within the caliper and sticking to the caliper bracket. This condition may lead to a vibration and noise which is heard during the last portion of brake pedal travel, before coming to a complete stop.

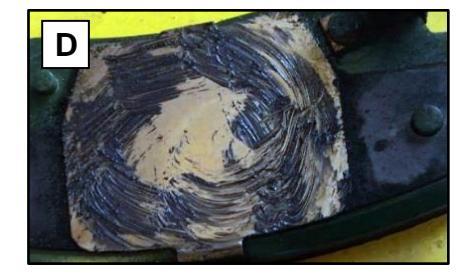
- Remove the brake pads, rotors and verify remaining service life. Replace any worn components, as needed. If the rotors are still within specification, use a brake hone (A) to create a swirl pattern on the rotor surface to prevent the pads from glazing upon reinstallation. Additionally, use the brake hone to remove any rust from the hub surfaces.
- 2. Reinstall all removed components. Before reinstalling the brake pads, apply Hi-Temp Disc Brake grease (B) on the sliding surfaces of the brake pad ears (C) and the area of contact between the brake caliper piston and the pad backing (D). Note: Do <u>NOT</u> use an excessive amount of grease and be sure to avoid contaminating the friction material surfaces. Additionally, do <u>NOT</u> use any products such as Disc Brake Quiet liquid.
