This bulletin provides the procedure for upgrading the base audio system software of some 2017MY Forte (YDm) vehicles, produced from May 15, 2016 to August 12, 2016, to improve Bluetooth[®] pairing.

This issue number is <u>SA239</u>.

SERVICE ACTION: BASE AUDIO SYSTEM UPGRADE (SA239) SUBJECT:

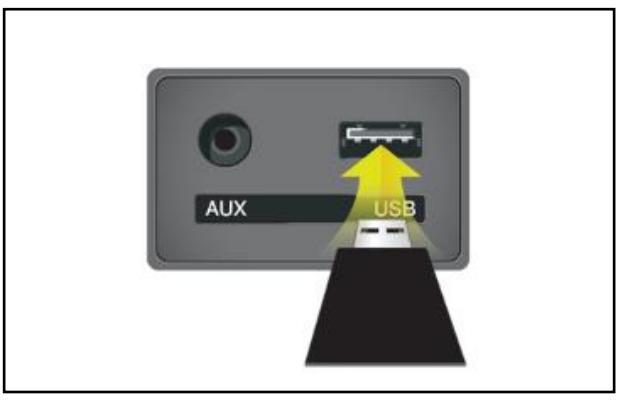
- 5. Turn the head unit ON and wait until booting is finished (approx. 10 seconds) before proceeding to the next step.
- If performing the update using a USB stick, obtain the correct YDm Audio (A) Pairing SW USB Drive (yellow) from your Service Manager and insert it in the vehicle's USB port. NOTE: Make sure to allow for the sound file to play for one second before proceeding to the next step.

Images shown are for demonstration only purposes and will vary by model.

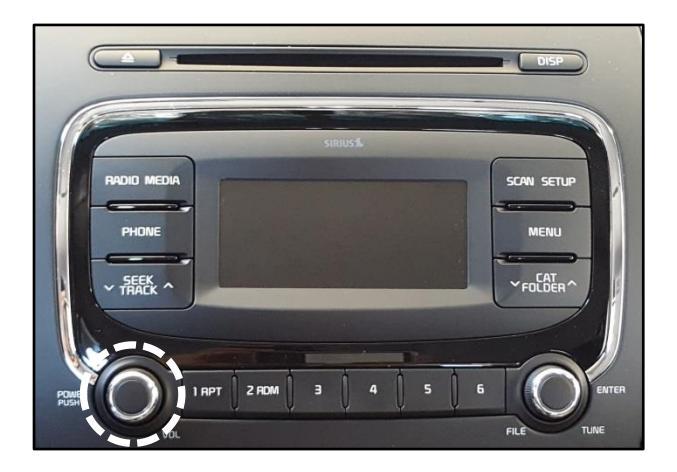
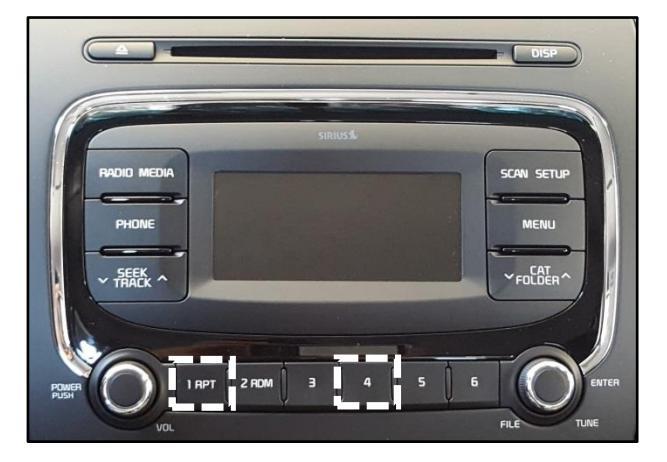
8. Press and hold preset button "1" and then preset button "4" and continue to hold both for five (5) seconds.

If the software version screen is displayed when pressing and holding the preset buttons "1" and "4", restart the procedure from step 7.

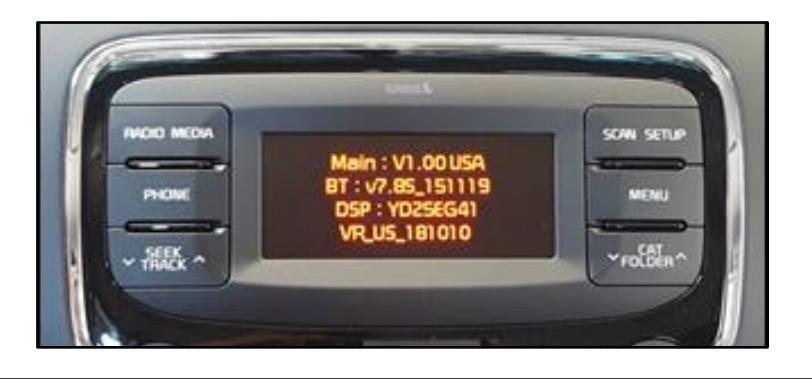
9. Immediately after releasing preset buttons "1" and "4", press preset button "1" four (4) times in a row quickly within half a second each.

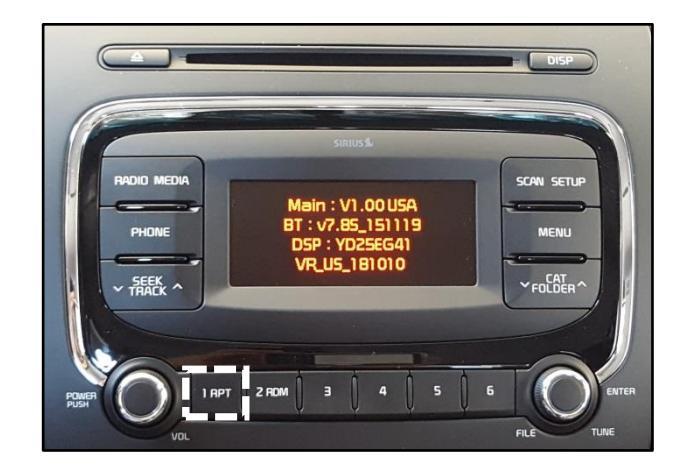
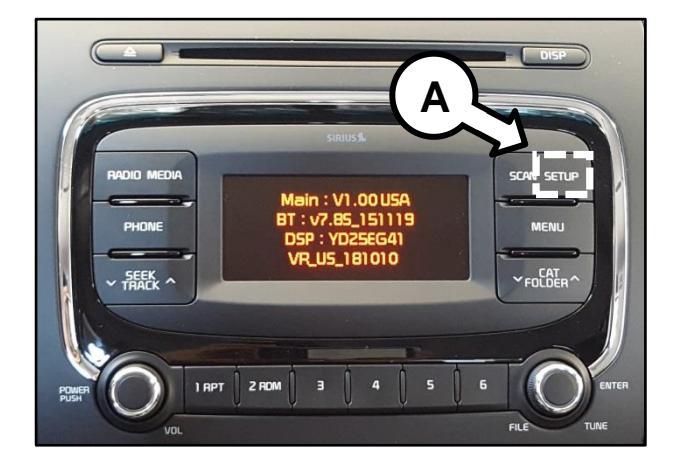
10. If the S/W version screen displays correctly, press the **SETUP (A)** button.

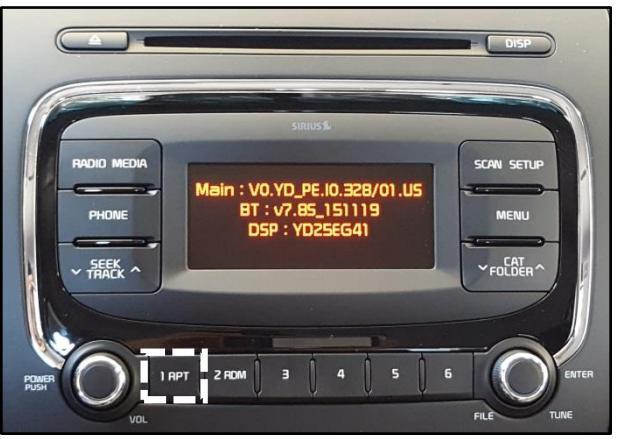
11. Press preset button "1" to display the firmware upgrade menu.

- Β scan setu MENU FOLDER 2 RDM I APT
- 12. Once the Firmware upgrade menu is displayed, press preset button "4" to update MICOM (B).

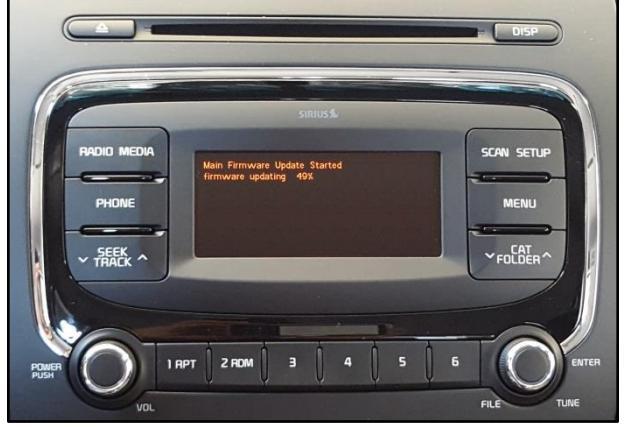
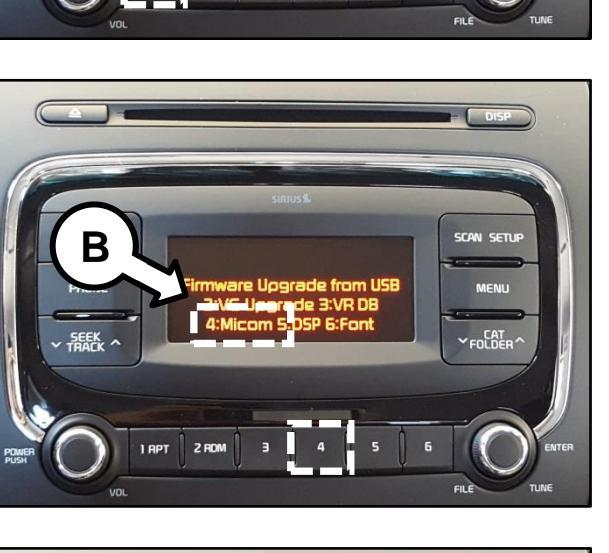
13. The upgrade will begin and system will display the progress on the screen. Once the upgrade is complete, the head unit will automatically reset and then turn off.

The update will take approximately three (3) minutes to complete.

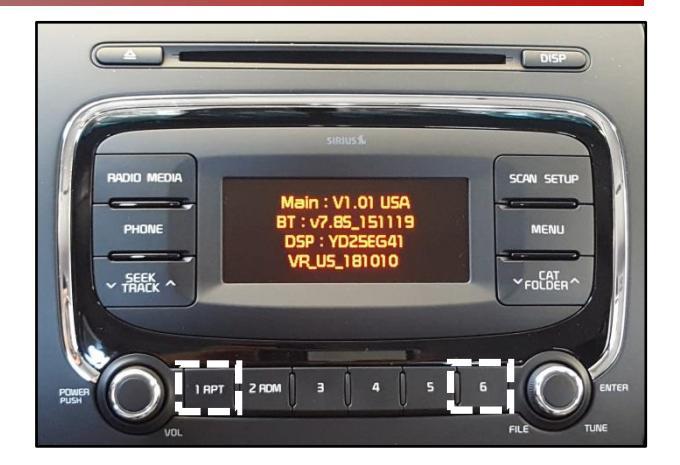
14. With the head unit off, press preset buttons "1" and "6" at the same time for two seconds or more and verify that the software update is successful. If update is not successful, restart the procedure from step 5.

Model	Updated Version			
Forte (YDm)	V1.01 USA
