## Technical Service Bulletin

#### 01 MIL on (DTC P0456 (EVAP emission control system small leak detected))

01 16 59 2040924/2 April 20, 2016. Supersedes Technical Service Bulletin Group 01 number 16-51 dated January 13, 2016 for reasons listed below.

Model(s)	Year	VIN Range	Vehicle-Specific Equipment
Q7	2014 - 2015	All	3.0L engine

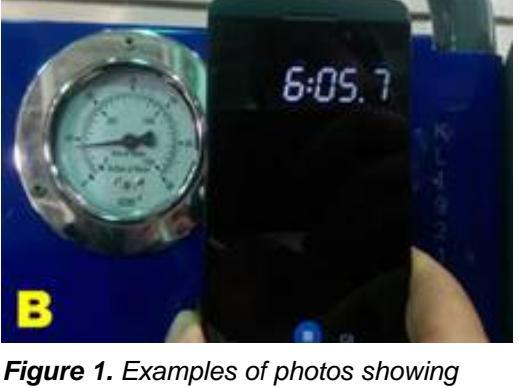
*Figure 1.* Examples of photos showing pressure gauge at beginning of test (A) and after test (B).

- 1. Visually inspect the EVAP system for any loose connections or damaged parts. If found, repair the loose connections and/or replace the damaged parts.
- 2. Connect KLI9210 and turn knob to "Hold". Before proceeding, have a stopwatch ready.
- 3. Perform basic settings 70/71 test. Monitor the pressure increase and record the max value. (The max pressure should be between 9-13 inch/water.)
- 4. Monitor and **document** the pressure drop within six minutes (Figure 1):
  - Record the beginning pressure and take a photograph of the stopwatch and gauge for documentation.
  - As soon as the pressure stops increasing, start the stopwatch and turn the ignition off.
  - At max pressure, and after six minutes, take another photograph of the stopwatch and gauge for documentation.
