01 MIL on; small EVAP leak (DTC P045600)

01 16 63 2044156/1 May 10, 2016.

Model(s)	Year	VIN Range	Vehicle-Specific Equipment	
A6	2016	000001 - 111348	3.0 TFSI

Technical Service Bulletin

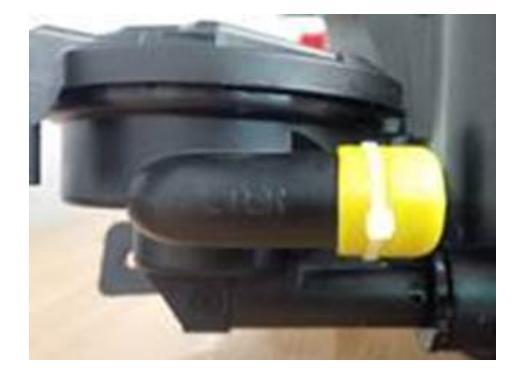
Figure 1. Block the filter port on the NVLD sensor.

- 1. Before proceeding, ensure that the gas cap was tight and that the DTC is present.
- 2. Test for a leak by first calibrating tester KLI9210 to 0.02 inch port with 14 inch/water as described on the tester. Set marker on flow meter to this position and take a picture for documentation.
- 3. Block off the filter port on the NVLD sensor (Figure 1).

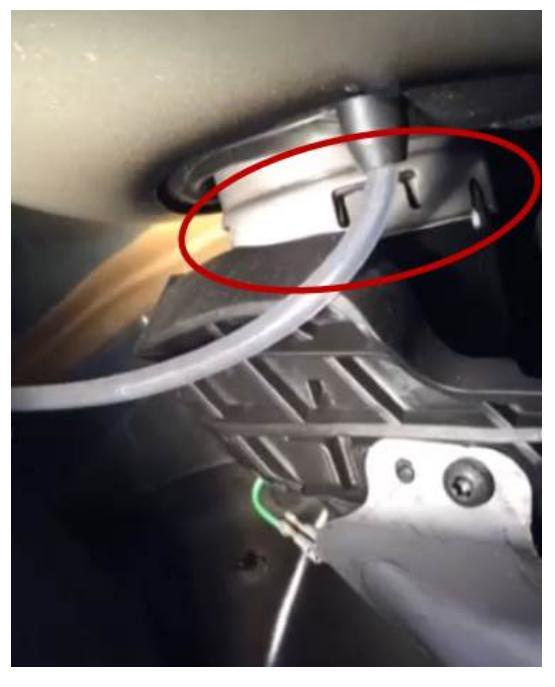
Rubber O-ring at tank filler neck is out of position.

Figure 2. Check for smoke escaping around the filler neck.

- 4. Connect the tester to the vehicle and pressurize the system (3- 5 minutes).
- 5. Take a picture of the flow meter.
- 6. Remove the purge line from the N80 valve.
- 7. Generate smoke with the smoke function of the KLI9210 tester until smoke comes out of the purge line on the N80 side.
- 8. Smoke EVAP system under pressure.
- If smoke is escaping around the filler neck of the fuel tank (wheel liner removed) replace fuel tank (Figure 2).
 - If no leak can be found, contact TAC.
