Technical Service Bulletin

SUBJECT: TSB-17-54-003 No: MAIN DRIVE BATTERY CANNOT BE DATE: July 2017 CHARGED TO FULL AVAILABLE CAPACITY -MODEL: 2012-13 i-MiEV WARRANTY EXTENSION – REVISED CIRCULATE TO: [] GENERAL MANAGER [X] PARTS MANAGER [X] TECHNICIAN [X] SERVICE ADVISOR [X] SERVICE MANAGER [X] WARRANTY PROCESSOR [] SALES MANAGER

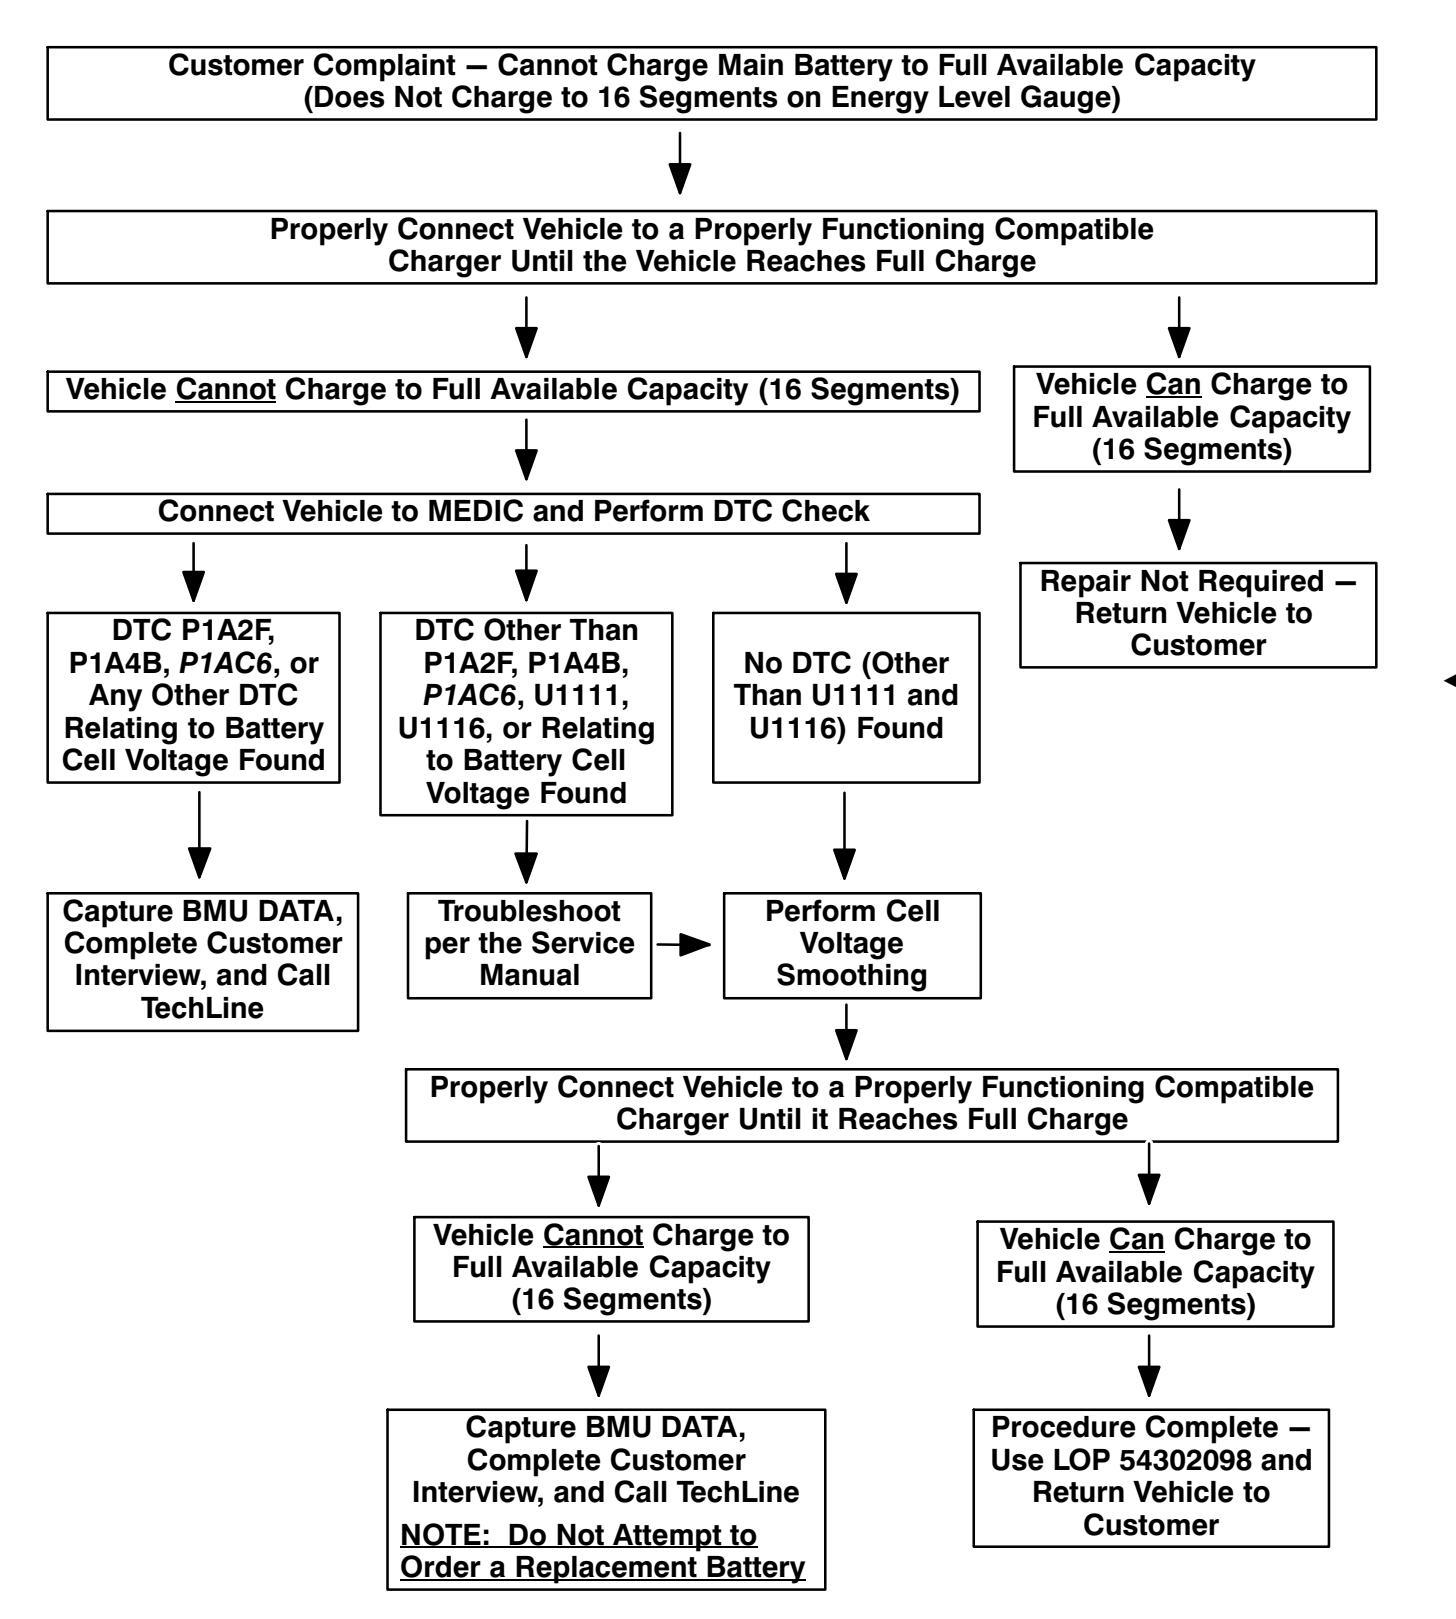
Follow the flow chart below to troubleshoot the customer's concern.

<u>Before</u> performing any procedures described in this TSB, properly connect the vehicle to a properly functioning compatible charger until it reaches full charge. If the vehicle <u>CAN</u> charge to full available capacity (16 segments on the Energy Level Gauge), return the vehicle to the customer and advise a repair is not required at this time.

If the vehicle <u>CANNOT</u> charge to full available capacity (16 segments on the Energy Level Gauge), perform the procedures described in this TSB.

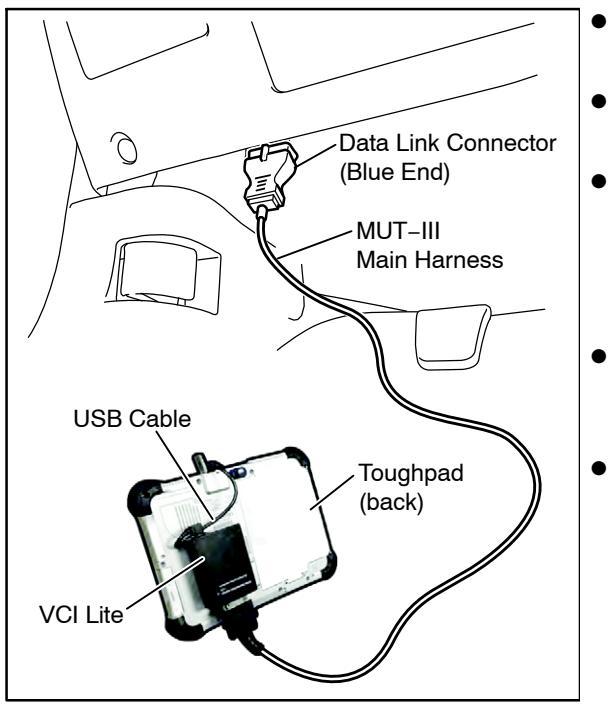
1. Connect the equipment as follows:

NOTE: VCI Lite and MEDIC 4.0 Toughpad shown for illustration purposes only.

- Connect the USB cable from the MEDIC laptop/ tablet to the VCI/VCI Lite.
- Connect the MUT–III main harness with the blue DLC connection to the VCI/VCI Lite.
- Turn the MEDIC PC/tablet on. If the battery indicator in the lower right hand corner of the screen does not show a full charge, it is recommended that either the battery be charged prior to beginning, or be used with the A/C power adaptor connected.
- For VCI Only: Turn the VCI power switch ON. Verify that the indicator lamp in the upper right corner of the screen is green.
- Connect the blue connection of the MUT–III main harness to the vehicle's data link connector.

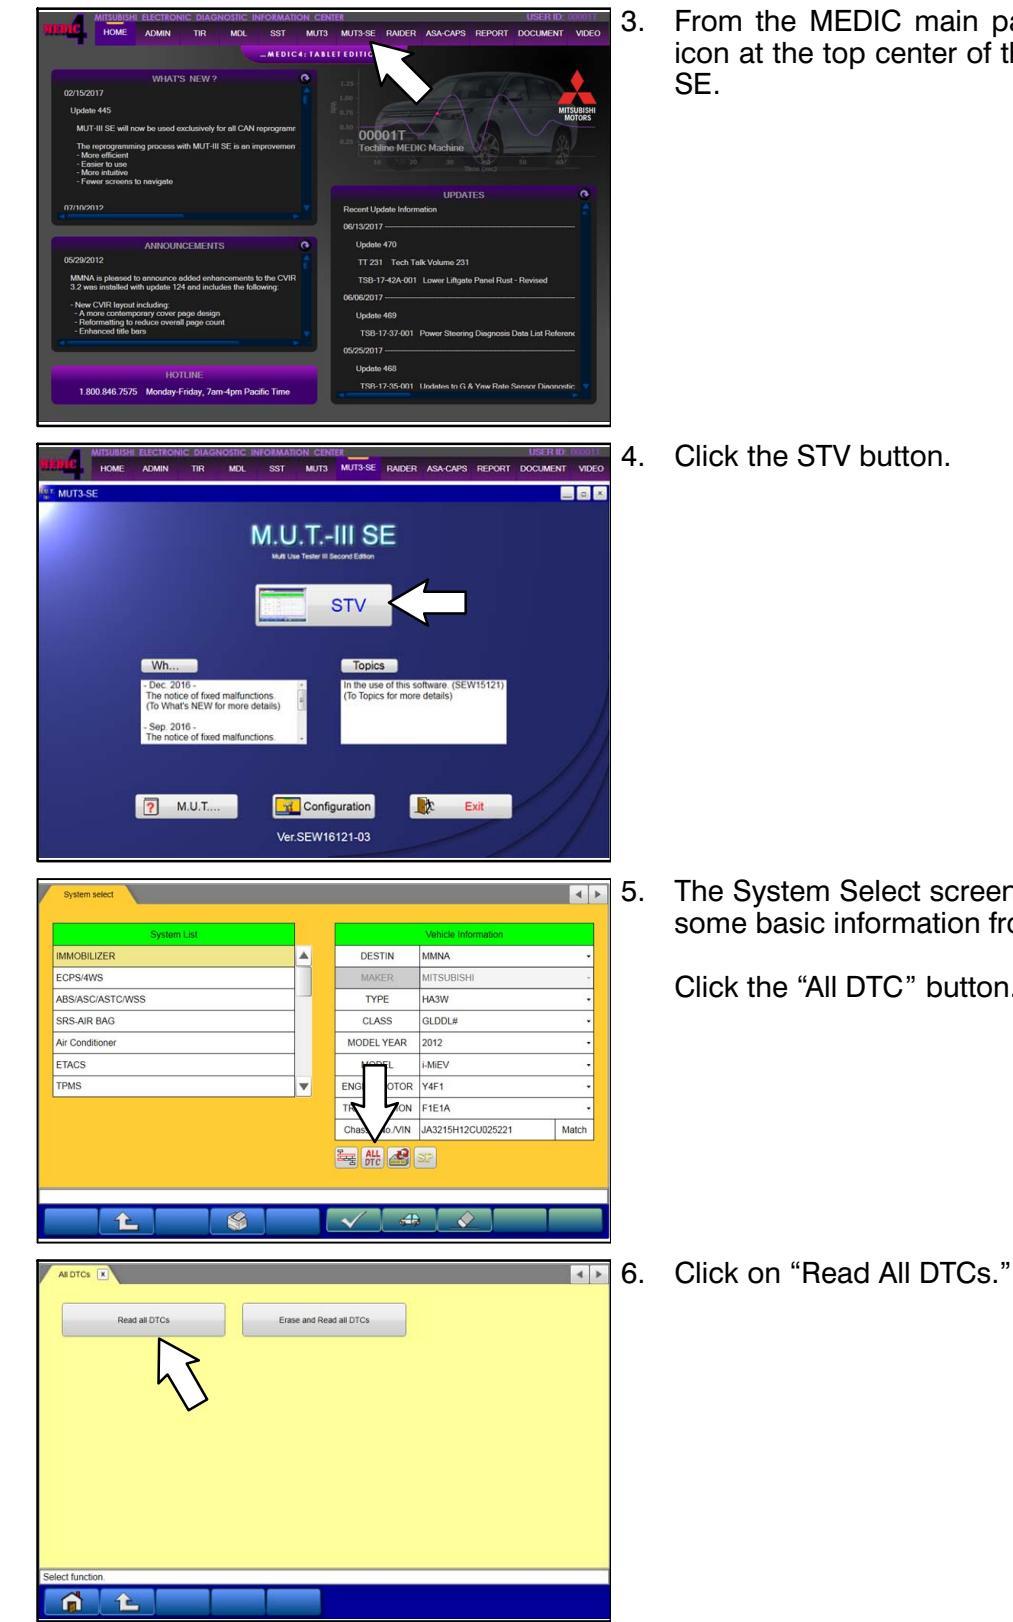
From the MEDIC main page, click the "MUT3-SE" icon at the top center of the screen to open MUT-III

Click the STV button.

The System Select screen opens and populates with some basic information from the vehicle.

Click the "All DTC" button.

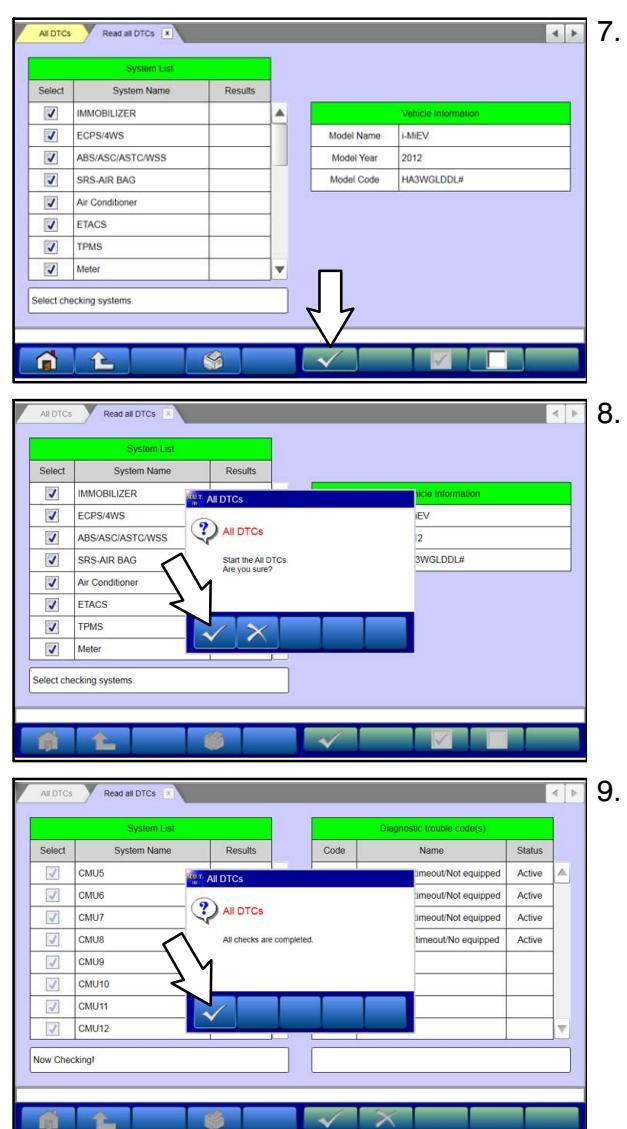
The "System List" on the left side of the screen will have all selections checked. <u>Do not</u> change these selections. DTCs may be set if the vehicle is equipped with options that are unchecked.

Click the check mark to continue.

A window will pop up asking you to start All DTC checking.

Click the check mark for DTC reading to begin.

A window will pop up indicating the DTC checking is complete.

Click the check mark in the dialog box.

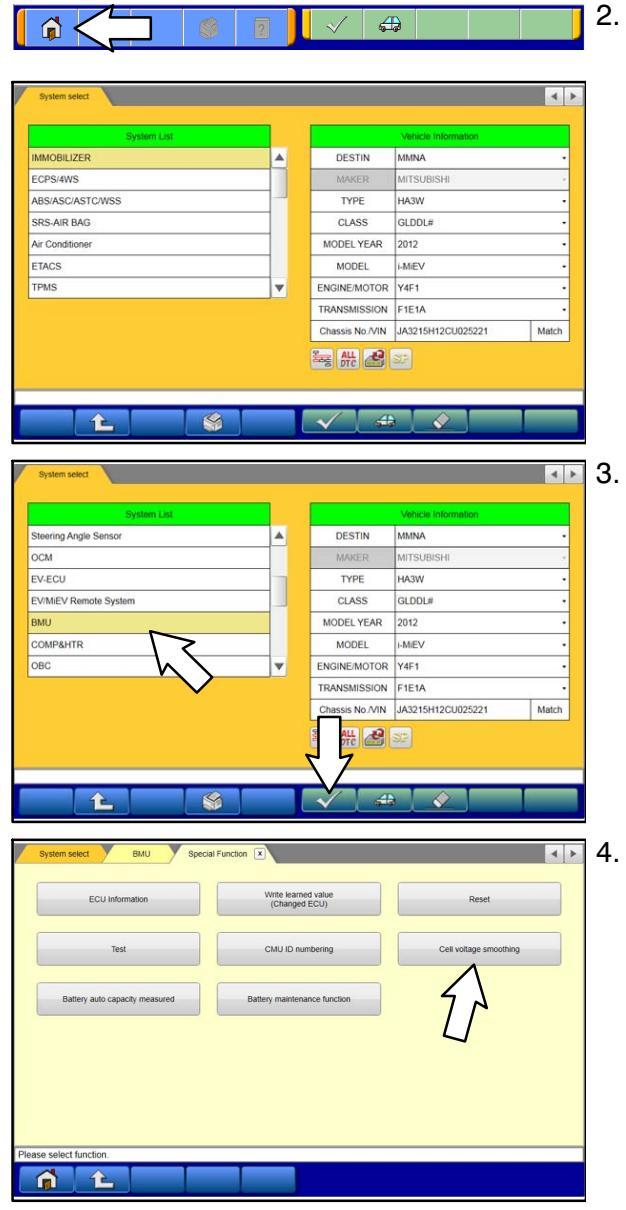
Return to the System select page by selecting the Home icon in the lower left corner.

In the System List, scroll down and select "BMU," then click the check mark.

Select "Cell voltage smoothing."

- Wait approximately 2 hours for Cell voltage smoothing to complete.
 - **NOTE:** During Cell voltage smoothing, the "Execution status" will display "Active."
- 10. The Cell voltage smoothing is complete when the "Execution status" displays "Not active" (1).
- 11. Once the Cell voltage smoothing is complete, properly connect the vehicle to a properly functioning compatible charger until it reaches full charge.
- 12. Confirm the Battery cell maximum voltage value (2) and the energy level gauge.
 - a. If the Battery cell maximum voltage value (2) is more than 4.080V and the energy level gauge can charge to 16 segments, repair is complete. Complete the warranty claim with **LOP 54302098**.
 - b. If the Battery cell maximum voltage value (2) is <u>less</u> than 4.080V, or the energy level gauge <u>cannot</u> charge to 16 segments, proceed to the **Capture** BMU Data section.

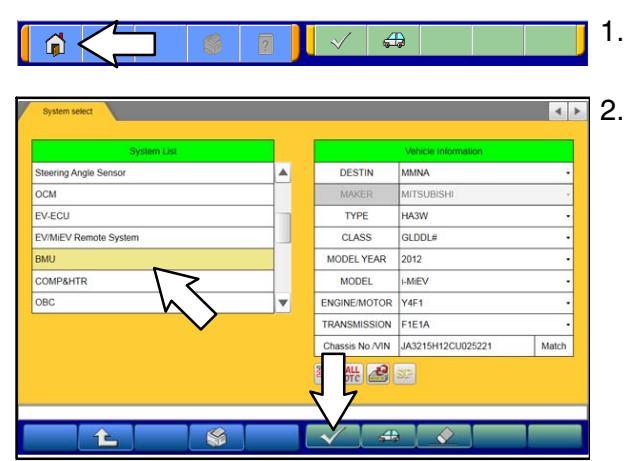
- Return to the System select page by selecting the Home icon in the lower left corner.
- In the System List, scroll down and select "BMU," then click the check mark.
