Technical Service Bulletin

91 Parking aid system does not work (DTC 1549, 1626, 1627, 1628, and/or 1629)

91 17 19 2023006/4 March 30, 2017. Supersedes Technical Service Bulletin Group 91 number 14-31 dated April 7, 2014 for reasons listed below.

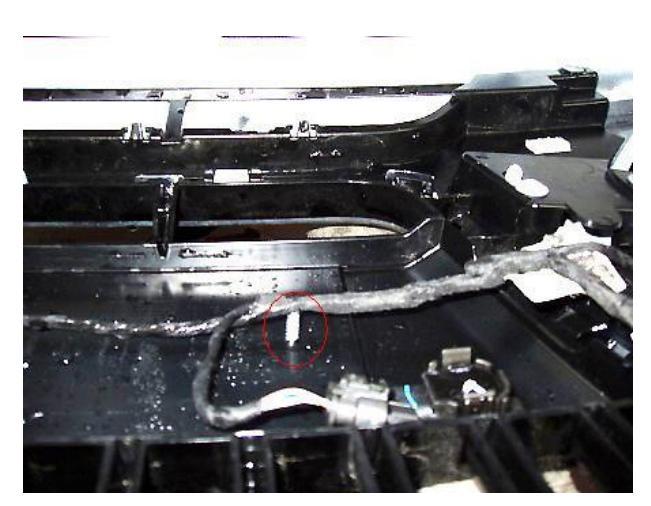
The wire harness for the parking aid system may have been damaged when the front license plate frame was installed (Figure 1).

Figure 1. Damage to the wire harness for the parking aid system.

Repair the wire harness as necessary.
