Technical Service Bulletin

40 Service information for lower bonded rubber bushing for pendulum support

40 17 60 2047207/1 April 12, 2017.

Model(s)	Year	VIN Range	Vehicle-Specific Equipment
A3	2005 - 2013	All	Not Applicable
Q3	2015 - 2017	All	Not Applicable

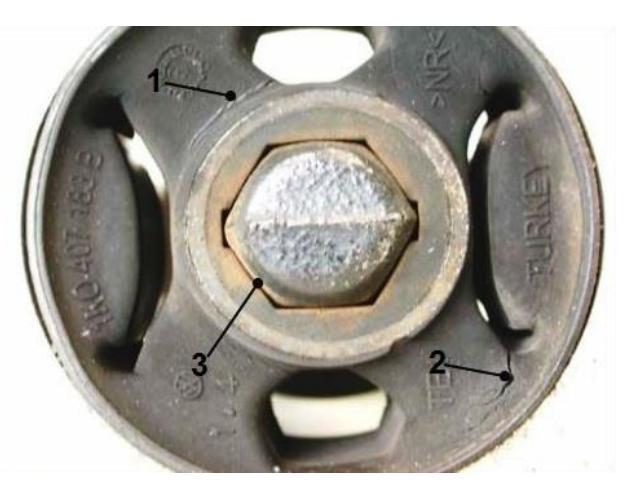
Cracks which are not significant parts of the bearing elastomer or rubber structure (for example: bars), do not affect the mounting properties. This applies in particular to open "corner of the mouth cracks" up to about 10 mm (3/8-inch) long in the corners of bars. Cracked rubber skins on the edges of bars are production residues - rubber skins do not have any function.

Figure 1. Harmless shallow hairline cracks, long corner of the mouth cracks, and permissible free play.

1. Harmless shallow hairline cracks (Figure 1).

2. Up to about 10 mm (3/8-inch) long corner of the mouth cracks (Figure 1).

3. Permissible free play between transverse link hexagonal bolt and bonded rubber bush (Figure 1).

If the cracks on the rear mounting bracket match the above criteria, a parts replacement is not necessary.

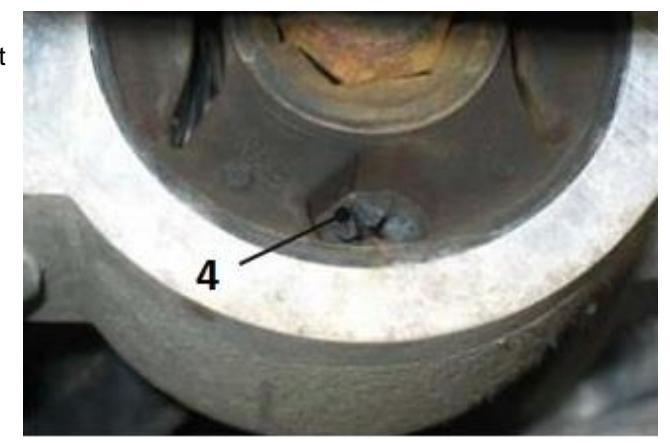
4. Harmless cracked rubber skins (Figure 2).

Figure 2. Harmless cracked rubber skins.
