Service Bulletin

Subject:	Gan Between (Center Pillar Upper	Trim Panel and	d Door Seal
Subject.	Oap Detween C	Senter Final Opper	i i i i i i anei an

Models: 2014 Cadillac CTS Sedan (VIN A) Built Prior to May 1, 2014

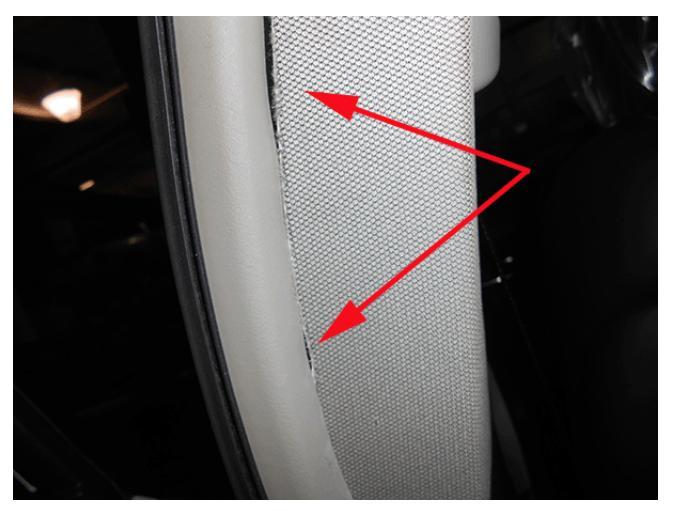
Some customers may comment that there is gap between the center pillar upper trim panel and the door seal.

This condition may exist because the center pillar upper trim panel may flex, allowing a gap to the door seal.

If this gap is present as illustrated above, there has been a redesigned trim panel released to correct the gap. Replace only the affected center pillar upper trim with the redesigned trim panel. Refer to the Center Pillar Upper Trim Panel Replacement in SI.
