Service Bulletin

Subject: Information on Installation of Stage One and Two Rear Wicker Bills on Spoiler

Brand:	Model:	Model Year:		VIN:		Engine:	Transmission:
Branu.		from	to	from	to		
Chevrolet	Corvette	2015	2019		-	All	All

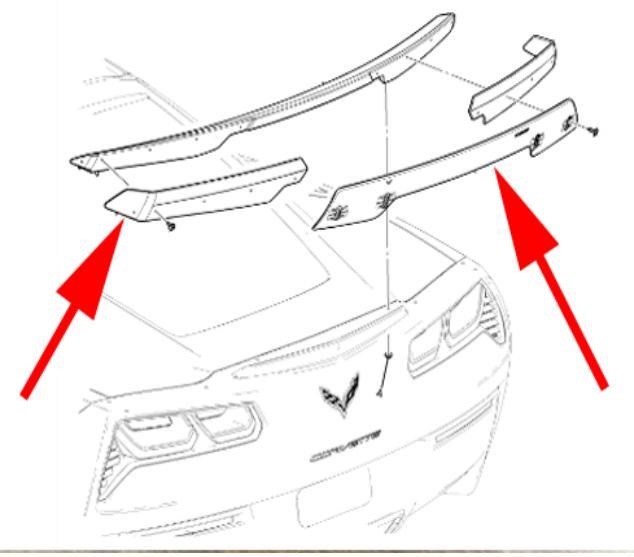
4180967

During the installation of the rear wicker bills that are fastened on the rear spoiler, some technicians may revert to the use of power tools to tighten the fasteners.

When installing the wicker bills onto the vehicle, it is recommended to hand start the fasteners before using the correct hand tools to tighten the fasteners to the proper torque specifications.

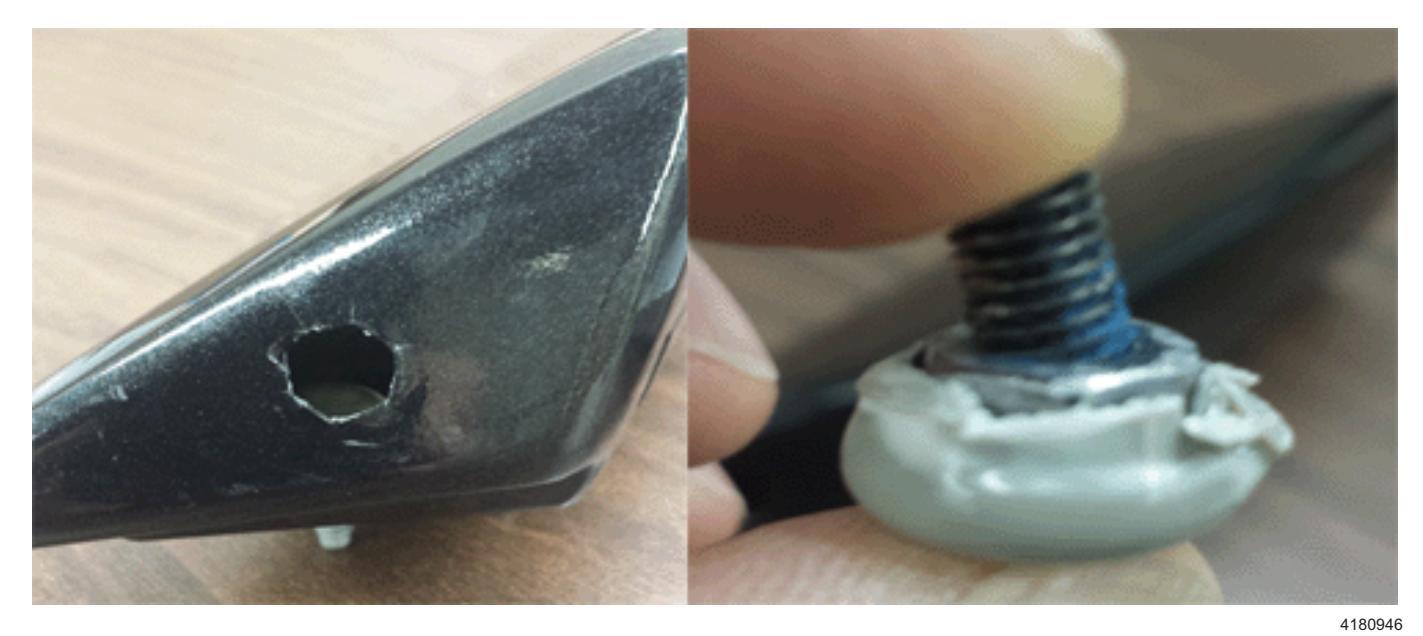
The use of power tools should not be used due to the fact that this could lead to damage to the fasteners and/ or the spoiler.
