August 9, 2018 23X1 UPDATE – ECM Software Update (FED_EMS)

Model(s)	Year	Engine Code	Trans. Code
Atlas	2018	3.6L (CDVC)	ALL

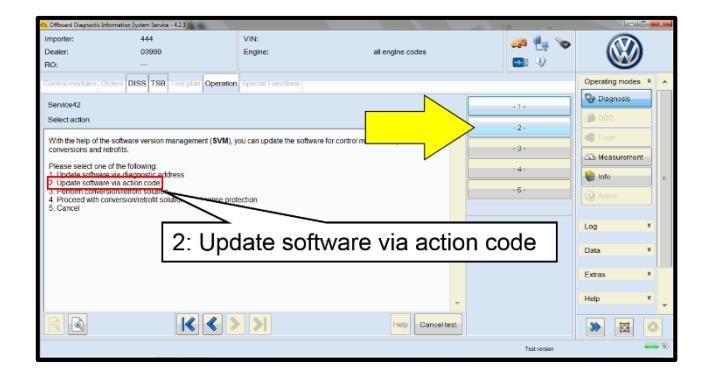
- Confirm that scan tool is communicating with the diagnostic head by USB <Green Arrow>.
 - If the Bluetooth symbol is shown <Red Arrow> then disconnect the diagnostic head from the vehicle and reconnect the USB cable to the diagnostic head and then reattach to the vehicle.
- Upon ODIS startup, verify the "Diagnosis" operating mode is selected <as shown>.
- Once the GFF scan is complete, select "Special functions" <arrow 1>, then "Adapting software" <arrow 2>, then select "Perform test" <arrow 3>.

• Select option 2 to "Update software via action code".

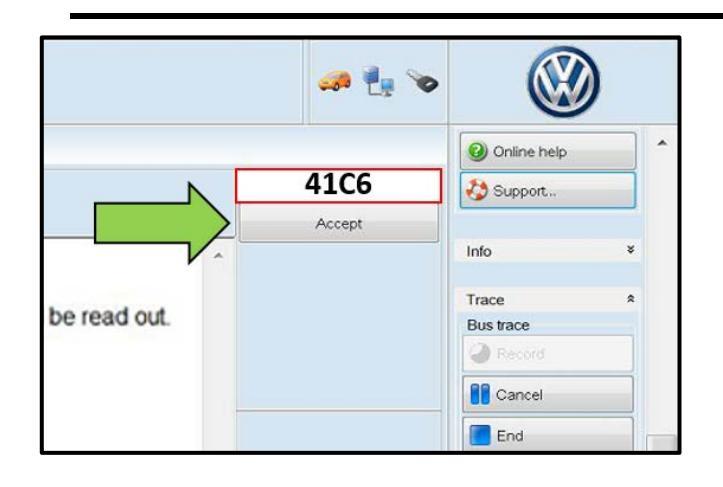
• Enter the corrective action code (SVM code) as listed below.

- Select "Accept" <arrow> and follow the on screen prompts.
- During the flash, this screen appears during the update process.

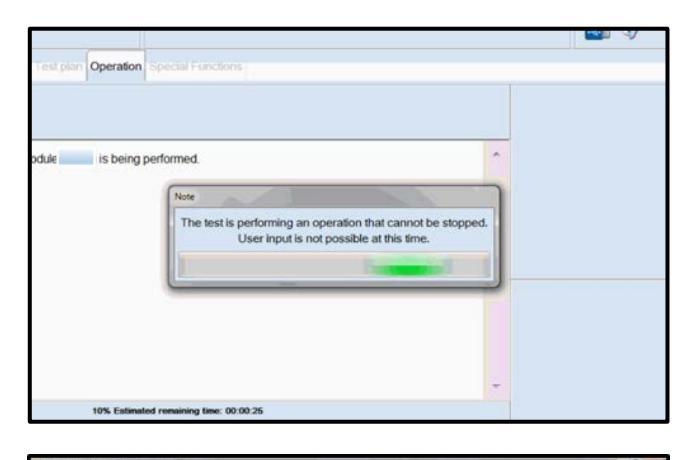
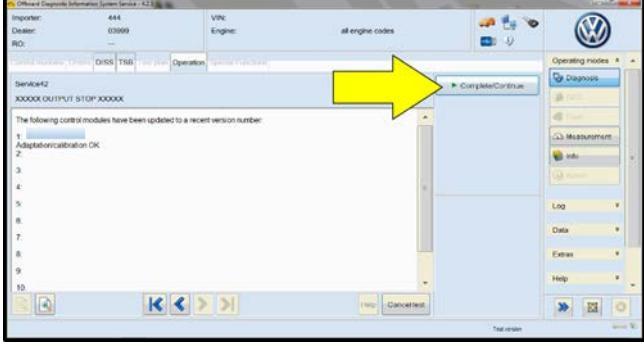
If the software in the vehicle is already current, a message will appear indicating this. If this occurs, complete the ODIS test plan and send the diagnostic protocol online.

• Select Complete/Continue <arrow> after each operation is completed.

- When the SVM update is complete a confirmation message is displayed <as shown>.
- Select "Complete/Continue" <arrow>.

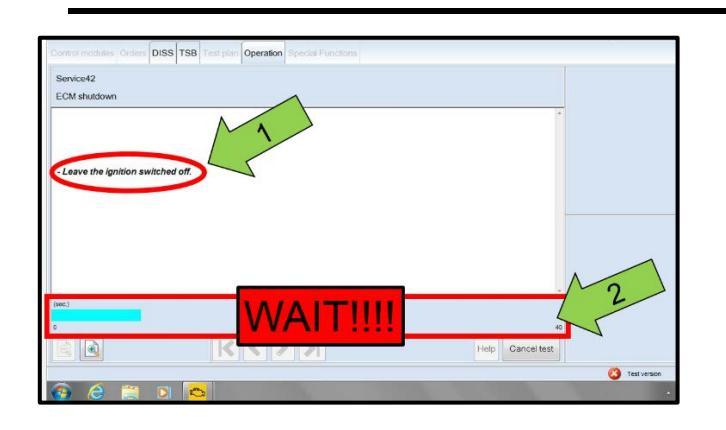
- It is <u>IMPERATIVE</u> that <u>ALL</u> of the ignition cycle on/off delay requests are fulfilled in their entirety during this flash process <arrow 1>.
- Failing to wait for the ignition on/off timing cycle to complete (progress bar and countdown timer <arrow 2>) before cycling the ignition on/off MAY damage a control module.
- Damage to control modules as a result of failing to wait the specified time displayed by the progress bar and countdown timer <arrow 2> are <u>NOT</u> covered under this action.
- After the software update is completed and before sending the GFF Log Online:
 - Select the "Control Module" tab.
 - Scroll down and right click on the module that was updated (0001).
 - Select "Identify Control Module" <arrow>.
- Exit GFF and send diagnostic protocol online when prompted.

Static communication faults may store in various control modules during the flash. These faults can only be cleared by following one of these steps:

- Drive the vehicle a short distance (around the parking lot, for example).
- After selecting "Yes", turn the ignition off for 30 seconds, turn it back on and repeat the GFF exit program.
- Clear faults using OBD (an additional key cycle may also be required).
- Release the parking brake.
- Disconnect the VAS tester.
- Switch off and disconnect the battery charger.
- Reinstall the battery cover.
