Mazda North American Operations Irvine, CA 92618-2922

Subject: Service Alert No.: SA-041/18 ENGINE RUNS ROUGH AND/OR LACK OF POWER WITH DTCs Service Alert No.: SA-041/18 P0340:00, P0304:00, P3400:00, P349B:00, P3498:00 Last Issued: 12/06/2018

2018 CX-5 with cylinder deactivation 2018 Mazda6 with cylinder deactivation

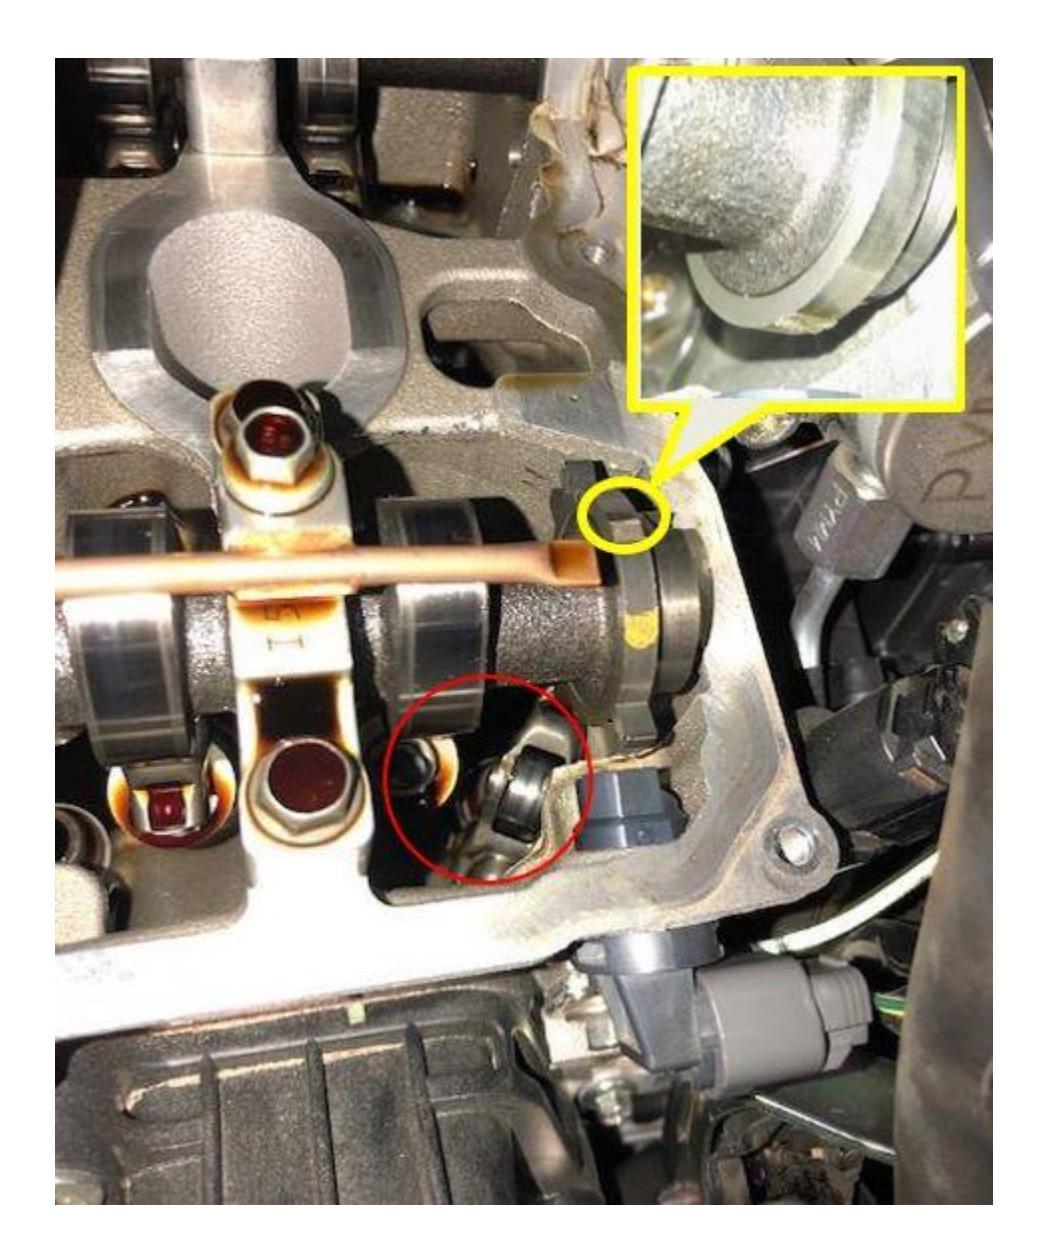
- 1. Remove cylinder head cover and inspect valvetrain area.
- 2. Inspect for fallen or broken rocker arm, especially in cylinder deactivation area (cylinders 1 and 4).
- 3. Verify engine oil change records.
- 4. Submit pictures of fallen rocker arm, camshaft trigger wheel and engine oil filter cartridge to Siebel.

- 1. Collect ODR.
- 2. Contact Technical Assistance Hotline for engine replacement authorization via MASH.
- 3. Collect and secure all broken pieces into a bag when shipping.
