SI B11 14 17 Engine February 2019 Technical Service

N20 AND N26 ENGINES: TURBOCHARGER ELECTRIC WASTEGATE ACTUATOR LINKAGE PIN CORROSION

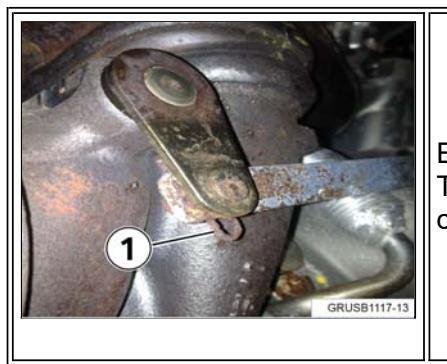
Example: The turbocharger wastegate actuator linkage pin (1) is rusted and cannot be removed.

Use the attached procedure to remove the turbocharger, remove the remaining portions of the corroded electric wastegate linkage pin and install the electric wastegate linkage pin repair clip P/N 83 30 2 456 269.

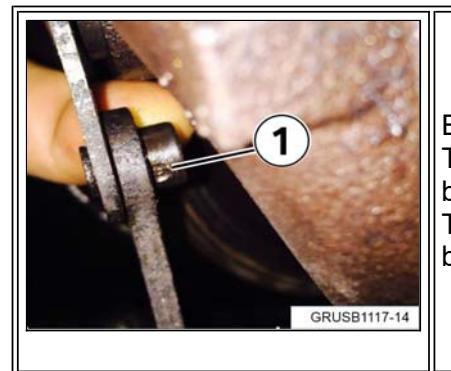
Example: The turbocharger wastegate actuator linkage pin (1) has already broken or is missing due to corrosion. The remaining portion of the pin is seized in the hole and it cannot be removed.

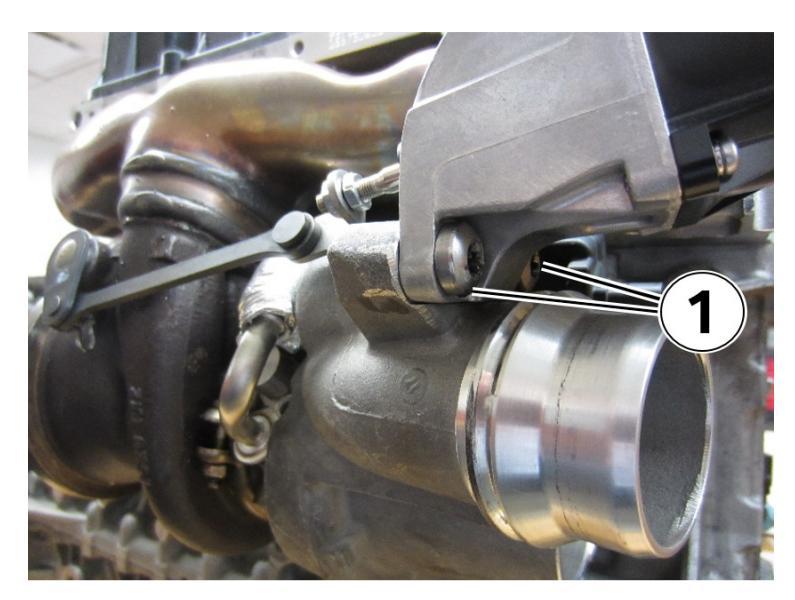
Remove both of the electric wastegate actuator Torx screws (1).

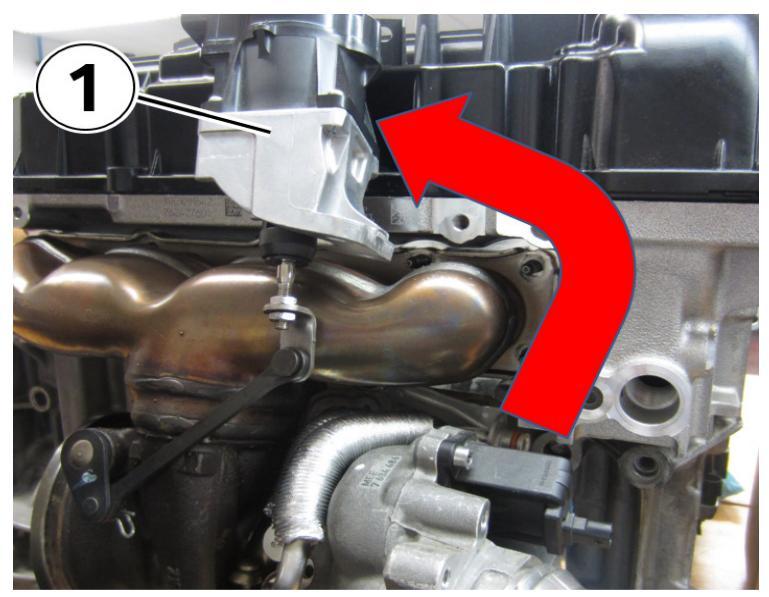
Rotate the wastegate actuator (1) upward in the direction of the arrow.

Temporarily secure the wastegate actuator in this position with a wire tie or similar fastening device.

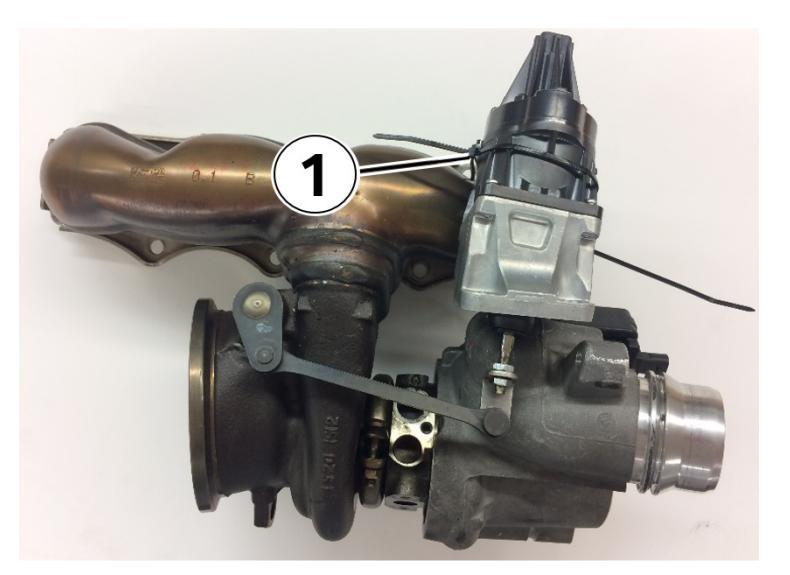
If you are reusing the wastegate actuator then it must be secured with wire ties (1) so that it does not get damaged during the next steps.

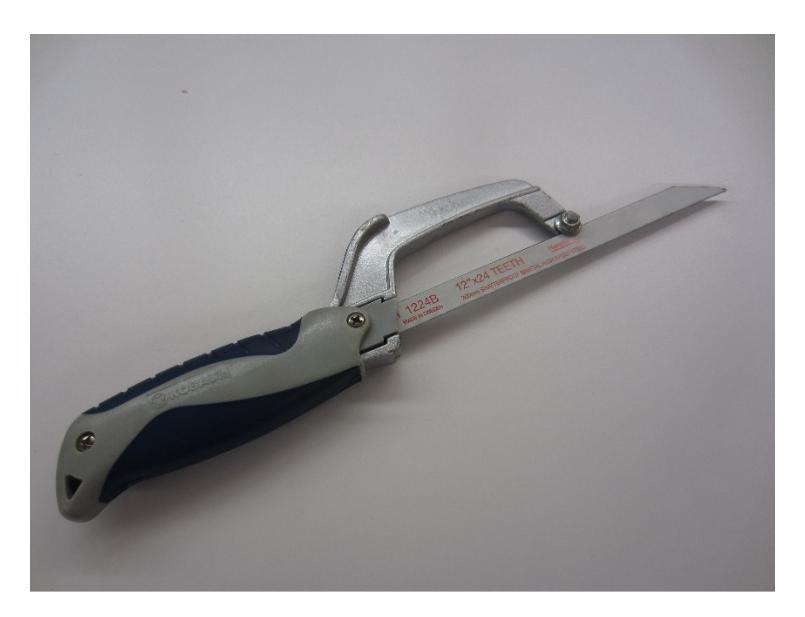
Modify a hacksaw blade (1) as shown using a pair of sheet metal cutters (2).

Cutting the angle on the hacksaw blade will increase access to the corroded wastegate pin.

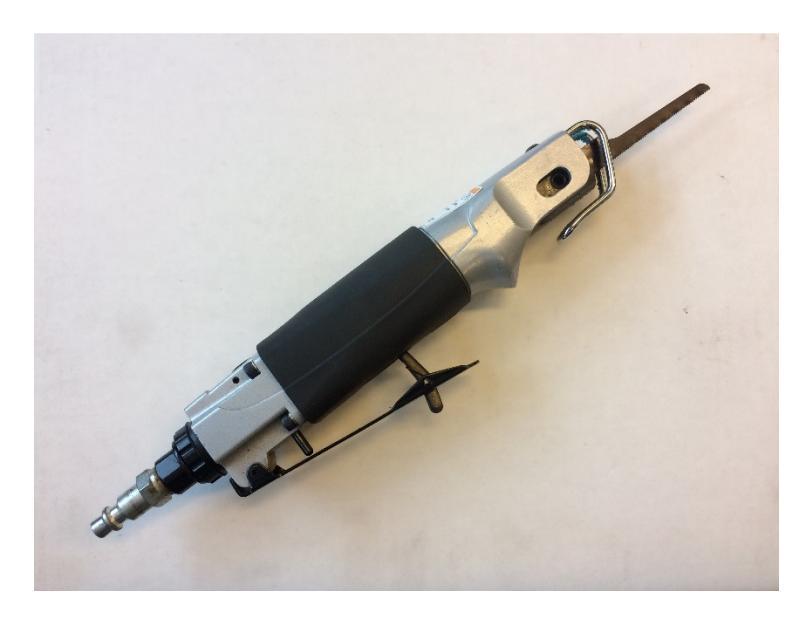
Install the modified hacksaw blade into a suitable holder tool as shown in the illustration.

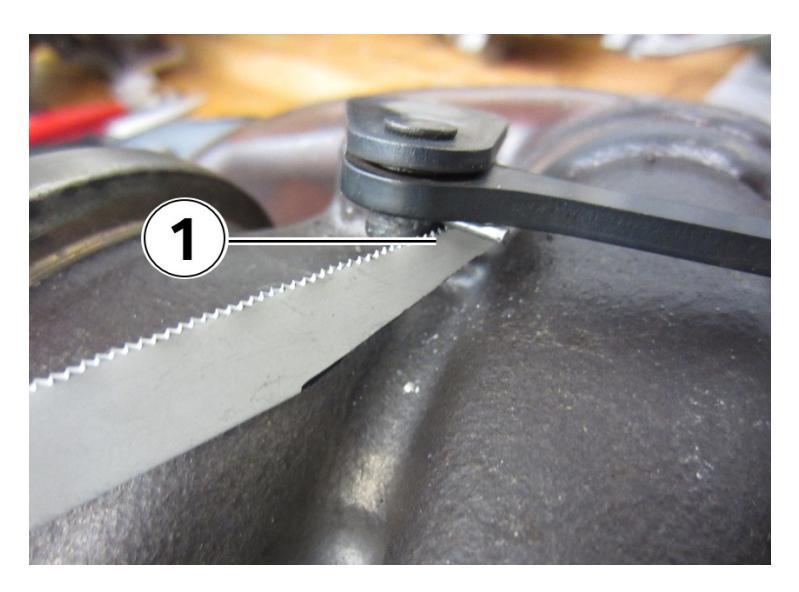
A pneumatic tool with a thin blade (1) can also be used to remove the pin.

Use the modified blade (1) to trim/remove the remaining portion of the waste gate pin.

Do not damage the waste gate lever surface.

Damage to the surface can cause binding.

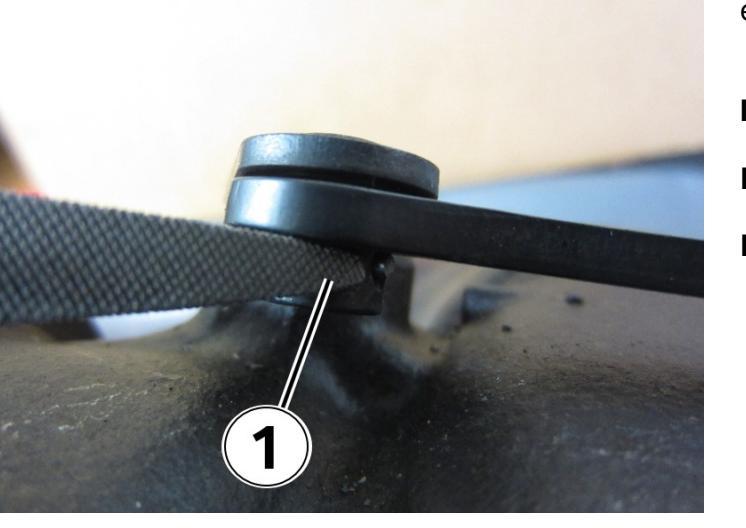
Use a fine metal file (1) to gently remove any existing burrs.

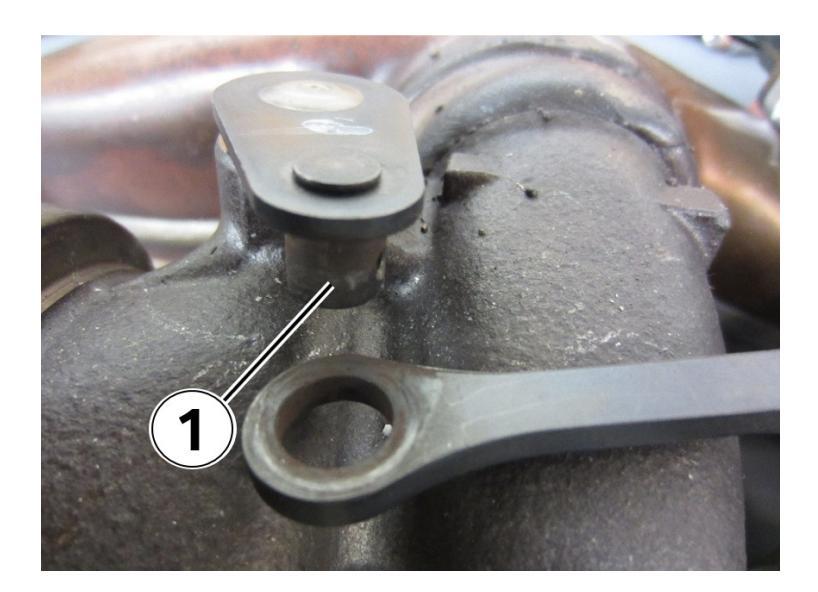
Remove the wastegate linkage from the wastegate lever.

Inspect the wastegate lever (1) for damage.

Use a fine metal file or polishing pad as needed to remove any remaining burrs.

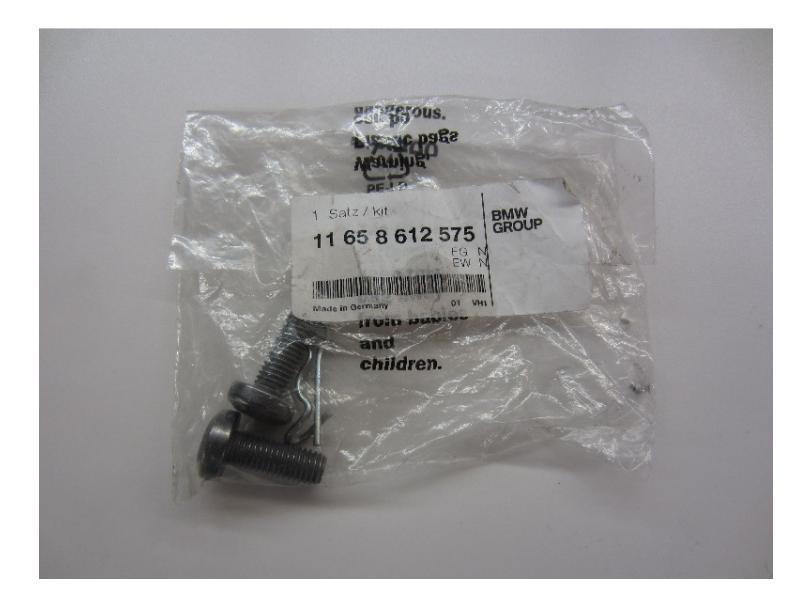
Remove the M8 Torx screws from fastening set P/N 11 65 8 612 575.

Discard the small spring steel clip.

Install the wastegate actuator as per the applicable repair instruction and torque the fasteners.

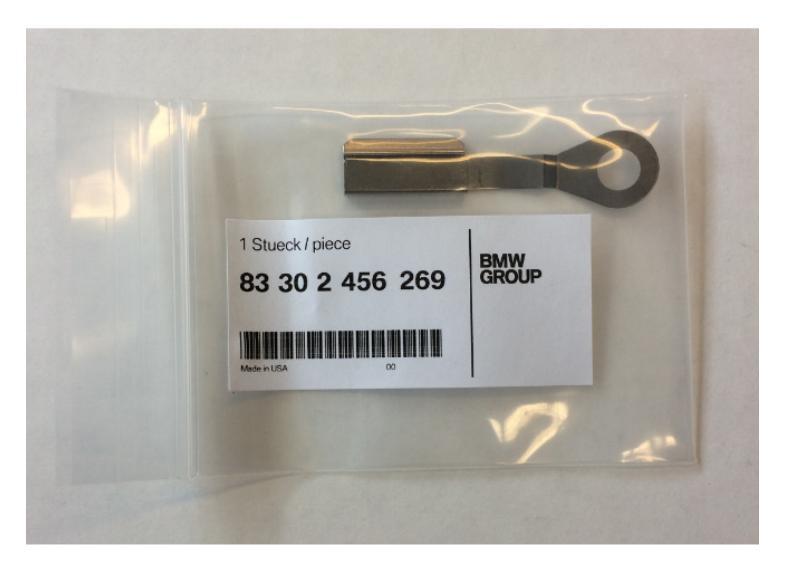
The clip is pre-bent (1) intentionally to place a predetermined preload on the wastegate lever and linkage. See arrows.

Do not straiten the repair clip before installation.

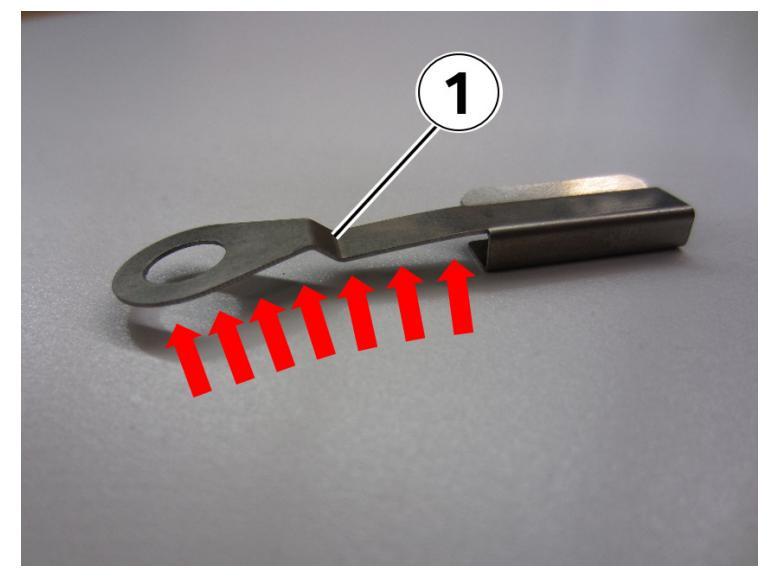
Install the portion of the clip with the channel onto the wastegate linkage arm (1).

Then gently rotate the eye to the center of the wastegate lever in the direction of the arrow.

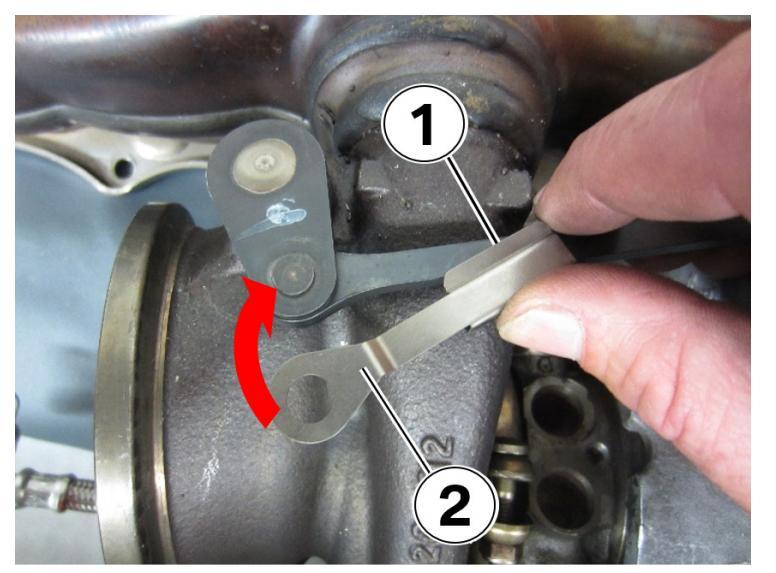
Make sure the channel portion of the repair clip and linkage (1) locks together.

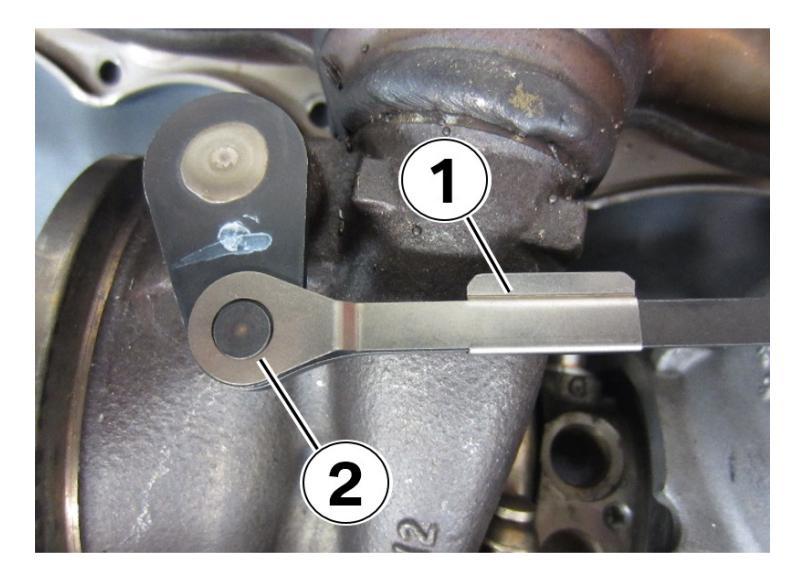
When the clip (1) is correctly installed it will look like the example in illustration.

The eyelet (2) must be locked in place.
