February 15, 2019

Version 1

2016-18 Civic 1.5L: Software Update with A/C Control Unit Update; DTC P0300, P0301, P0302, P0303, P0304, or P0172

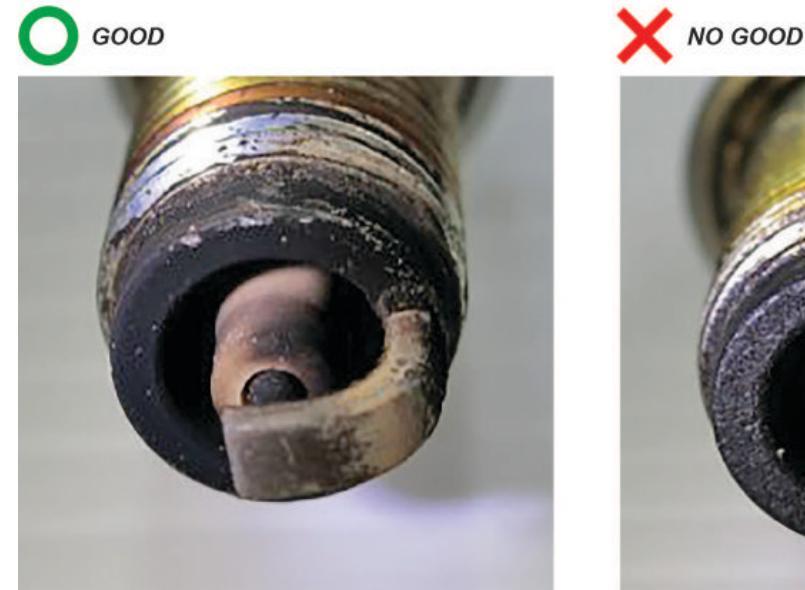
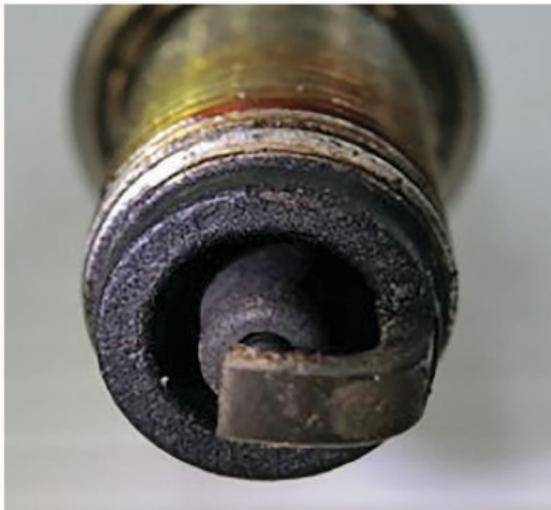
1. In some cases, the DTCs may return. If this happens, inspect the spark plugs.

- If the spark plugs are OK, the procedure is complete. Continue with normal troubleshooting.
- If the spark plugs are fouled, go to step 2.
- 2. Replace the spark plugs per service information and check for stored DTCs.

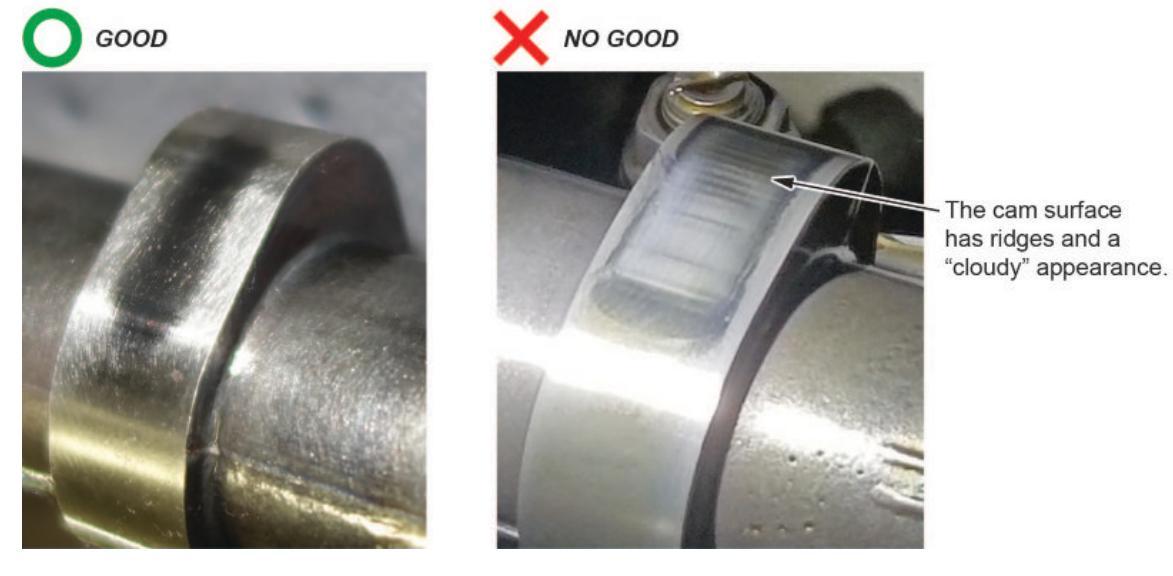
7. Compare the appearance of the camshaft lobes to the photo below.

- If the camshafts appear similar to the no good photo, go to step 8.
- If the camshafts appear similar to the good photo, this bulletin does not apply. Continue with normal system troubleshooting.
- 8. Take a photo of the cam lobe, then follow the directions in the parts catalog when ordering the necessary parts.

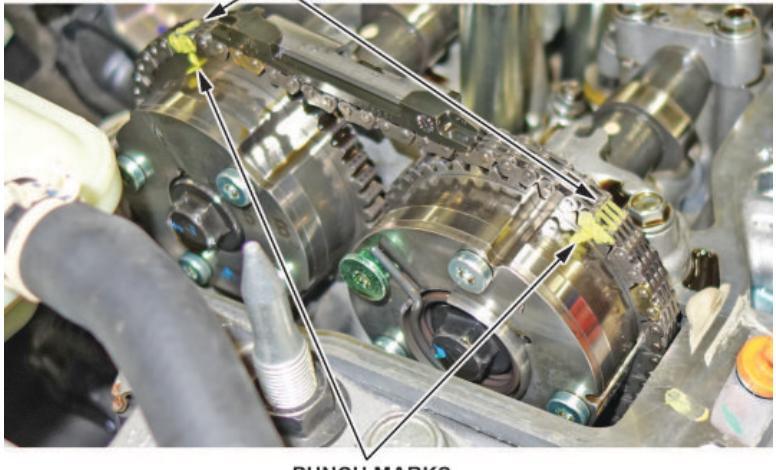
PUNCH MARKS

- 1. Relieve the fuel pressure and remove the high pressure fuel pump. Refer to the service information for additional instructions.
- 2. Set the crankshaft to top dead center (TDC) for No. 1 cylinder. Refer to step 4 of the Camshaft Timing Inspection in the service information.
- 3. Mark the timing chain at the punch marks on the exhaust and intake camshaft sprocket and VTC actuator as seen below.

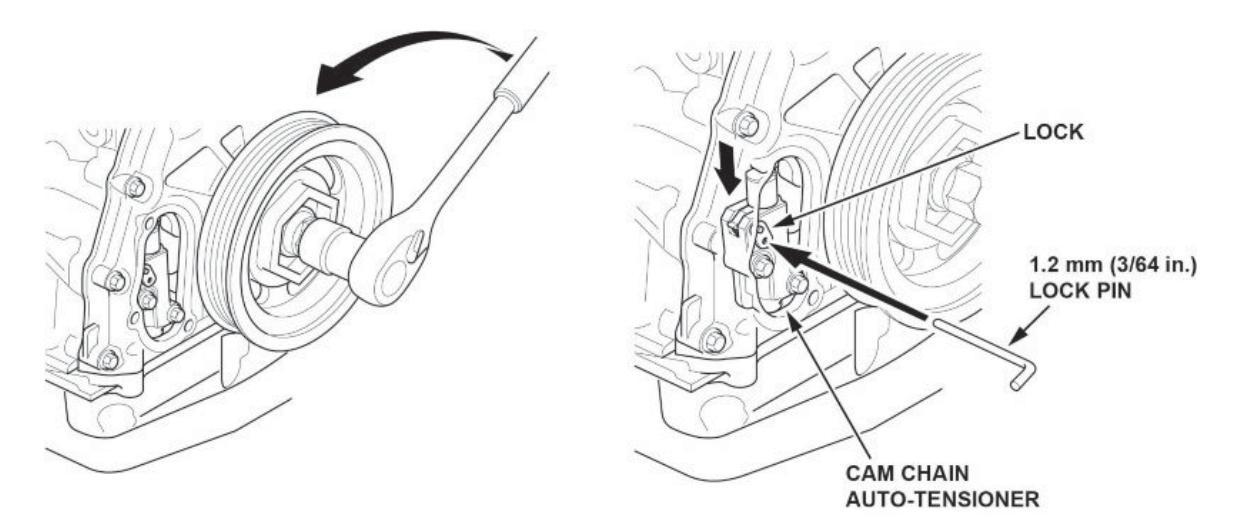
- 4. Raise the vehicle on a lift.
- 5. Remove the right front wheel and the engine undercover.
- 6. Remove the cam chain auto-tensioner (chain case) cover.
- 7. Slightly rotate the crankshaft counterclockwise to compress the auto-tensioner. Line up the hole in the lock and auto-tensioner, then insert a 1.2 mm diameter lock pin.

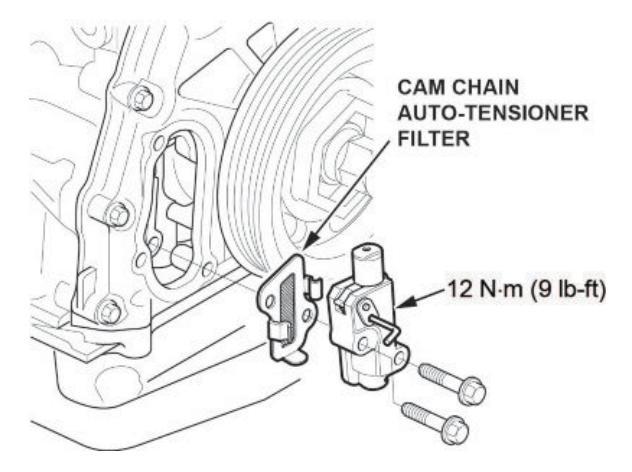
9. Remove the camshaft chain auto-tensioner with the lock pin inserted.

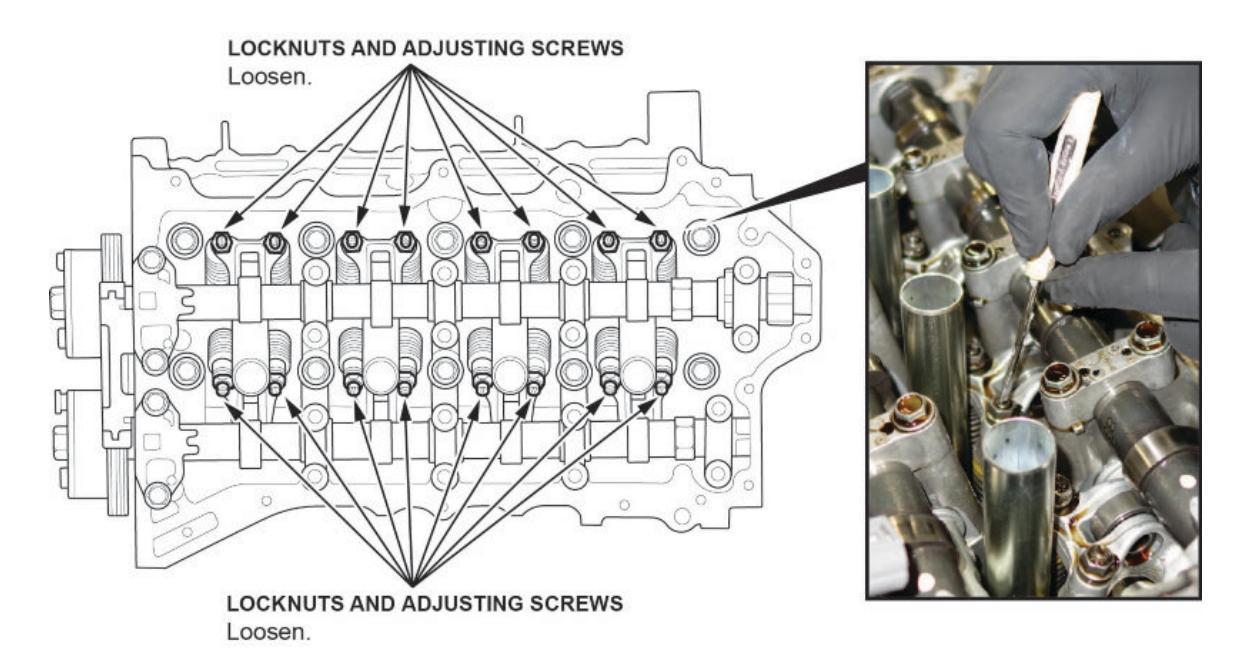
- 10. Lower the vehicle.
- 11. Loosen the locknuts and adjusting screws.

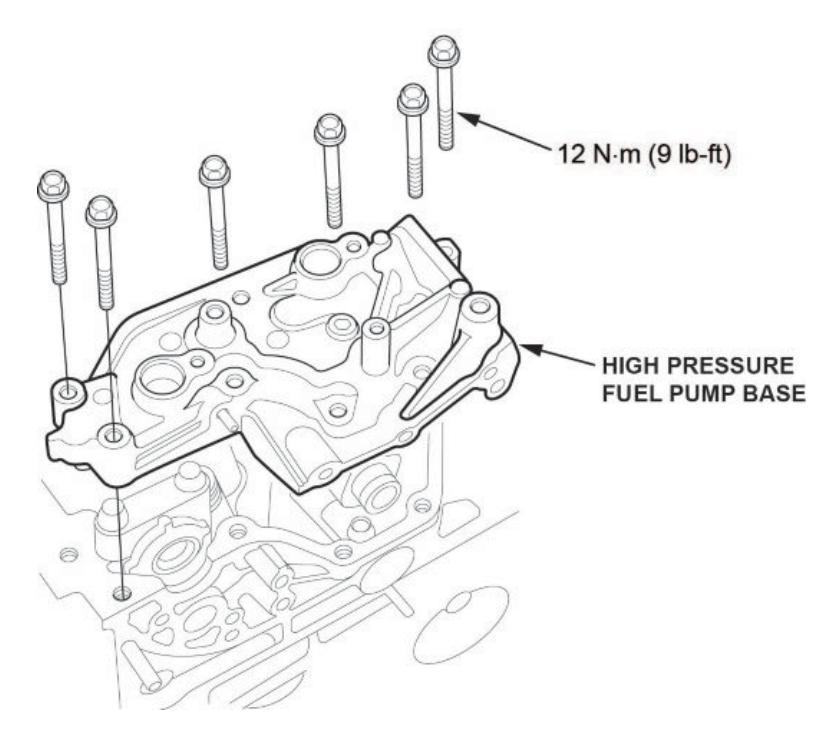
12. Remove the high pressure fuel pump base.

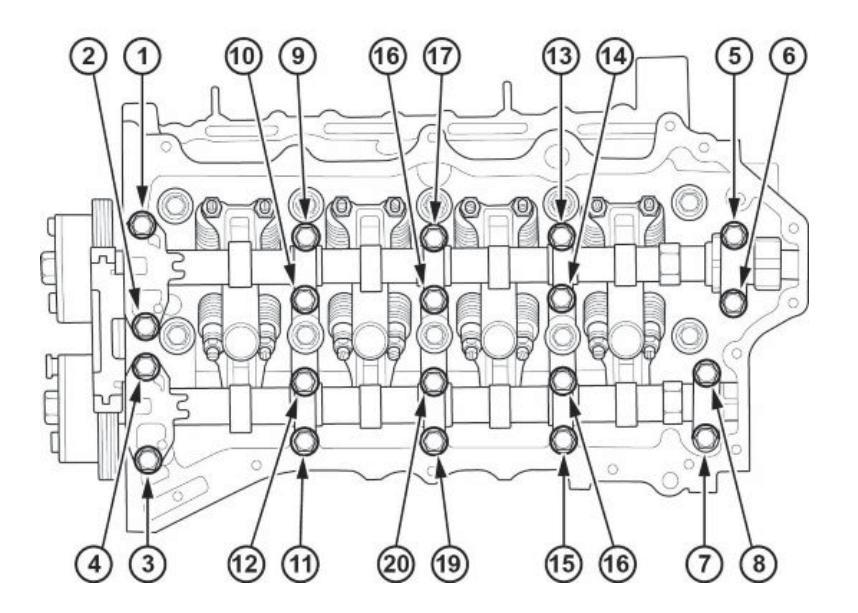
13. Remove the camshaft holder bolts, then remove the camshaft holders. To prevent damaging the camshafts, loosen the bolts in sequence, two turns at a time.

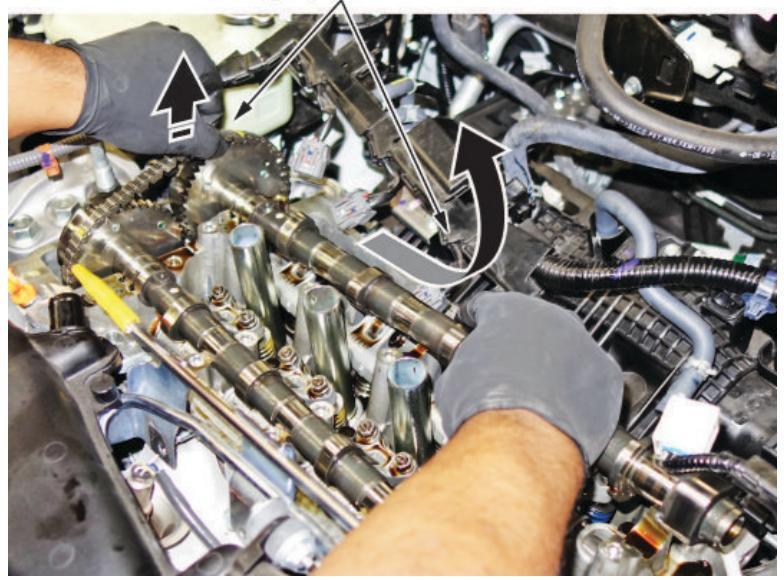
14. Lift up the cam chain, then carefully remove the intake camshaft followed by the exhaust camshaft. You must maintain tension on the cam chain while you do this.

Lift up the cam chain and carefully slip the camshaft out.

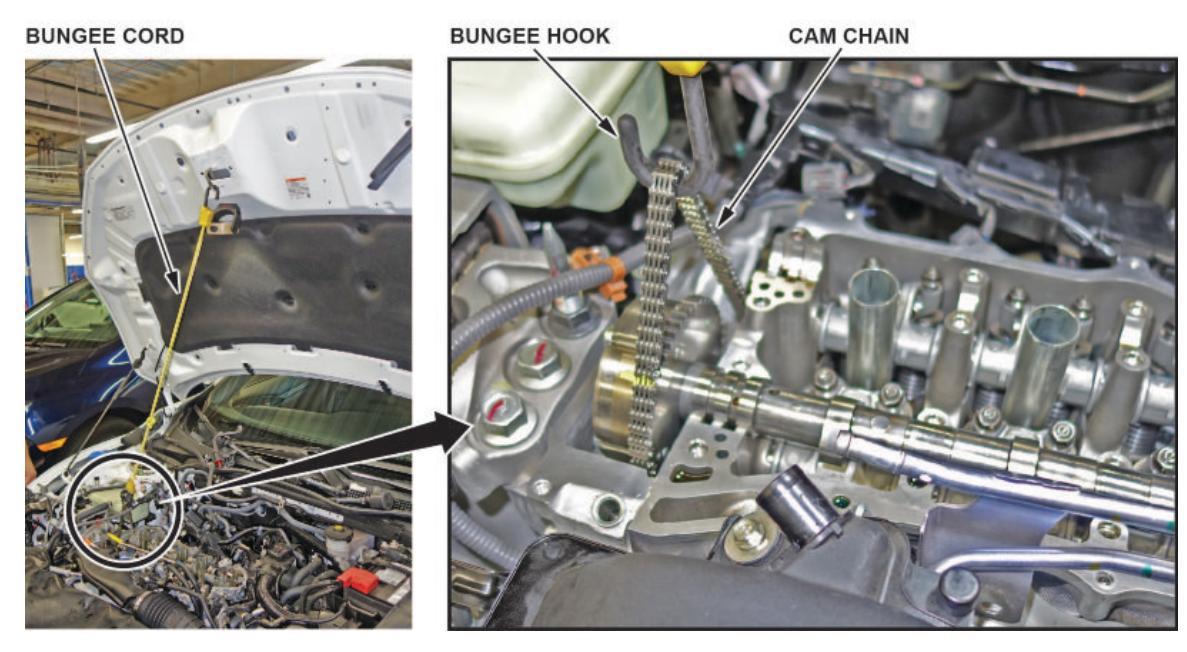
15. Use a bungee cord to hold tension on the cam chain while you are replacing the camshafts.

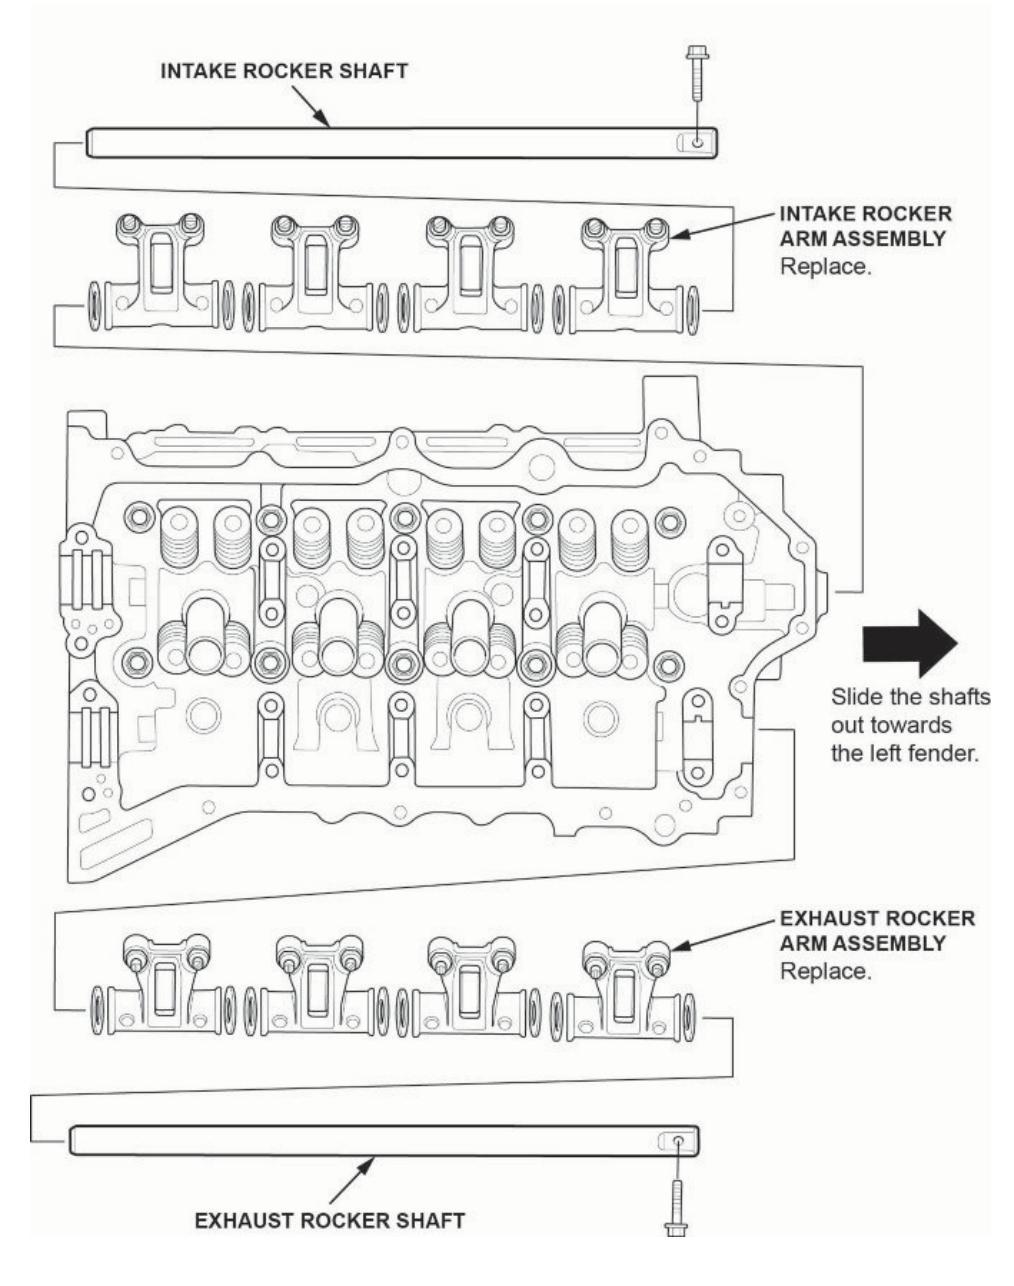
17. Remove the rocker arm assembly, and install the new set. Refer to the service information for additional instructions.

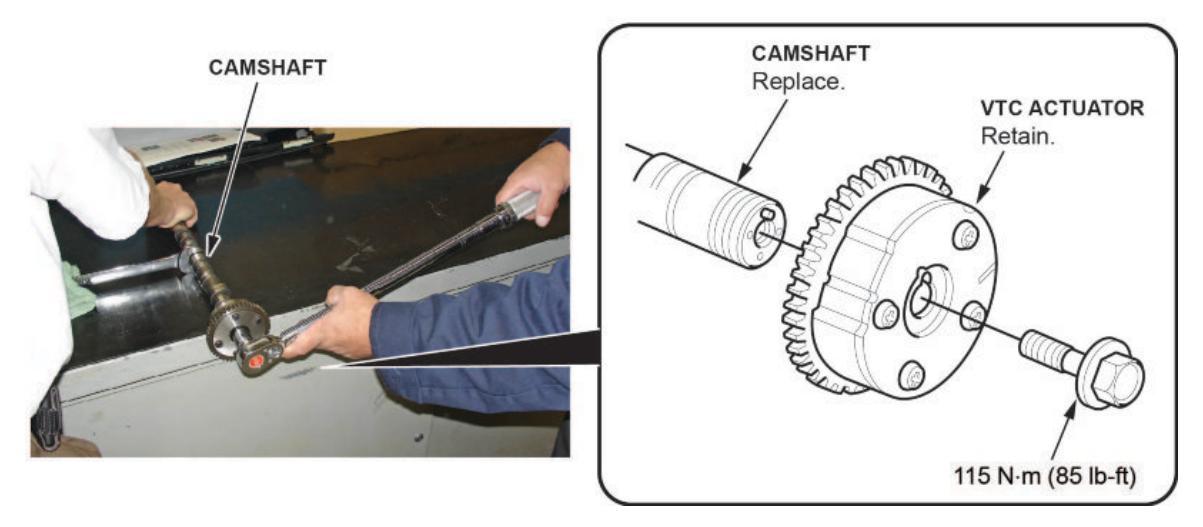
- 18. With the camshafts out of the engine, hold them with an open-end wrench and loosen the VTC actuator mounting bolts on both camshafts.
- 19. Install the VTC actuators on the new camshafts.

You may need an assistant to help you with this procedure.

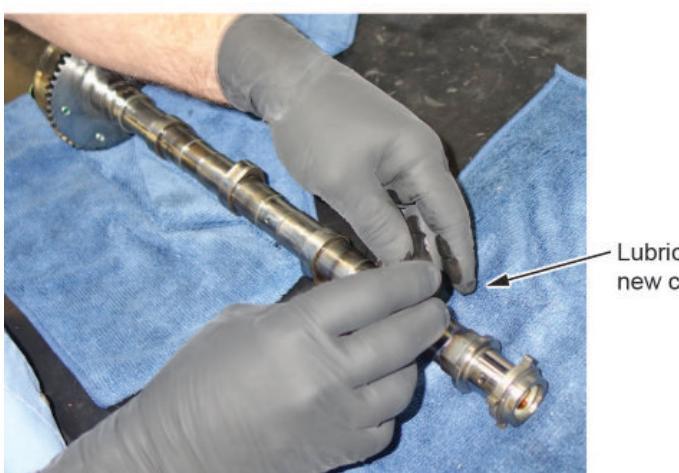
20. Apply fresh engine oil to the new camshafts, and install.

Lubricate the new camshaft. 21. When installing the new camshafts, ensure the previously made marks on the VTC actuator and cam chain line up.

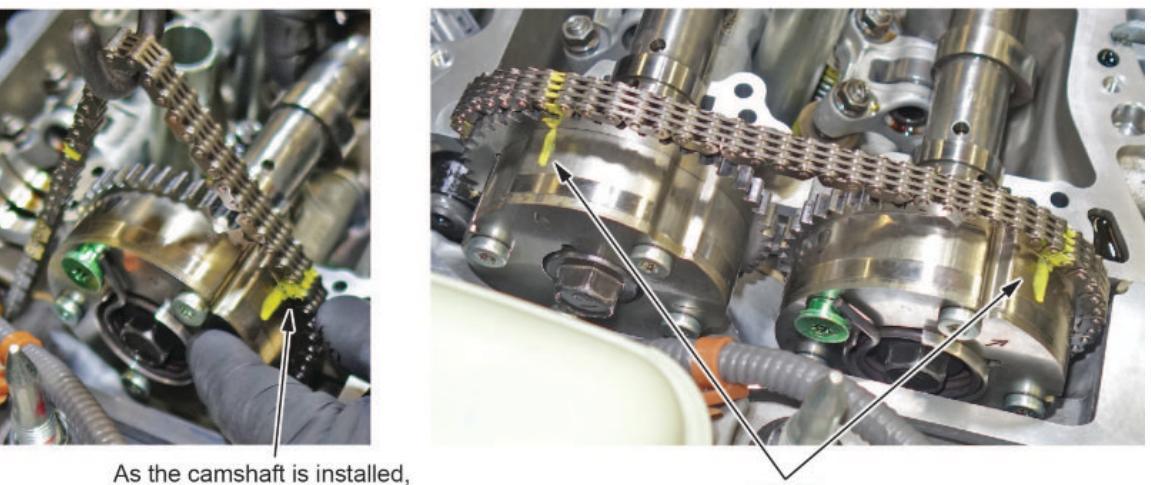
MARKS

As the camshaft is installed, line up the marks made in step 3.

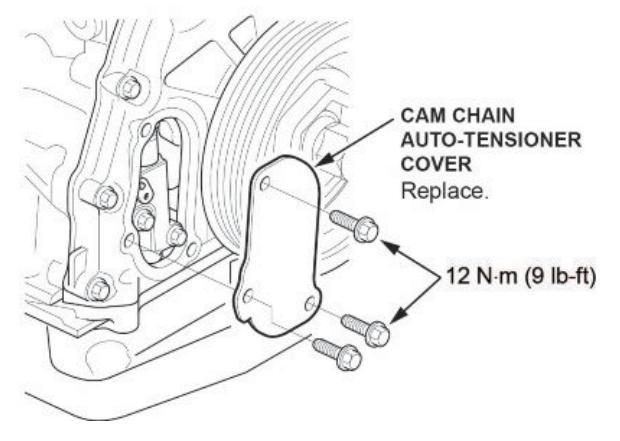
- 22. Install the camshaft holders and the cam chain guide, then torque them to specification.
- 23. Install the camshaft chain tensioner and release the lock pin.
- 24. Install the new cam chain auto-tensioner (chain case) cover.

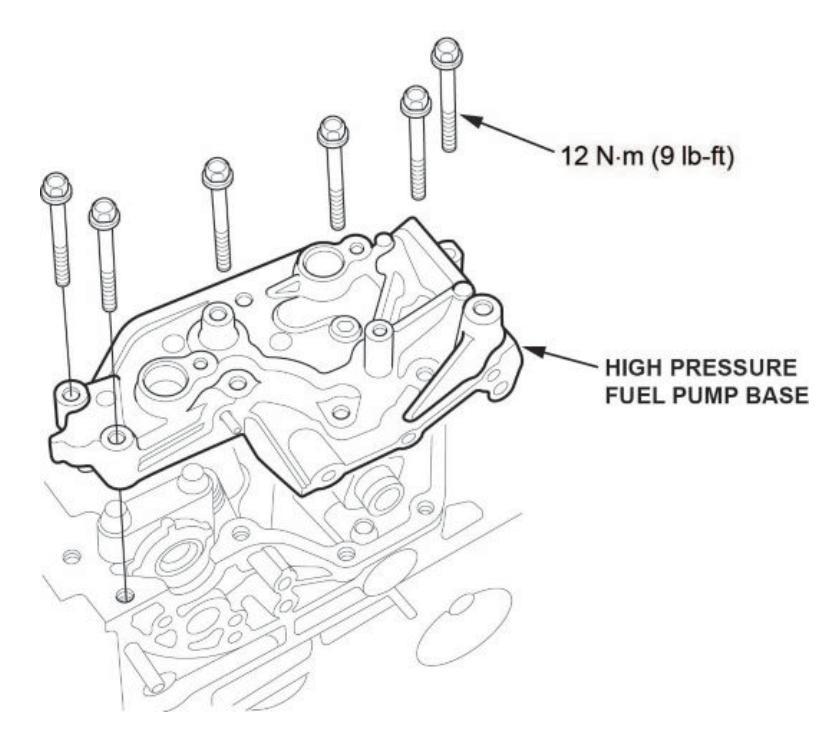
27. Install the high pressure fuel pump base and new camshaft holder cover. Refer to step 6 of the installation section of the Camshaft and VTC Actuator Removal, Installation, and Inspection (1.5L Engine) in the service information.
