Preliminary Information

PIT5660 HVAC Mode Does Not Move to the Correct Position / Unable to Reach Certain Mode Positions / Mode Door Stuck / No Related HVAC DTCs

<u>Models</u>

Brand:	Model:	Model Years:	VIN:		Engine:	Transmissions:
			from	to	Engine.	Transmissions.
Chevrolet	Silverado 1500 (New Model)	2019	All	All	All	All
GMC	Sierra 1500 (New Model)	2019	All	All	All	All

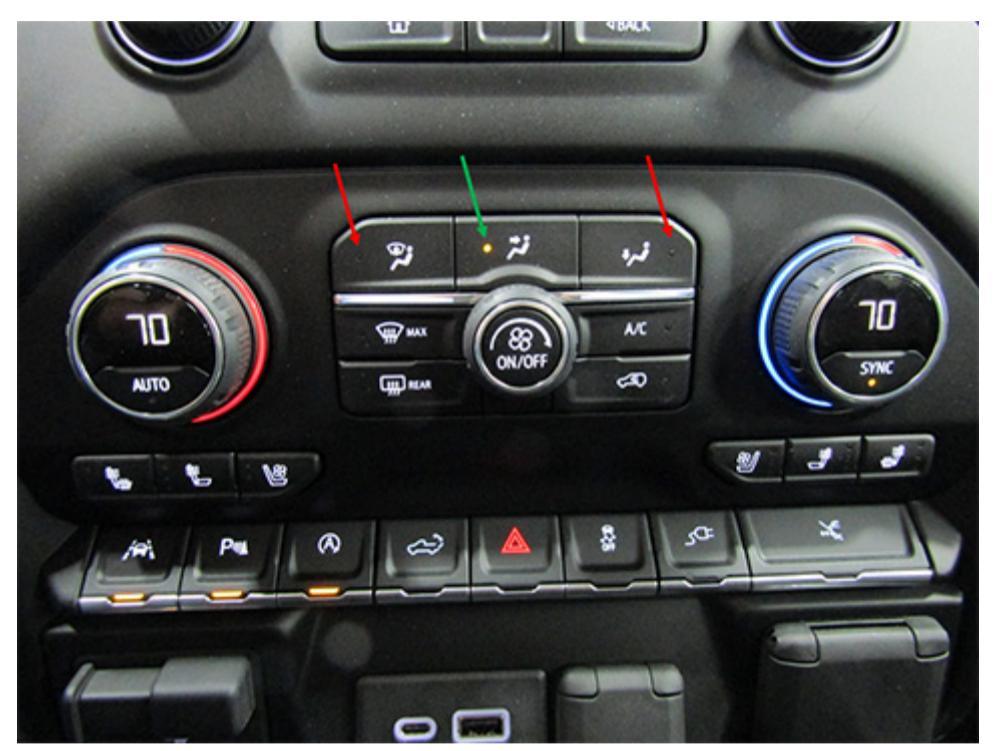
- 1. Open all of the panel vent outlets (front dash panel vents and rear seat vents)
- 2. Start the engine
- 3. Set the HVAC blower to the lowest speed
- 4. Select full panel vent mode by verifying the "Panel/Vent" button LED is on and the "Floor" and "Defrost" button LEDs are OFF, example shown below. Then, wait 15 seconds before performing the next step.
- 5. Press the HVAC "MAX Defrost" button on the HVAC control panel and then wait another 15 seconds before performing the next step.

6. Repeat step 4.

7. Set the blower speed to a higher setting and cycle between each of the HVAC modes to verify the vehicle has been repaired.
