Technical Service Bulletin

LEATHER STEERING WHEEL SURFACE WEAR / PEEL

Bulletin No.: 06-002/19

Last Issued: 05/23/2019

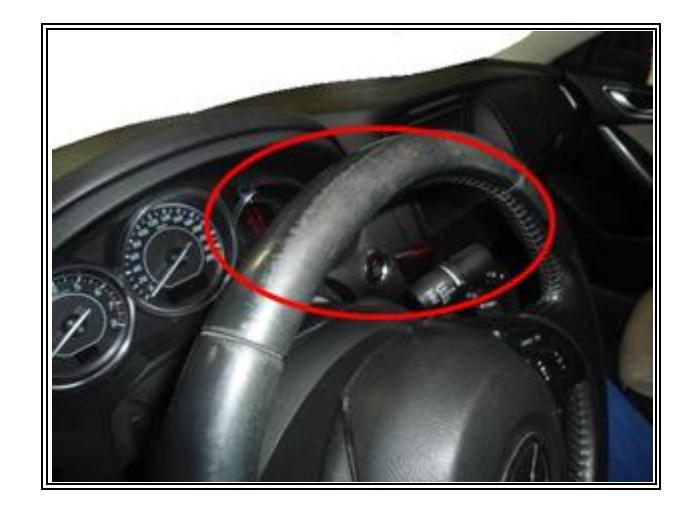
Some vehicles may exhibit wear/peel-off of the leather steering wheel surface causing a poor appearance. This concern may be caused by an insufficient wear resistance of the steering wheel surface.

Customers having this concern should have their vehicle repaired using the following repair procedure.

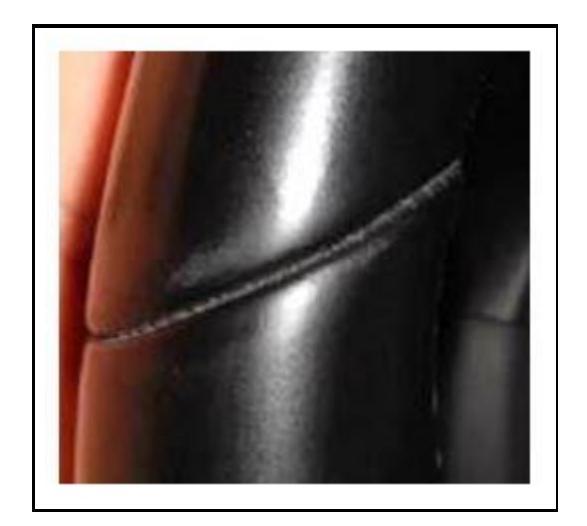
NOTE: Slight wear on a seam of the steering wheel is not applicable to this bulletin. It is inevitable since friction and force are applied while turning the steering wheel.

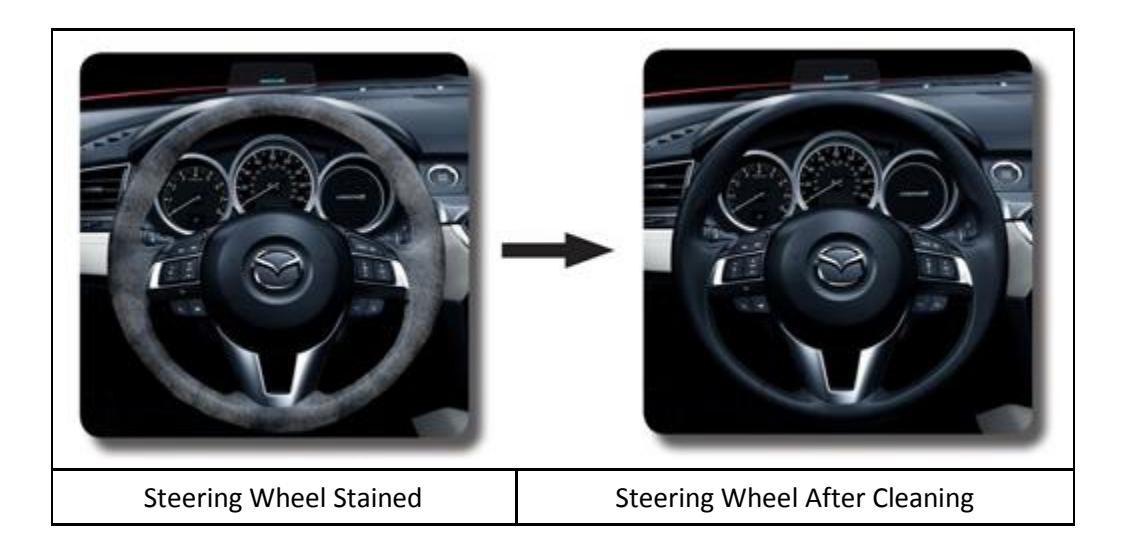
NOTE: Some vehicles may have steering wheel stains caused by chemicals such as hand lotions.

1. Use a clean towel damped in leather/vinyl cleaner or mild soap to clean the steering wheel.

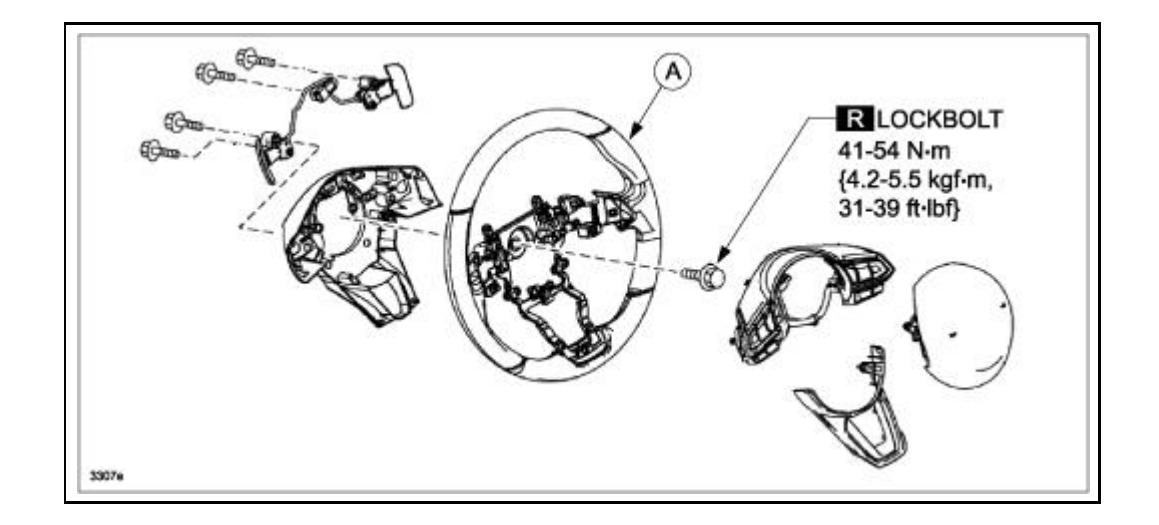
3. Replace the steering wheel (A) according to the repair instructions on MGSS online:

- Mazda3 STEERING WHEEL AND COLUMN REMOVAL/INSTALLATION.
- Mazda6 STEERING WHEEL AND COLUMN REMOVAL/INSTALLATION.
- CX-3 STEERING WHEEL AND COLUMN REMOVAL/INSTALLATION.
- CX5 STEERING WHEEL AND COLUMN REMOVAL/INSTALLATION.
- CX9 STEERING WHEEL AND COLUMN REMOVAL/INSTALLATION.

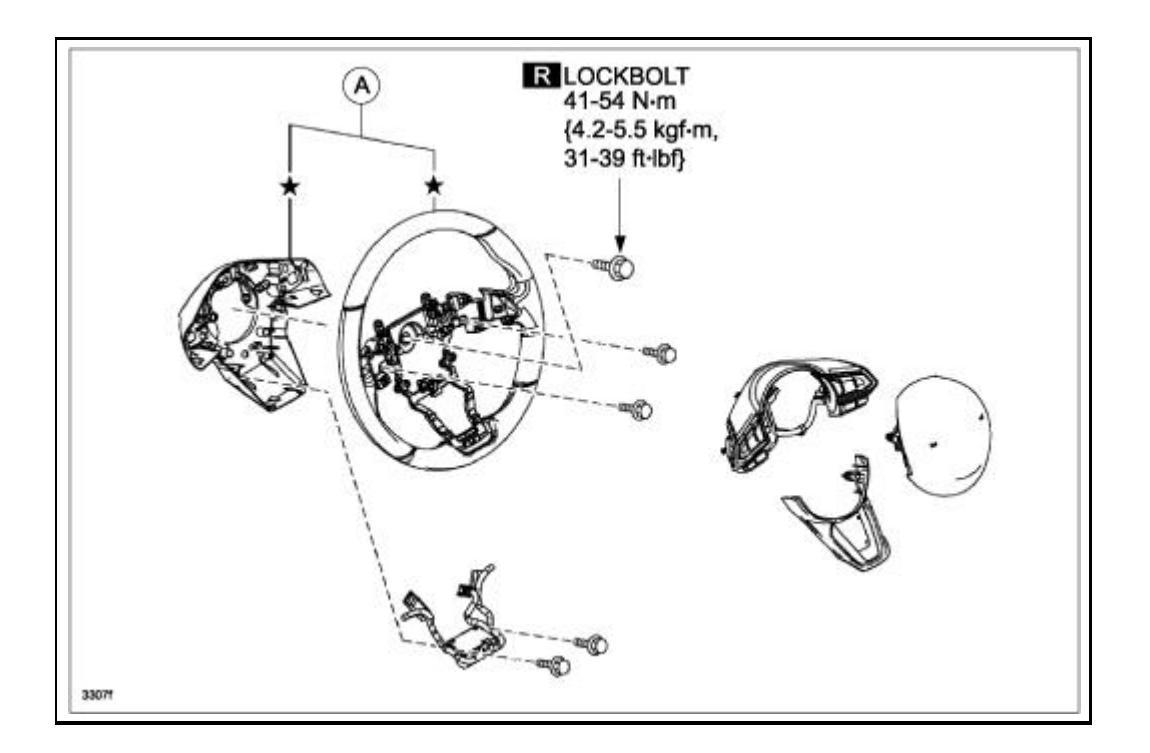
NOTE: For vehicles with a steering wheel warmer, replace the steering wheel hub kit (A).

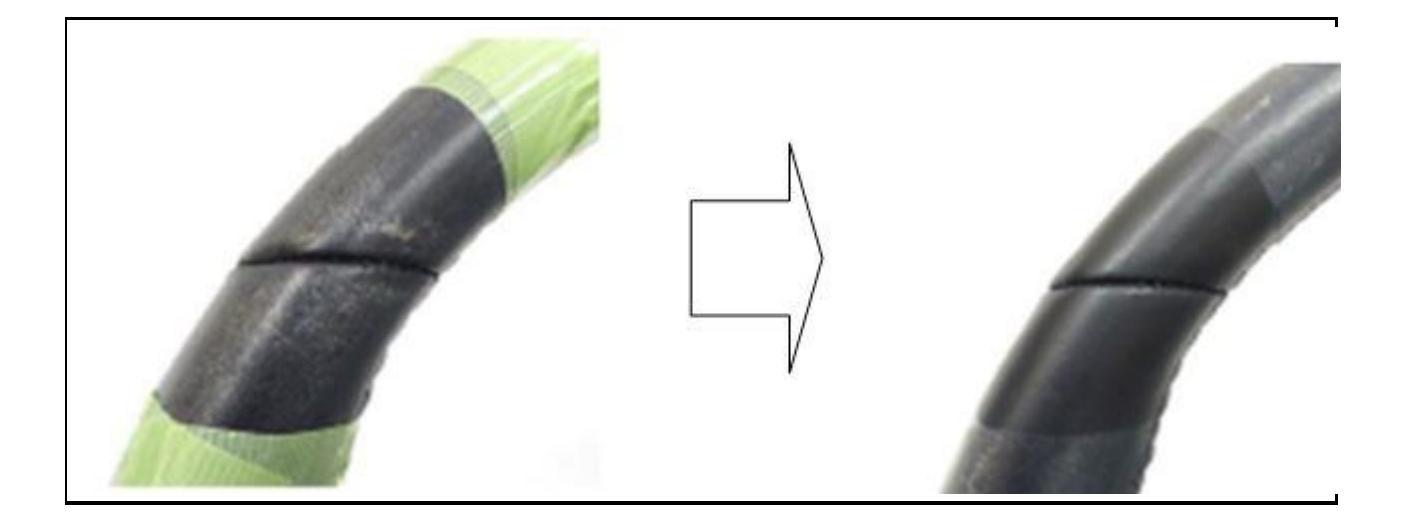
If the leather surface is dirty, wipe it off with a moist cloth using warm water. After wiping, dry off the remaining moisture with a clean dry towel.

NOTE: To avoid wear to the leather, do not use a rough surface towel or wipe off with too much force.

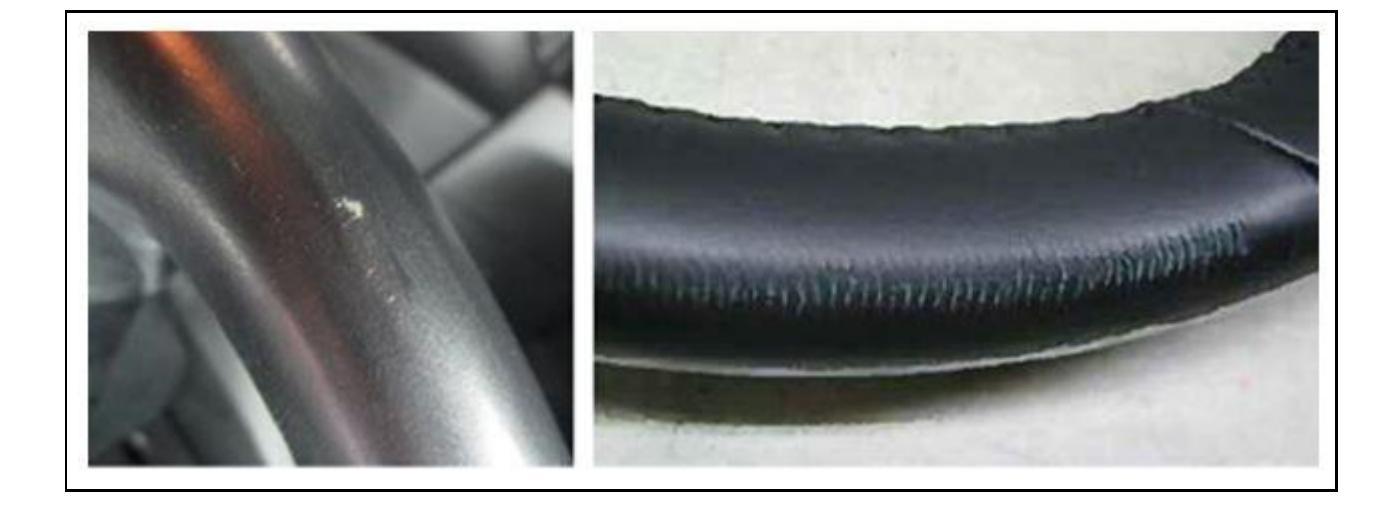
- Do not use general leather cleaners or waxes when wiping off dirt since it may deteriorate the leather coating of the steering wheel. In addition, perfumes, cosmetics, hand creams, sun screens, wet tissue papers, excessive sweat and sebum may also deteriorate the coating.
- Do not scratch or scrub the leather with anything hard, such as a belt buckle, wrist watch, bracelet or rings etc.

NOTE: The examples above are caused by outside influence and therefore not covered under this bulletin.
