PIC6338B Service Parts Restriction - ZR1 Carbon Fiber Body Parts and Ground Effects

Brand:	Model:	Model Years:	VIN:		Engine:	Transmissions:
			from	to	Engine.	
Chevrolet	Corvette ZR1	2019	All	All	LT5	All

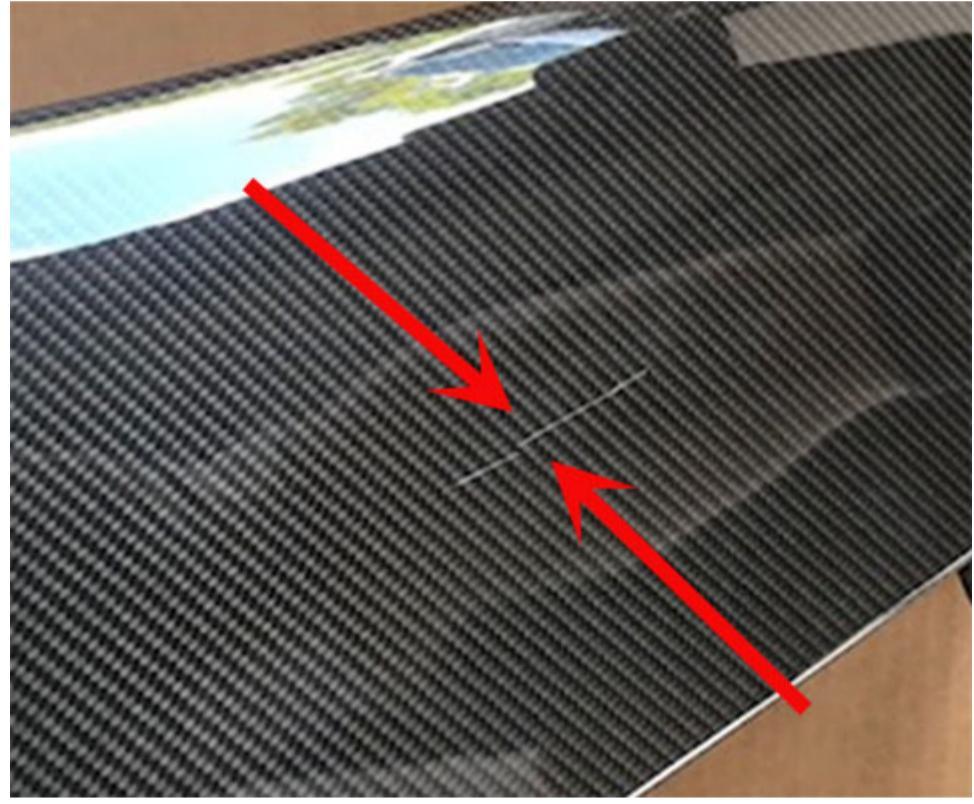
Important: Extreme care should be taken when removing the bubble wrap used to protect the carbon fiber parts. The use of razor blades, box cutters and/or pointed scissors is not recommended. Rounded nosed, or safety scissors would be the best tool to remove the bubble wrap. Parts damaged by using the incorrect tool will be the dealership's responsibility to repair or replace. Here is an example of how a razor blade can easily damage a part during the unpacking process.
