# **Technical Service Bulletin**

#### PSS 90 Audi Virtual Cockpit center display area is black

90 19 24 2055885/1 August 14, 2019.

Model(s)	Year	VIN Range	Vehicle-Specific Equipment
A6, A7, A8, and Q8	2019	All	With Audi Virtual Cockpit

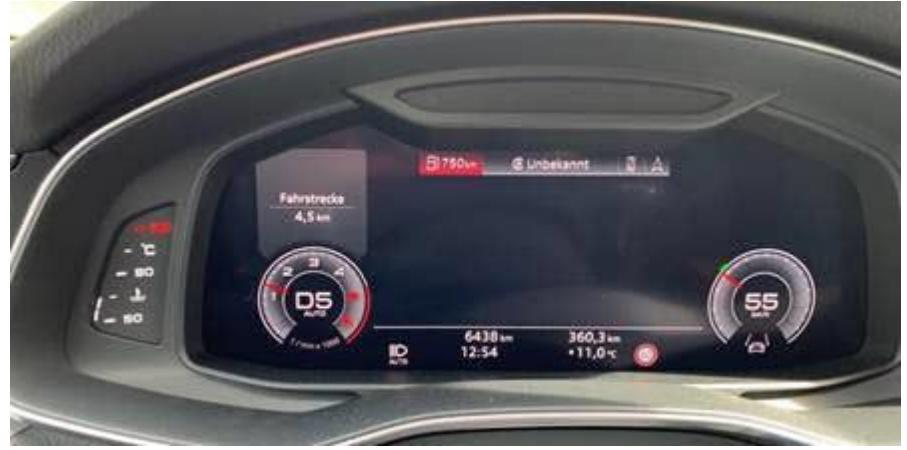
- The central display area in the Audi virtual cockpit is black and does not show the expected tab (Figure 1).
- It is irrelevant which tab the Audi virtual cockpit currently displays (on-board computer, infotainment, phone, navigation, etc.).
- The display of the speedometer and tachometer are always visible in each tab.

Figure 1. Virtual Cockpit with black center screen.

A software malfunction can cause the center display not to be displayed.

- 1. Explain to the customer that a solution is forthcoming and that no repairs are necessary at this point. Do not replace any components for this condition since this will not resolve the customer's concern.
- 2. Create a PSS record in the PSS application through the Pending Service Solutions (PSS) link in AccessAudi (under *Related Links* >> *Service*), or through the Technical Assistance page in Elsa.
