Service Bulletin

Subject: Diagnostic Tip for Malfunction Indicator Lamp (MIL) Illuminated - DTC P0171 P0174 Set

Brand:	Model:	Model Year:		VIN:		Engine:	Transmission:
		from	to	from	to		
Chevrolet	Colorado	2017	2020			LGZ	
GMC	Canyon				LGZ

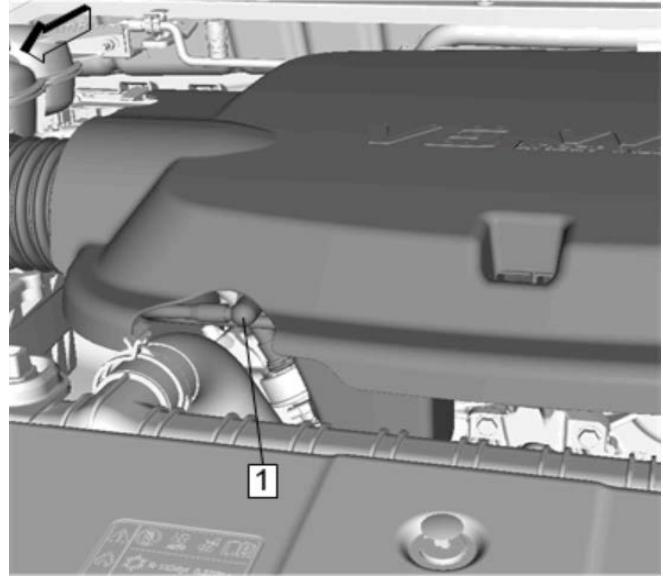
4915133

- 1. Using care, inspect the PCV fresh air tube connection (1) at the Air Cleaner Outlet Duct.
 - If a leak was found, connect the tube to the air cleaner duct port and no further repairs are needed.
 - If the tube is secure, validation of the foul PCV tube must be done.

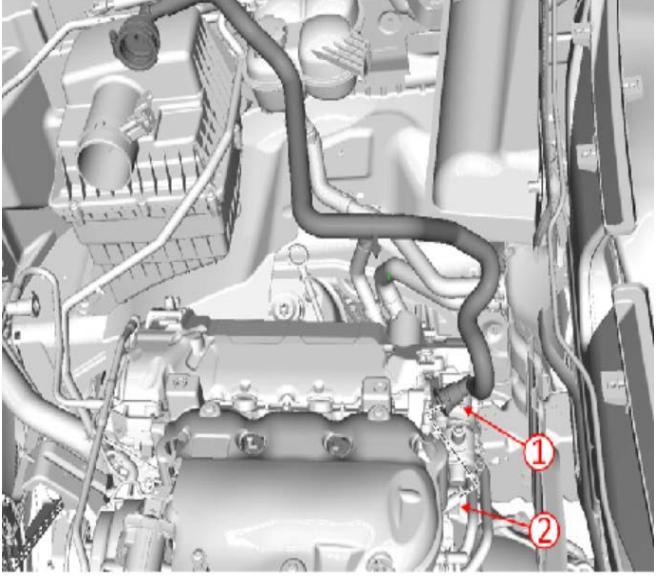
4915265

- 3. Using care, inspect the PCV foul air tube connection (1) on the rear side of the intake manifold vacuum port (2).
 - If a leak was found, connect the tube to the vacuum port and no further repairs are needed.
 - If no issues were found at either location, refer to SI for further diagnostics.
