## SIB 51 30 16

## TAILGATE UNINTENTIONALLY OPENS

This Service Information Bulletin (Revision 4) replaces SI B51 30 16 dated March 2018.

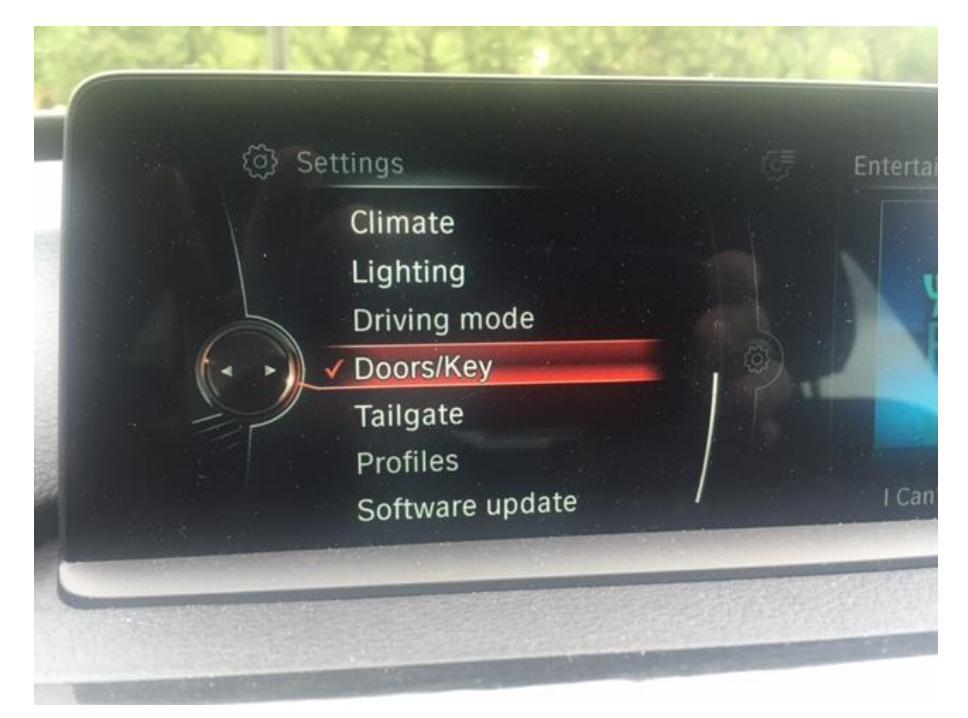
Under the Vehicle settings menu, select Doors/Key:

After performing the conversion, the follow settings must be selected for the conversion to work as intended:

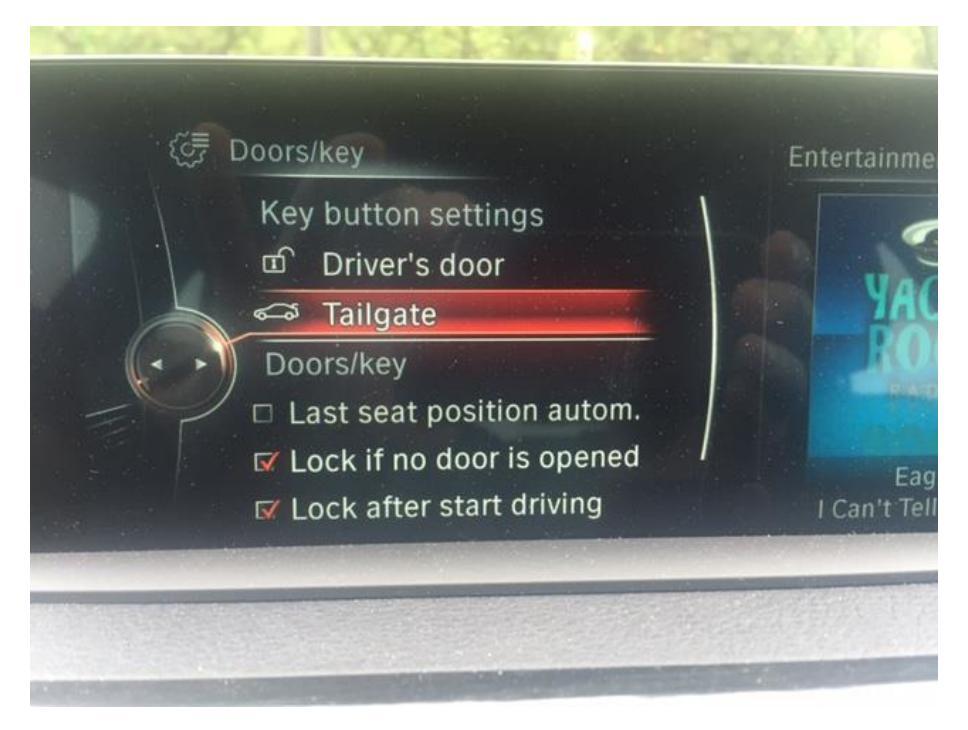
#### Then select Tailgate:

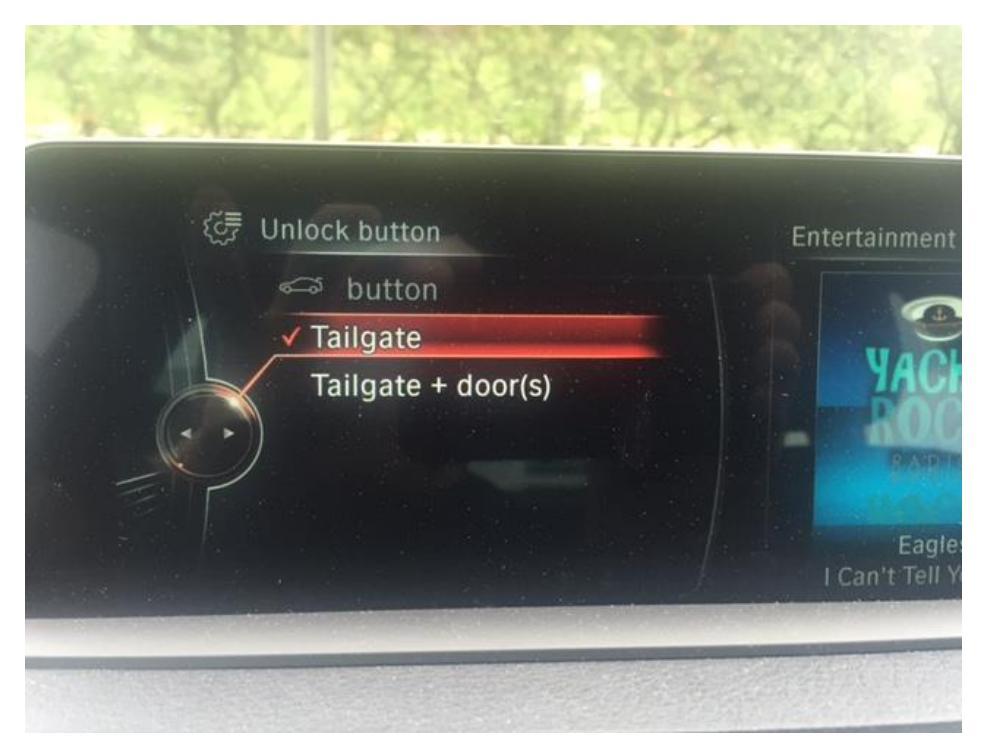
## Ensure that Tailgate is checked off:

a) After the conversion is complete, demonstrate to the customer that the two-button logic is only active if the setting for the "tailgate" is activated in the vehicle menu.
