STAR ONLINE PUBLICATION

Case Number: S2005000003

Symptom/Vehicle Issue: ABS And ESP Warning In EVIC C0037-1D C003A-1D

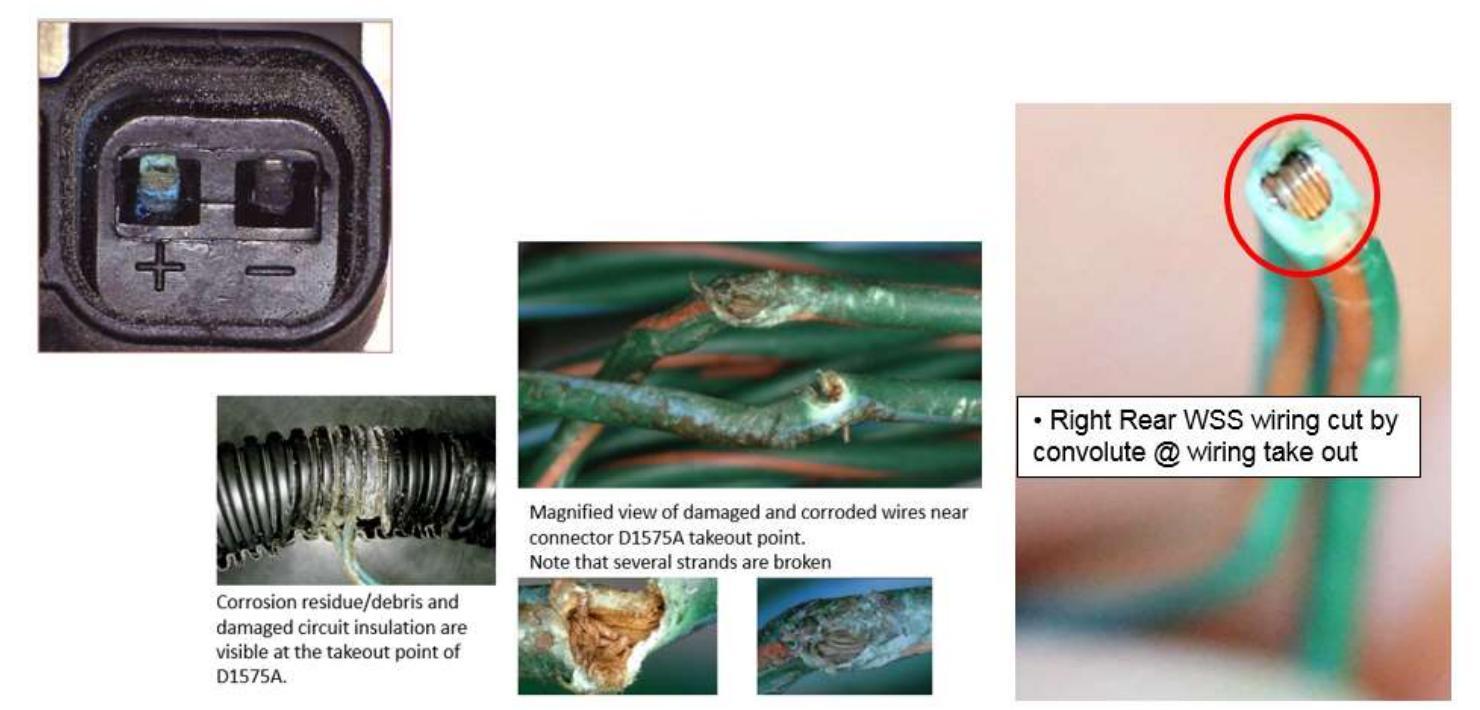
Examples of corrosion and wire damage.

If the above DTC's set active, inspect the wheel speed sensor circuits and pins wiring for signs of damage and corrosion (page 2). Small areas of damage can be repaired using MoPar splicing guidelines. Refer to service information for wire splicing 29 - Non-DTC Diagnostics / Circuit Testing Procedures / Standard Procedure WIRE SPLICING. Inspect the harness. If no damage is seen on the outside of the convolute tubing, open the convolute and remove tape on the harness to inspect the wire insulation.
