# **Technical Service Bulletin**

#### 37 Beveling groove on connections for the gear oil cooler are normal

37 20 99 2060148/1 July 13, 2020.

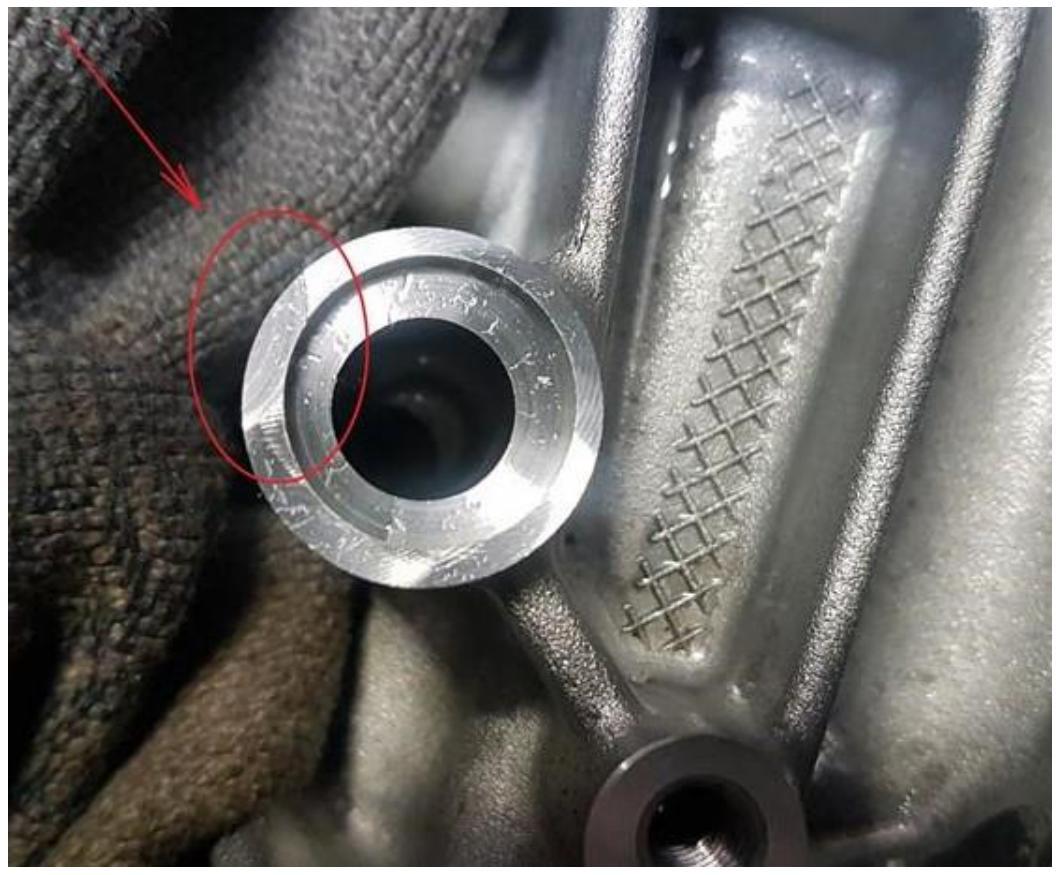
• After removing the gear oil cooler, beveling grooves can be seen on the connections for the transmission oil cooler (Figure 1).

Figure 1. OGC oil cooler connection beveling grooves.

The above beveling grooves on the connections for the gear oil cooler are required for the robotic camera inspections. With these grooves, the correct installation of the seal can be confirmed by the robotic camera. They are not part of the sealing surface and do not have influence on any oil leaks from this area.

The beveling grooves on the connections for the gear oil cooler are machined on many different types of transmissions and are not a defect. Do not replace the transmission. A replacement transmission will also have these grooves.
