| GROUP | NUMBER | |
|---|---|--|
| ENGINE | 20-EM-002H | |
| JULY, 2020 | ELANTRA (ADa) | |

## **Technical Service Bulletin**

SUBJECT: ENGINE THERMOSTAT REPLACEMENT DTC P0128 / P2181

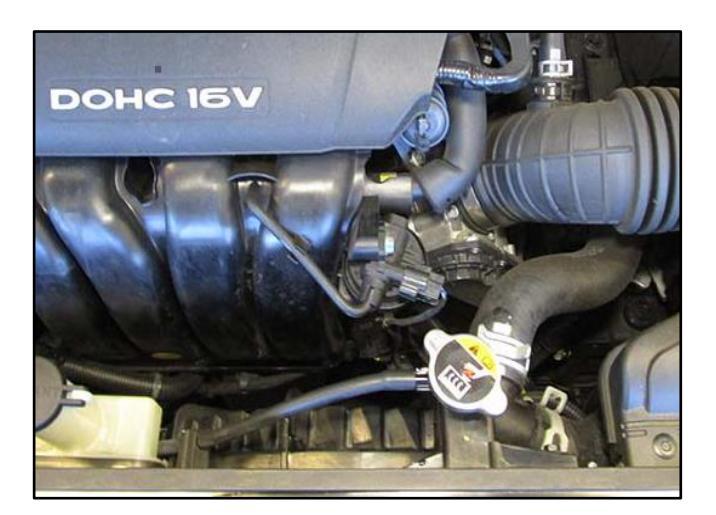
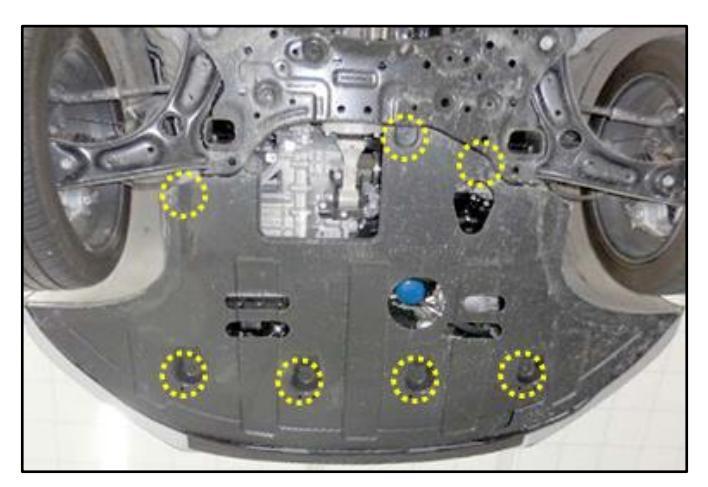
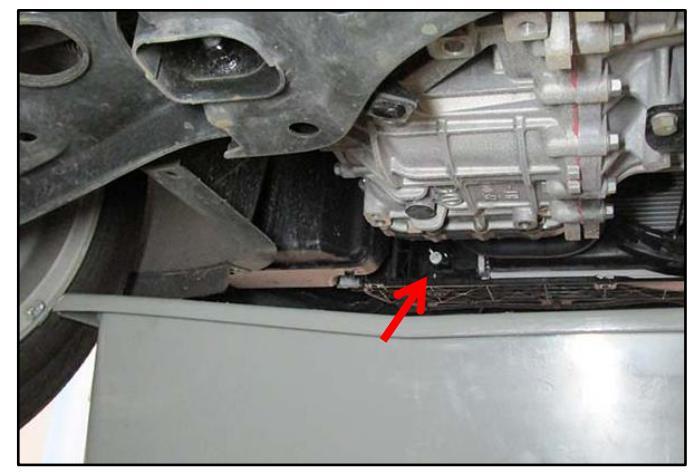
Use a 10mm socket and ratchet to remove 7 bolts as shown.

Use a trim tab or similar tool to remove 12 plastic fittings and remove the undercover.

Use pliers to loosen the plastic drain plug for the radiator and drain approximately 1/2 gallon of coolant.

Place the same coolant container under the engine.

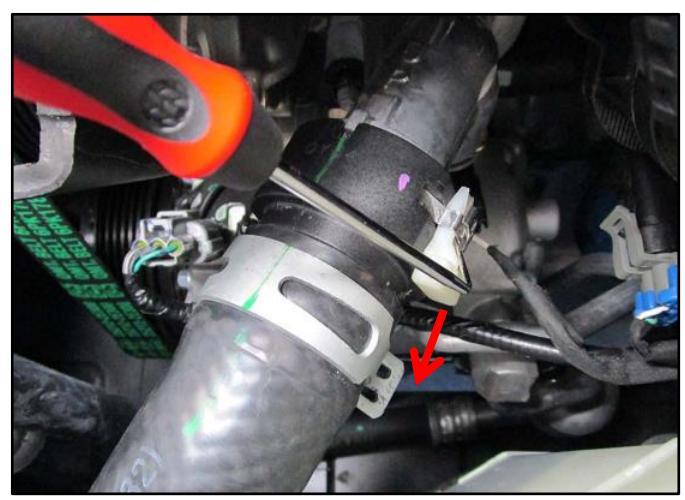
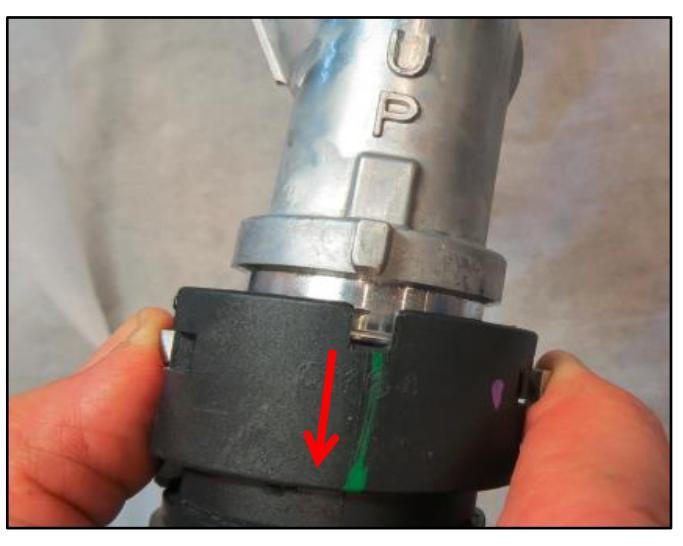
5. Locate the lower radiator hose with integral quick disconnect under the alternator.

Insert a 90° pick or similar tool under the silver tab. Gently rotate the pick clockwise and lift the silver tab up. Pull the white retainer out of the tab.

6. Press the tabs on the left and right sides of the quick disconnect and pull the radiator hose from the thermostat.

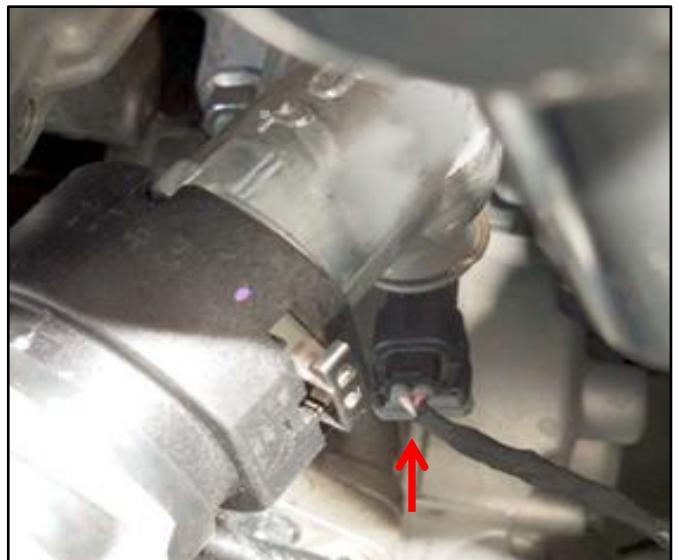
7. Press the tab on the bottom side of the coolant temperature sensor connector and disconnect the connector.

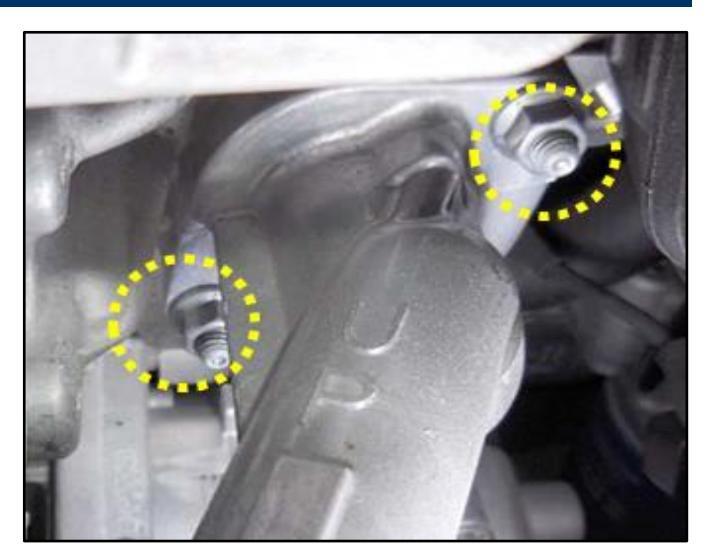
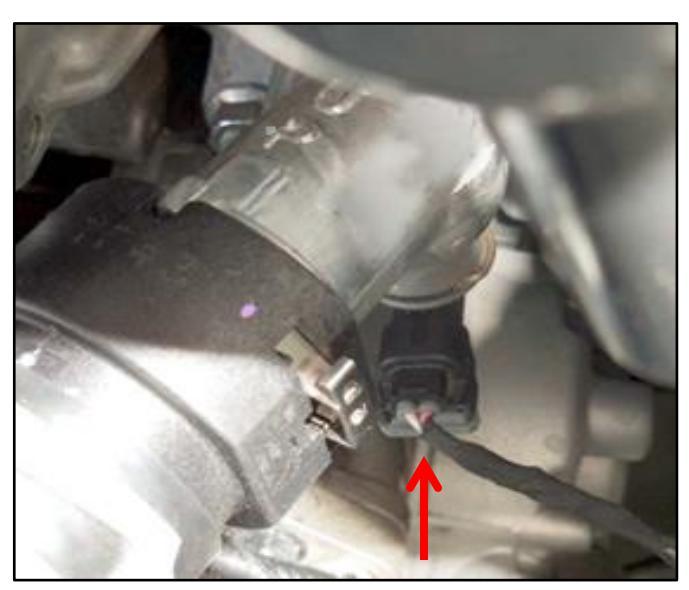
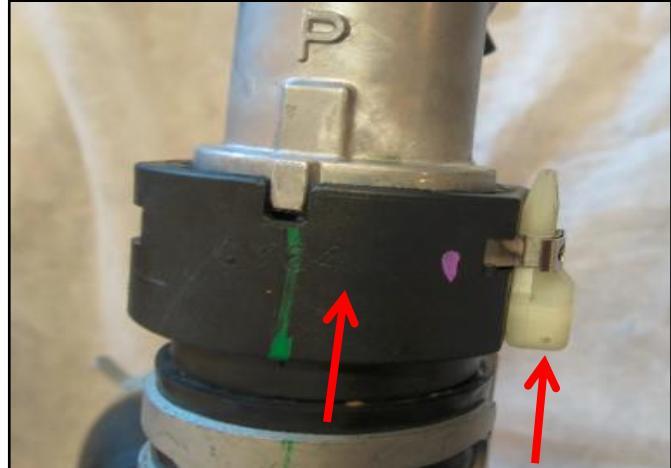
8. Use a 12mm socket and ratchet to remove the nuts for the thermostat and remove the thermostat.

Install the new thermostat and tighten the nuts to the specified torque.

Tightening torque: 23 Nm (17 lb-ft)

9. Reconnect the coolant temperature sensor connector.

- Push firmly until a click is heard from the quick disconnect.
- Insert the white retainer into the tab (if applicable).

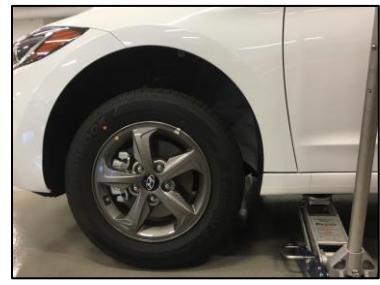
- 12. Elevate the FRONT LH corner of the vehicle.
  - Park vehicle on level ground with parking brake ON, and block the rear wheels.
  - Raise the front left side of the vehicle at the lift point approximately 100mm (4 inches) higher than the rest of the vehicle.

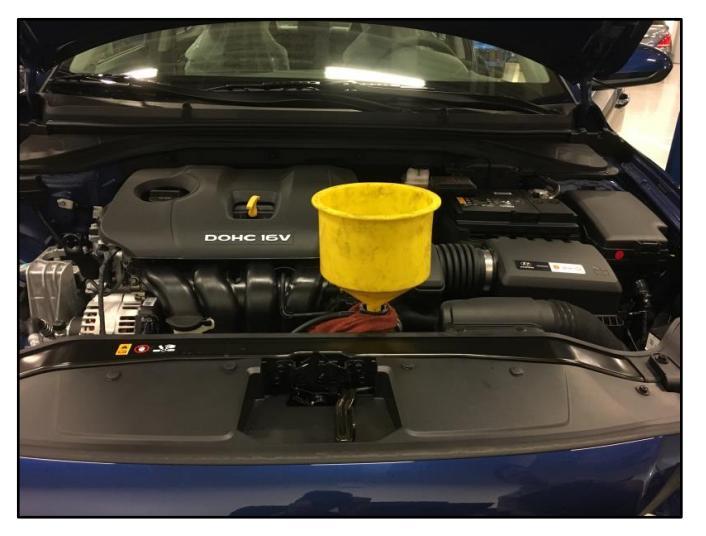
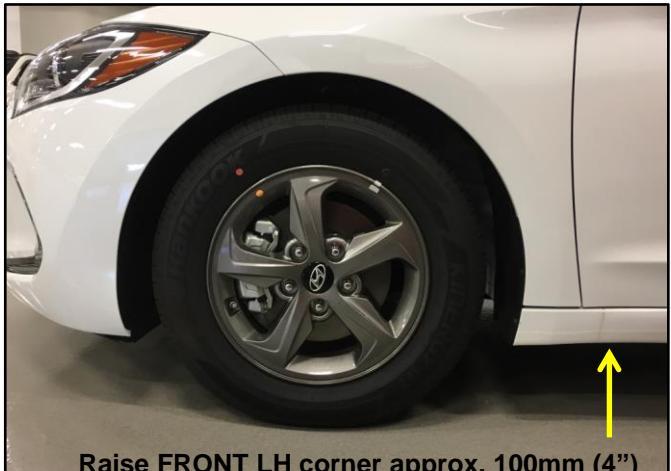
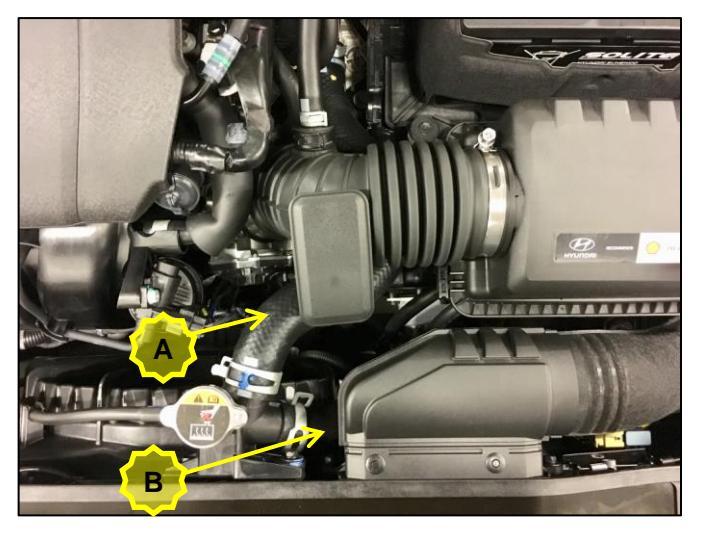
- 13. Gently squeeze the 2 upper radiator hoses leading to the filler neck Y-Junction several times to initially release any trapped air.
  - Hose (A) leading towards the engine
  - Hose (B) leading towards the radiator

(Fill funnel not shown in this picture only for visual purposes.) Keep the funnel attached to the filler neck and partially filled with coolant until all air bleeding steps are complete.

Raise FRONT LH corner approx. 100mm (4")

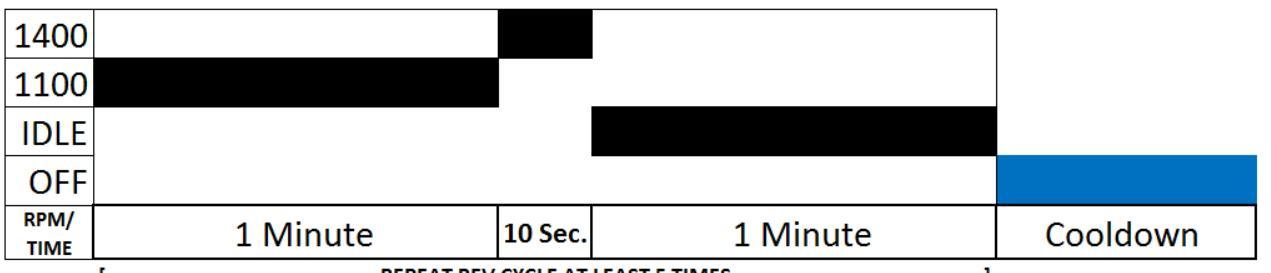
#### Engine REV Cycle

- 17. Perform the following Engine REV steps to help purge the remaining trapped air:
  - a) REV and hold the engine speed to approximately 1,100 RPM for 1 minute.

- b) REV and hold the engine speed to approximately 1,400 RPM for 10 seconds.
  - c) IDLE for 1 minute. (Check the level of the fill funnel and replenish coolant if necessary.)

- d) Repeat Steps (17a) through (17c) for at least 5 cycles, while observing for purged air.
  - e) Shut the engine off.
  - f) Allow the engine to cool with the funnel still attached and filled (observe for purged air).

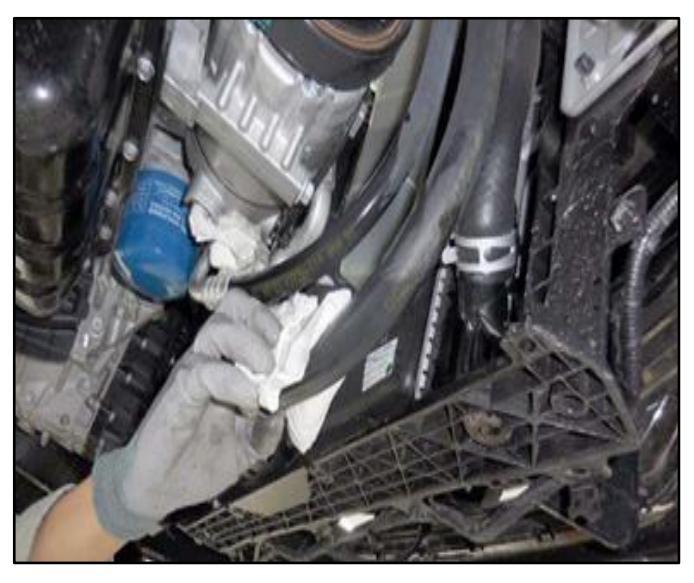
19. Clean any coolant residue under the engine.

Check for leaks from the thermostat.

Reinstall the undercover.

Tightening torque: 5 Nm (44 lb-in)
