14/22 ENU 9152

The Message "Enabling was performed" Appears Repeatedly on the PCM Screen: Restore Gateway (14/22)

Model Line:	911 (992)
Model Year:	2022
Country/Mark- et:	USA/Canada (NAR)
Equipment:	Mirrorlink (M no. 9WT)
Concerns:	Porsche Communication Management (PCM)
Information:	Customers are complaining about the recurring message "Enabling was performed" on the PCM screen. The message appears after each PCM start or after it has woken up from bus idle. This is caused by a runtime error in the communication between the PCM screen and the central computer.

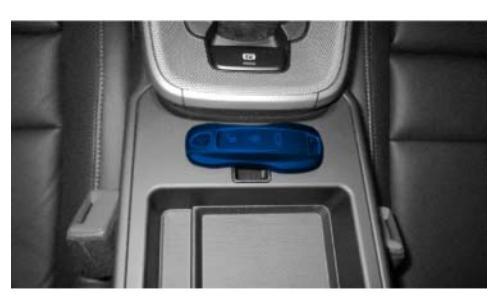
Emergency start tray

- Work procedure: 1 Connect a suitable battery charger, e.g. **battery charger 90A**, to the jump-start terminals in the luggage compartment and switch it on. \Rightarrow Workshop Manual '270689 Charging battery/vehicle electrical system'
 - 2 Place the driver's key with the back facing down in the area in front of the storage compartment under the armrest (emergency start tray) in order to guarantee a permanent radio link between the vehicle and driver's key ⇒ *Emergency start tray*.
 - 3 **9900 Connect PIWIS Tester 3** to the vehicle communication interface module (VCI) via the **USB cable**. Then connect the communication module to the vehicle and switch on the PIWIS Tester.

- 2 **9900 PIWIS Tester 3** must now be disconnected from the vehicle.
- 3 Remove the driver's key from the emergency start tray.
- 4 Disconnect the battery charger.
