Installation and Conversion Instructions

Macan (95В) 8/22 ENU 2635

Sports Tailpipe, Single-Branch – Silver (0P3)/Black (0P6)

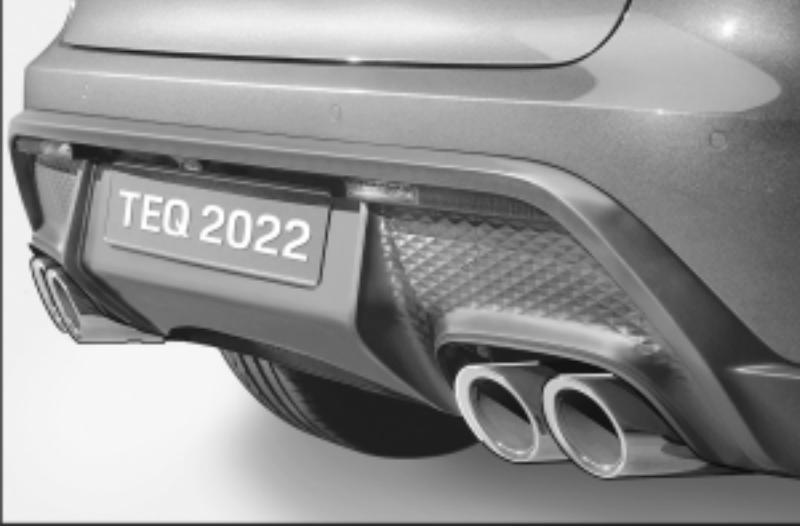
Figure 1

Notes: The standard exhaust system tailpipes can be replaced with sports tailpipes (\Rightarrow *Figure 1*) on the vehicles specified above.

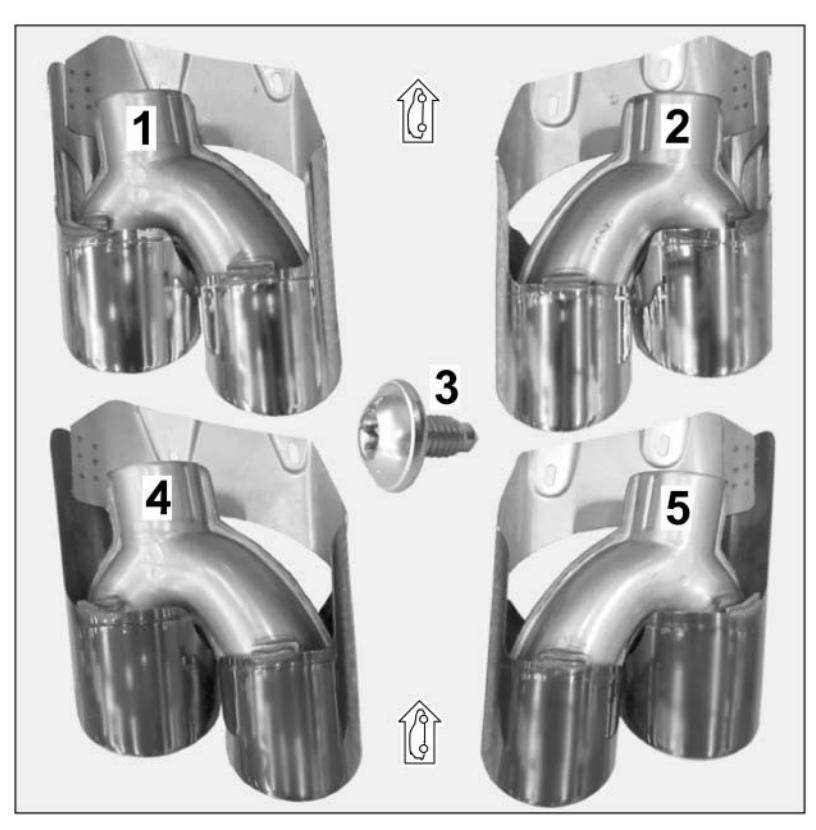
Sports tailpipe – silver chrome-plated (OP3), set:

95B.253.681.AK ¹	1 x	Sports tailpipe – left \Rightarrow Figure 2-1-
95B.253.682.AG ¹	1 x	Sports tailpipe – right \Rightarrow Figure 2 - 2-
999.073.594.01	4 x	Flat-head screw, M6 x 12 PA \Rightarrow Figure 2-3-

Sports tailpipe - black chrome-plated (OP6), set:

999.073.594.01	4 x	Flat-head screw, M6 x 12 PA \Rightarrow Figure 2-3-
95B.253.681.AQ ¹	1 x	Sports tailpipe – left \Rightarrow Figure 2 -4-
95B.253.682.AH ¹	1 x	Sports tailpipe – right \Rightarrow Figure 2-5-
