Installation and Conversion Instructions

Panamera (971) 35/21 ENU 9431

LED Tail Light With Light Panel, Dark-Tinted (8VQ)

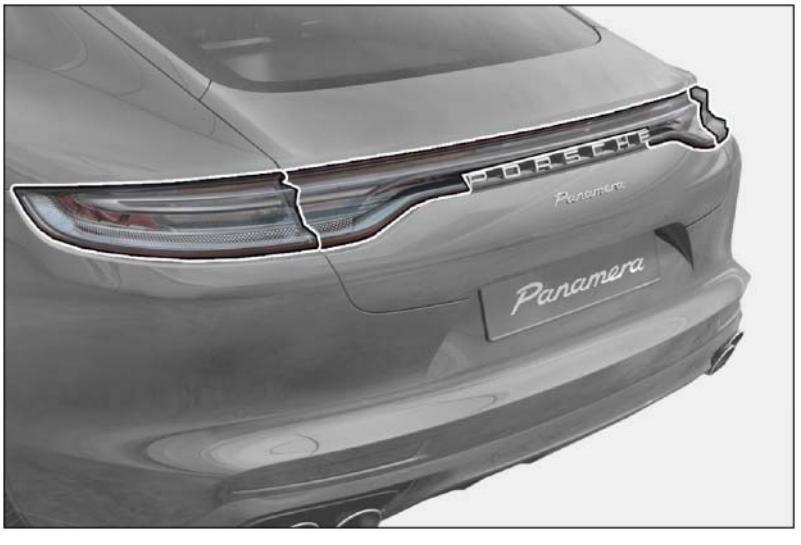
Figure 1

Notes: In vehicles with a standard LED tail light (8VG), a dark-tinted LED tail light or Exclusive Design tail light ($8VQ \Rightarrow Figure 1$) can be retrofitted.

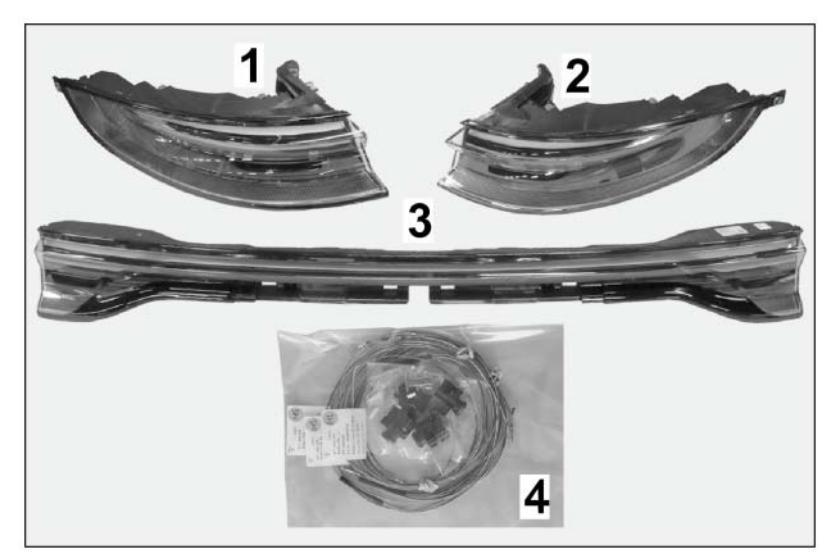
Figure 2

973.945.095.AM ¹	1 x	Tail light, left SAE (not shown)
973.945.096.AM ¹	1 x	Tail light, right SAE (not shown)
973.945.093.BC ²	1 x	Tail light in tailgate - SAE (not shown)
971.044.939	1 x	Electrical system scope \Rightarrow Figure 2-4-
N 911.585.01	6 x	Expansion rivet, B6.5 x 12.3 (not shown)

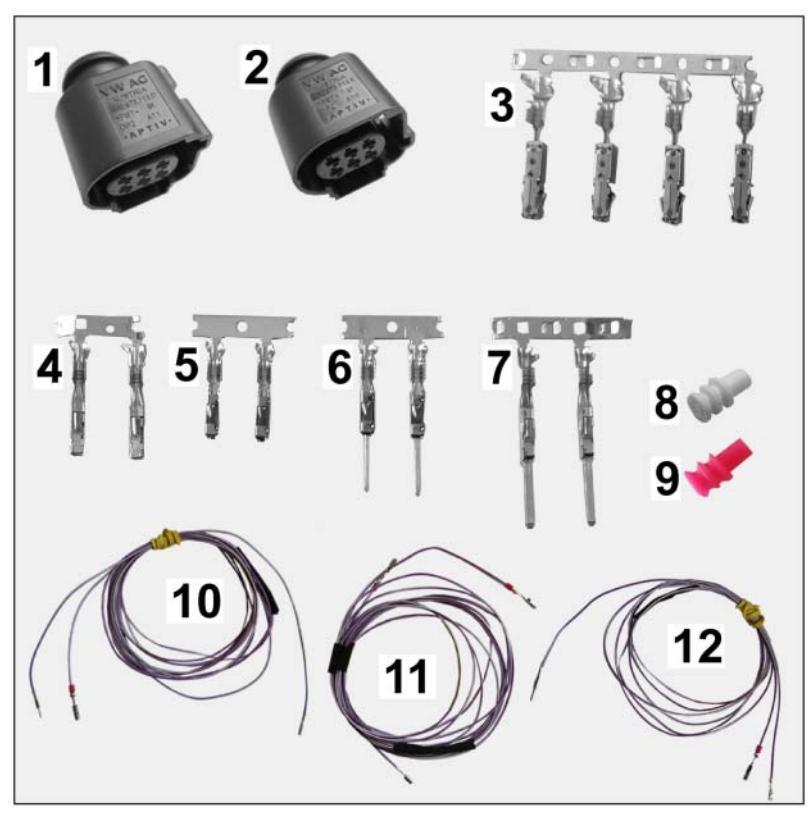
Electrical system components (971.044.939), consisting of:

1 x	Connector, 6-pin (4H0.973.713.D – light panel, right) ⇒ <i>Figure 3</i> -1-
	3 x	Connector, 6-pin (4H0.973.713.E) <i>⇒ Figure 3</i> -2-
N.105.112.03	4 x	Flat contact 1.5 \Rightarrow Figure 3-3-
	2 x	Sleeve/bush, length 16 mm/ 0.63 in \Rightarrow Figure 3-4-
	2 x	Sleeve/bush, length 14 mm/ 0.55 in \Rightarrow Figure 3-5-
	2 x	Pin, length 16 mm/ 0.63 in <i>⇒ Figure 3 -</i> 6-
	2 x	Pin, length 22 \Rightarrow Figure 3-7-
	5 x	Dummy plug, white \Rightarrow Figure 3-8-
958.612.740.00	4 x	Seal on individual wire, red \Rightarrow <i>Figure 3</i> -9-
	1 x	Wire harness for module FGR_le \Rightarrow Figure 3 -10-
	1 x	Wire harness for module HKL_le \Rightarrow Figure 3-11-
	1 x	Wire harness for module FGR_ri \Rightarrow Figure 3 -12-

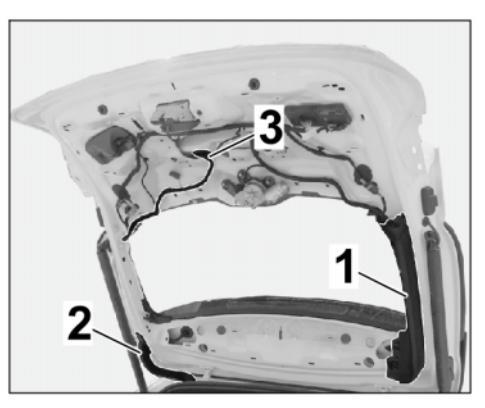
Figure 4 (Sport Turismo)

- 1.3.1 Remove tail light in tailgate. \Rightarrow Workshop Manual '943119 Removing and installing rear light on tailgate'
- 1.3.2 Remove trim panel for rear lid (lower, left and top). ⇒ Workshop Manual '709219 Removing and installing trim panel for rear lid'
 - 1 Trim panel for window frame (right)
 - 2 Grommet at connection point for tailgate (left)
 - Branch for wire harness and grommet (tailgate tail light)

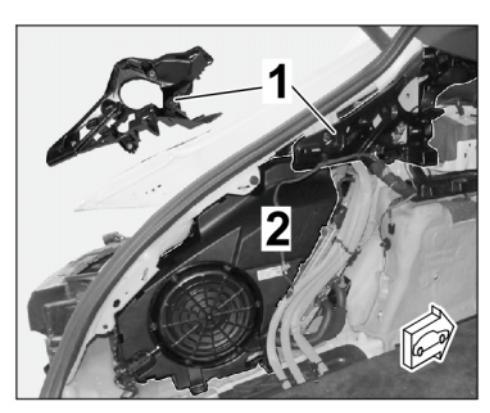
Remove (left) D-pillar holder. \Rightarrow Figure 5 (Sport Turismo)

- 1 D-pillar holder (left)
- 2 BOSE® Subwoofer
- 1.6.4 **ONLY** for vehicles with BOSE[®] Surround Sound System (9VL): ⇒ *Figure 5 (Sport Turismo)*-2-Remove subwoofer. ⇒ *Workshop Manual '913619 Removing and installing subwoofer'*
- 1.6.5 **ONLY** for vehicles with electric compressor (1G8): \Rightarrow *Figure 6 (Hybrid)* Remove tire sealant and compressor.
 - 1 tire sealant
 - 2 Compressor
 - **3** Retaining bar for vehicle electrical system battery
- 1.6.6 Remove retaining bar for vehicle electrical system battery (\Rightarrow *Figure* 6 (*Hybrid*)-3-) and unclip lines

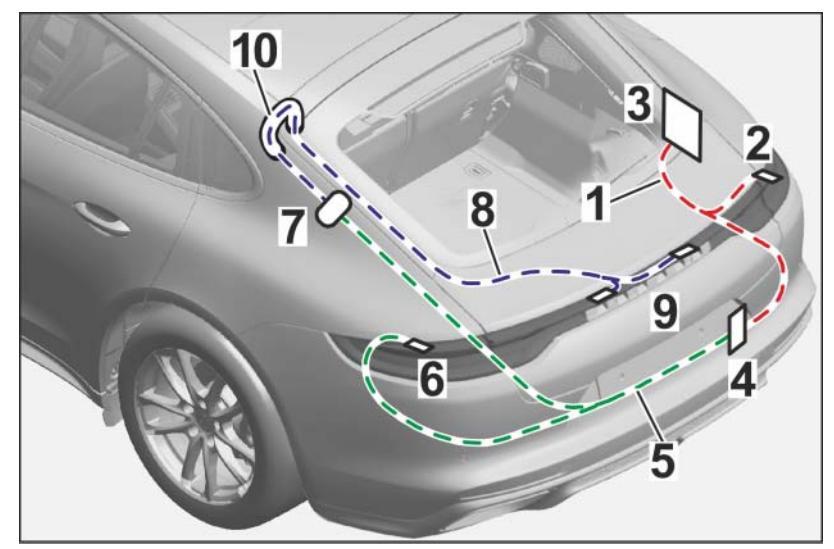
Overview of routing of wire harnesses \Rightarrow Figure 7

- 1 Wire harness for module FGR_ri
- 2 Tail light (right)
- **3** Rear-end electronics control unit BCM2
- 4 Rear cross-over connection point
- 5 Wire harness for module FGR_le
- 6 Tail light (left)
- 7 C-pillar connection point (left)
- 8 Wire harness for module HKL_le
- 9 Tail light to tailgate
- **10** Grommet on tailgate hinge (left)

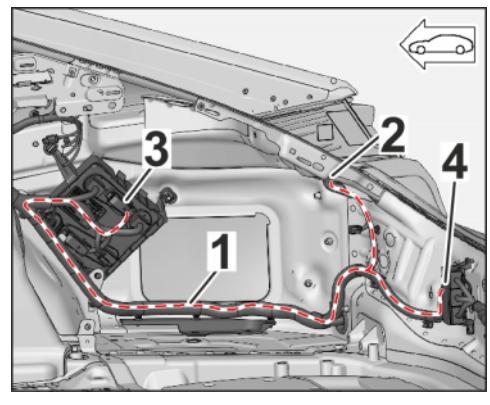
Overview of routing of wire harness for module FGR_ri: \Rightarrow Figure 8

- 1 Wire harness for module FGR_ri
- 2 Grommet for tail light (right)
- BCM2; connector C (black); chamber 5
- 4 Rear cross-over connection point / brown connector, chamber 12

- Remove branch (wire harness) for tail light with grommet (⇒ *Figure 8-2-*).
- Guide branch with connector (6-pin) into the luggage compartment.

- Route branch for BCM2 to BCM2. \Rightarrow Figure 8-3-
- Remove connector C (black) from BCM2 and open it. \Rightarrow Figure 10-2-

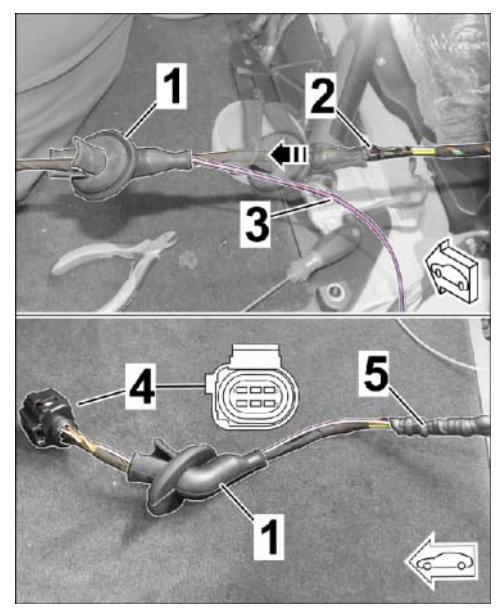
- 2.1.1 Tail light area, right (see also wiring diagram 12.2 Vehicle exterior lighting, sheet 2) \Rightarrow Figure 9
 - 1 Grommet
 - **2** Wire harness for tail light
 - **3** Line VT/WH; 0.5² (LIN)
 - 4 New connector housing (6-pin; 4H0.973.713.E)
 - **5** New sealing compound

• Carefully loosen the installed grommet on the branch (wire harness) and slide it towards the connector (6-pin). ⇒ *Figure* 9-**Top**, **arrow**-

- Carefully feed line VT/WH 0.5² with single-wire seal (connection for wire harness for module FGR_re) through the grommet and guide it to the connector (6-pin).
- Open the connector (6-pin) and change the lead in the **NEW** connector housing (6-pin, 4H0.973.713.E) at the same position.
- Insert socket contact (VT/WH 0.5² line with single-wire seal) into chamber 3.
- Close off chambers WITHOUT using dummy plug (white) configuration.

Connector (6-pin)	Function
4H0.973.713.E	SAE
Chamber 1 – BN; 0.5 ²	Weight
Chamber 2 – GY; 0.5 ²	Brake light and & direction indicator light
Chamber 3 – VT/WH; 0.5²	LIN = Control animation
Chamber 4 – BK/RD; 0.5²	Power supply, terminal 30G
Chamber 5 – YE/GN, 0.5²	Dummy plug (white)
Chamber 6	Dummy plug (white)

- Carefully install grommet with some sealing compound at the old position (⇒ *Figure 9-5-*).
- Guide connector (6-pin) with connection (wire harness for tail light) from luggage compartment to the outside.
- Install grommet in the body. Check that the grommet is seated correctly in the body.

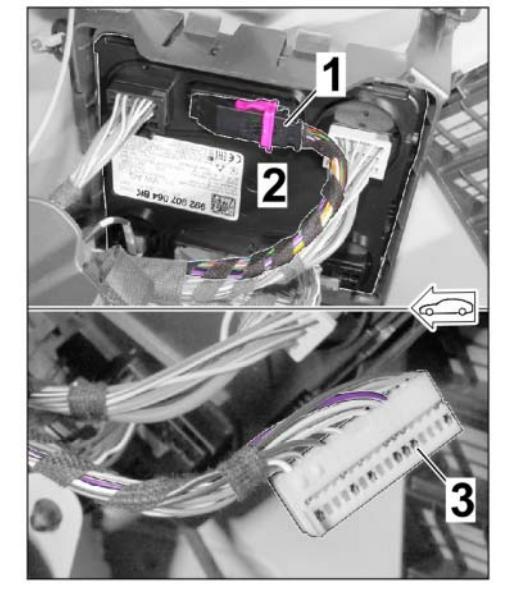
- 2.1.2 Rear-end control unit BCM2 area (see also wiring diagram 02_1 - Rear-end electronics, sheet 1) \Rightarrow Figure 10
 - 1 - Connector (32-pin, black)
 - 2 - Rear-end electronics control unit BCM2
 - 3 - Connector housing, chamber 5

- Check that chamber 5 already has a VT/WH 0.5² line (line 53003 Virtual pedal).)
- YES: Double connector on existing line.
- NO: Insert VT/WH 0.5² line with pin contact into chamber 5.
- Close connector C (black) and install in BCM2.
- Rear cross-over connection point 2.1.3 area \Rightarrow Figure 11
 - 1 - Wire harness for module FGR_ri
 - 2 - Rear cross-over connection point
 - 3 - Wire harness for module FGR_le

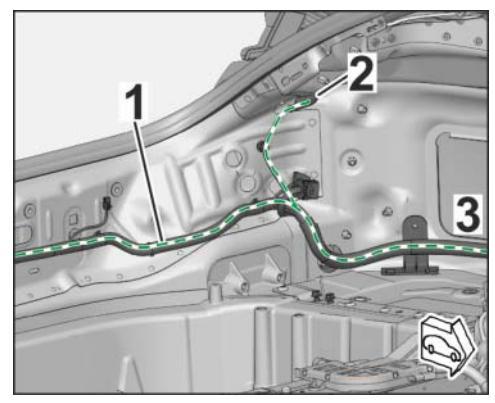
- 2.2 Route and connect wire harness for FGR_le module
 - 2.2.1 Tail light area, left (see also wiring diagram 12.2 Vehicle exterior lighting, sheet 2) \Rightarrow Figure 12
 - 1 Wire harness for module FGR_le
 - 2 Grommet for tail light (left)
 - 3 Branch at connection point for tailgate, left (C-pillar)
 - Repeat Step 2.1.1 for the left tail light. ⇒ *Figure 12-2-*

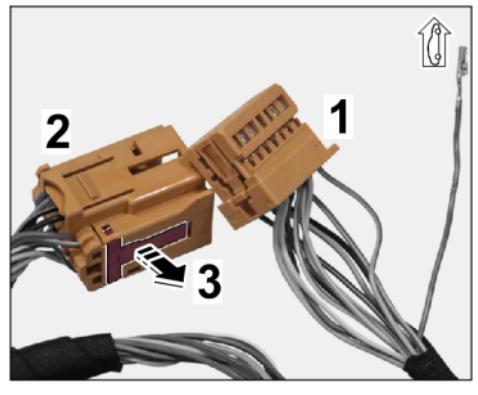
- 2.2.2 Rear cross-over connection point area \Rightarrow Figure 13
 - 1 Plug socket, 17-pin (brown), chamber 12
 - Pin connector socket,
 17-pin (brown), chamber
 12
 - **3** Unlocking / Locking
 - Route branch with pin contact along the wire harness to the rear cross-over connection point.

- Remove connector, 17-pin (brown) from holder and release it.
- Insert VT/WH 0.5² line with socket contact into chamber 12. \Rightarrow Figure 13-1-

Repeat Step 2.1.3 for connector, 6-pin (brown) – left side (in direction of travel) for VT/WH; 0.5² line with pin contact. ⇒ Figure 13-2-

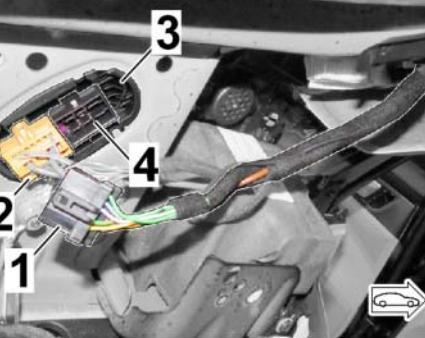
Rear lid connection point area, left C-pillar (see also wiring diagram $45A - \text{left rear cap} \Rightarrow Figure 14$

- 3 – Wire harness for module HKL le
- 4 - Grommet on rear lid, left
- Route branch with pin contact along the wire harness to the connection point on the rear lid (left C-pillar).

17-pin (black and brown) and remove plug connections holder from the C-pillar if necessary. \Rightarrow Figure 15

- Connector, 17-pin (black) 1
- 2 – Connector, 17-pin (brown)
- 3 – Plug connection holders
- 17-pin (black)
- Remove pin connector socket, 17-pin (black) on the back from

- Insert VT/WH 0.5² line with pin contact into chamber 8.
- Lock pin connector socket, 17-pin (black) and install on the back of the holder.
- 2.3 Route and connect wire harness for module HKL_le

- 2.3.5 Rear lid connection point, left C-pillar (see also wiring diagram 45A left rear cap) \Rightarrow Figure 14 and \Rightarrow Figure 15
 - Remove plug socket, 17-pin (black) on the front of the holder and release it.

- Insert VT/WH 0.5² line with pin contact into chamber 8.
 - Lock plug socket, 17-pin (black) and install it on the front of the holder.
 - Connect plug connections, 17-pin (black and brown) and install plug connections holder in C-pillar.

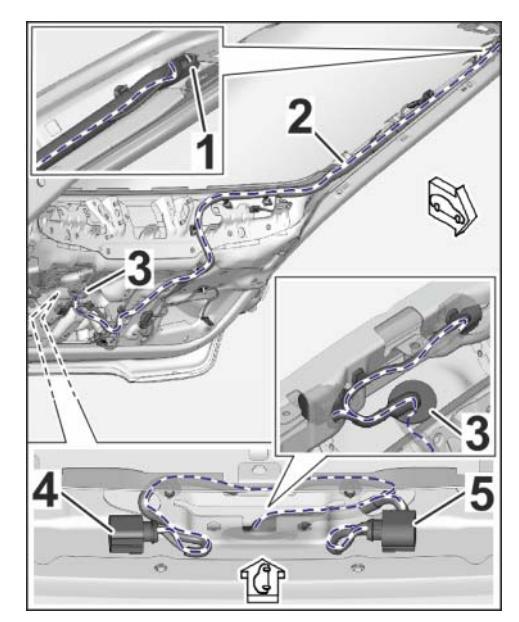
Figure 16

Overview of routing of wire harness for module HKL_le: \Rightarrow *Figure 14* and \Rightarrow *Figure* 16

- 1 - Wire harness for module HKL_le
- 2 - Grommet on tailgate hinge (left)
- 3 - Grommet rear light tailgate
- 4 - New connector, left (6-pin, 4H0.973.713.E)
- 5 - New connector, right (6-pin, 4H0.973.713.D)

2.3.2 Tail light grommet area in tailgate \Rightarrow Figure 16-3- and \Rightarrow Figure 17 (Sport Turismo) -3-

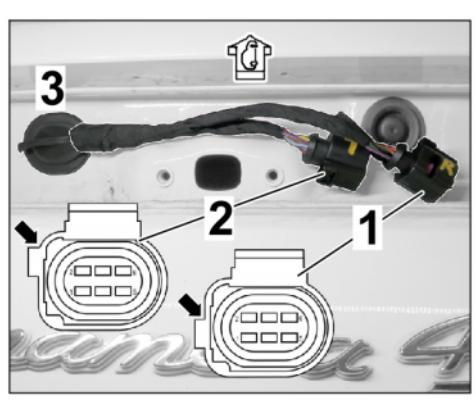
- 2.3.1 Tail light in tailgate area (see also wiring diagram 45A - Tailgate, left) \Rightarrow Figure 17 (Sport Turismo)
 - 1 - New connector, right (6-pin, 4H0.973.713.D)
 - 2 - New connector, left (6-pin, 4H0.973.713.E
 - 3 - Grommet rear light tailgate Arrows - Coding connectors, left/right

- Open connectors (6-pin) on the left and right side.
- Connect existing lines to NEW connector housing, 6-pin (left: 4H0.973.713.E / right: 4H0.973.713.D) at the same position.
- Insert socket contact (VT/WH 0.5² line with single-wire seal) into chamber 3.
- Close off chambers WITHOUT using dummy plug (white) configuration.
- Lock connectors (6-pin) on the left and right side. \Rightarrow Figure 17 (Sport Turismo)
- Function test: Connect plug connection (6-pin, left and right) for the new tail light in the rear lid and loosen it again.

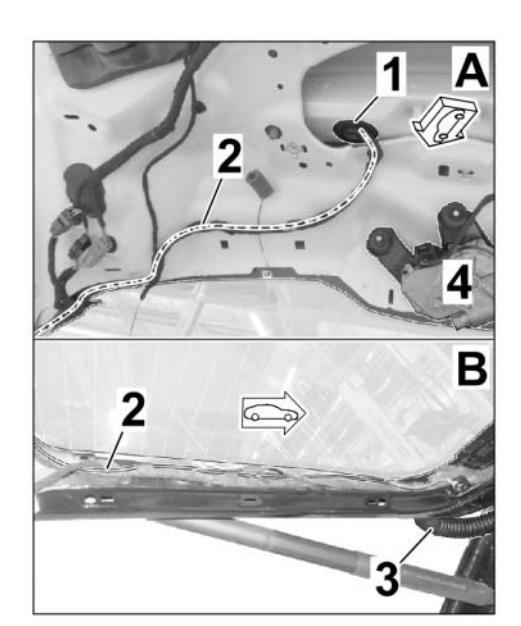
Figure 18

- 2.3.3 Inner tailgate area
 - 1 Grommet rear light tailgate
 - 2 Line VT/WH; 0.5²
 - Grommet on tailgate hinge (left)
 - 4 Rear window wiper
 - A Sport Tursimo

- B Basic/Executive
 - Route VT/WH 0.5² line (socket contact) along the existing line to the left side of the rear window frame. Sport Turismo:
 ⇒ Figure 18-A-

- Route VT/WH 0.5² line further along the left rear window frame to the grommet on the (left) tailgate hinge. ⇒ Figure 18-B-

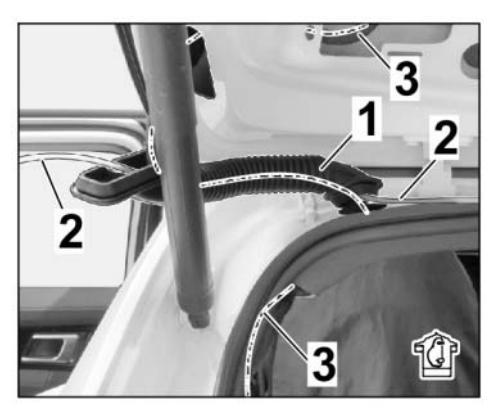
- 2.3.4 Grommet in area of left tailgate hinge \Rightarrow Figure 19
 - 1 Grommet on tailgate hinge (left)
 - 2 Piping (e.g. plastic rail)
 3 Line VT/WH; 0,5² with
 - socket contact
 - Loosen sleeve on (left) tailgate hinge from the body/rear lid.
 - Carefully guide socket contact and line VT/WH 0.5² through the grommet using a piping

- (e.g. plastic rail from transport protection for windscreen).
- Install grommet on (left) tailgate hinge in the body/rear lid. Check that the grommet is seated correctly.
