Service Bulletin

Subject: Diagnostic Tip for Checking Exhaust System for Leaks, Malfunction Indicator Lamp (MIL) Illuminated - DTC P11D5, P14D9, P20EE, P2C7A and/or P0421 Set

Brand:	Model:	Model Year:		VIN:		Engino	Tranamiasian
		from	to	from	to	Engine:	Transmission:
Cadillac	Escalade Models	2021	2023				
Chevrolet	Silverado 1500	2020	2021			Duramax 3.0L Turbo Diesel (RPO LM2)	
	Silverado 1500 - LTD (RPO J21, VIN Digit 5 = W/Y)	2022	2022 2023				
	Silverado 1500 - New (RPO J22, VIN Digit 5 = A/D)						
	Suburban	2021					
	Tahoe	2021	2023				
GMC	Sierra 1500	2020	2021				
	Sierra 1500 - Limited (RPO J21, VIN Digit 5 = 8/9)	2022	2022				
	Sierra 1500 - New (RPO J22, VIN Digit 5 = H/U)						
	Yukon Models	2021	2023

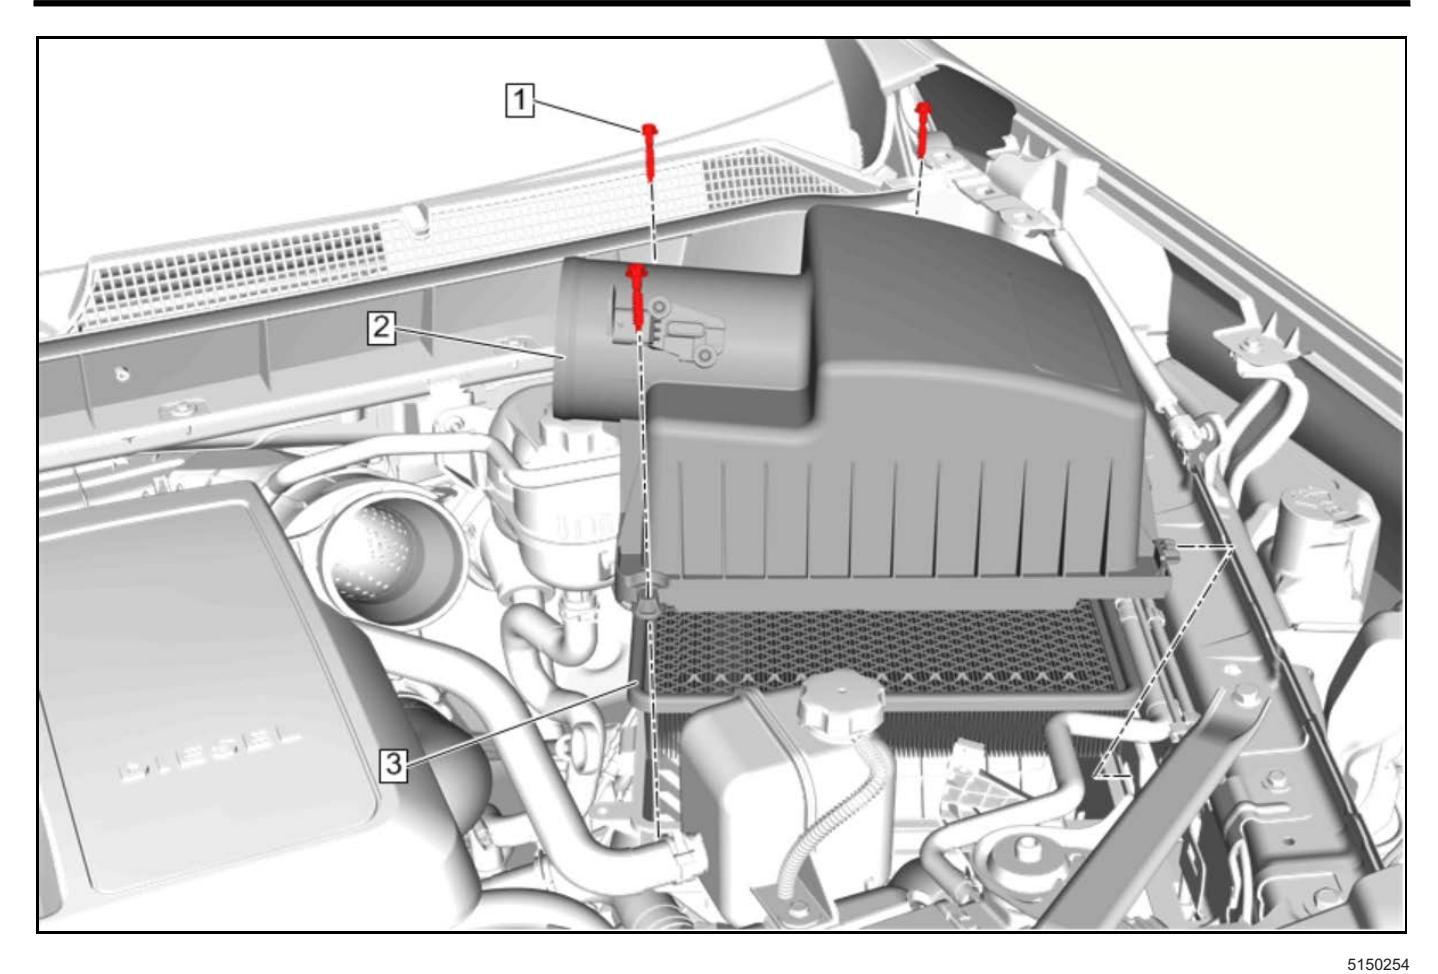
Note: A leak at the turbocharger vane actuator shaft is considered a normal condition. Any smoke or bubbles from this area should be ignored.

1. Remove the air filter (3) from the air filter housing. Refer to *Air Cleaner Element Replacement* in SI.

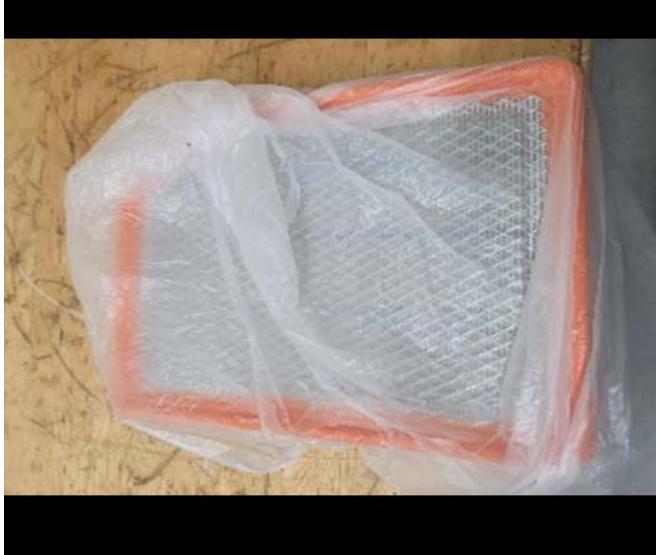
6140932

- 2. Put the air filter in a plastic bag.
- 3. Re-install the air filter into the air filter housing.
- 4. Raise the vehicle.

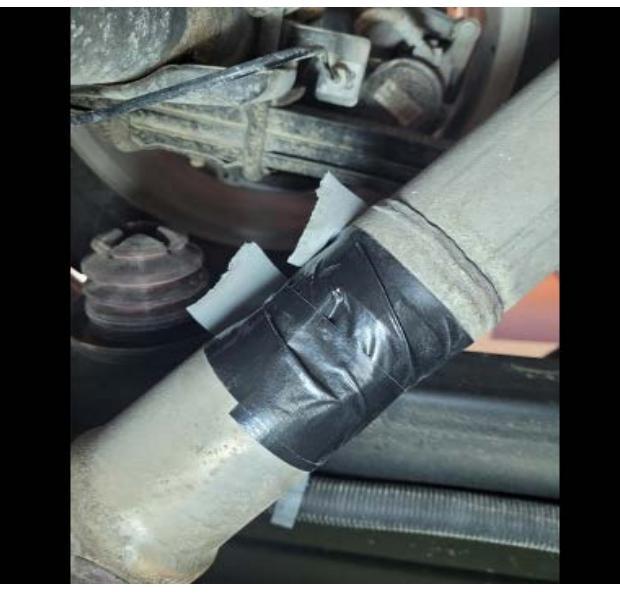
6140943

5. Locate the cooling ports in the exhaust system.

Note: The graphic depicts a single exhaust system. If equipped with a dual exhaust, both cooling holes will need to be taped off and one of the tail pipes sealed with a rag or equivalent.

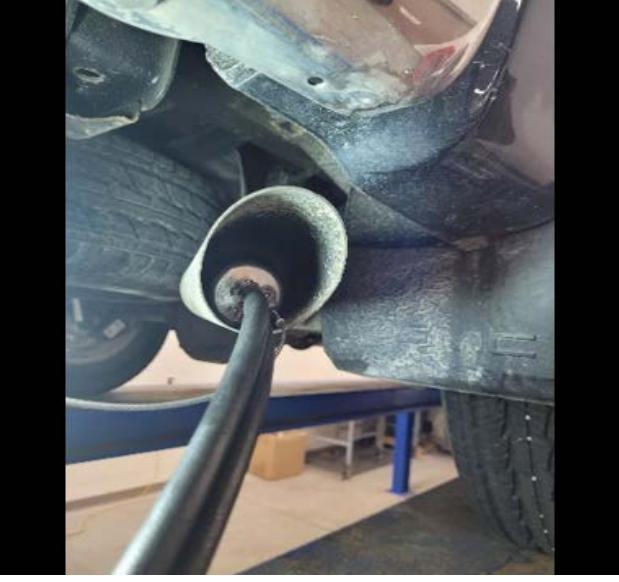
6140928

6. Tape the holes utilizing duct tape or equivalent.

- 7. Install the inflatable adapter (second largest adapter for our application) for the GE-52250 machine and insert it into the tailpipe.
- 8. Attach the GE-52250 to the adapter and shop air supply.
- 9. Command the vapor test, and adjust the test pressure to 34–55 kPa (5-8 psi).
- 10. Using a soapy water mixture, spray all connections, welds, and sensors with the soapy water mixture, and look for air leaks (See Examples of Exhaust Leak Areas of Concern section below).
- 11. Once all the leaks are detected and corrected, verify that the exhaust is sealed by retesting with the GE-52250.

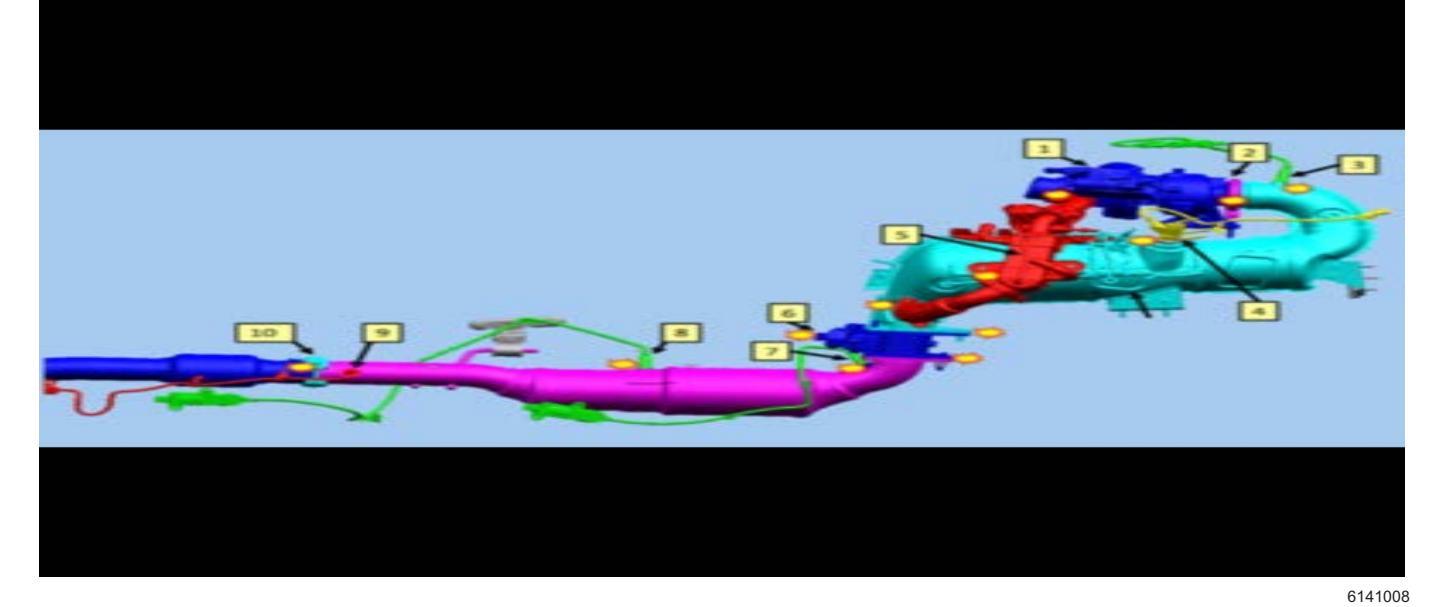
LM2 After Treatment Exhaust System				
Note: The areas that have been marked on the graphic require inspection for leaks.				
Exhaust Leak Areas of Concern				
1	Turbocharger			
2	V-Band Clamp			
3	NOx Sensor			
4	Def Injector			
5	LP EGR Cooler			
6	EXH. Throttle/Back Pressure Valve			
7	NOx 2 Sensor			
8	NOx 3 Sensor			
9	Particulate Matter Sensor			
10	Norma Band Clamp
