Applicable Vehicles									
Model(s)	Year	Eng. Code	Trans. Code	VIN Range From	VIN Range To				
ID.4	2021 – 2022	All	All	All	All

Revision Table								
Instance Number	Published Date	Version Number	Reason For Update					
2069239/1	1/25/23	91-23-01	Original publication

The customer may complain that, at start up, a message that reads "Please have an inspection service performed" appears in the instrument cluster display.

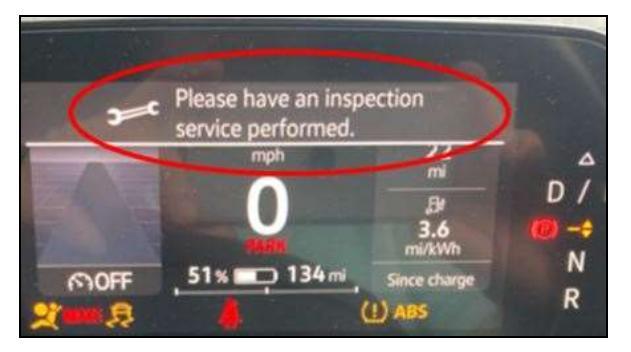
Figure 1.

This complaint will only affect MY 21 and MY 22 ID.4 vehicles that have had the campaign **97FY** update completed previously. Additionally, only vehicles with mileage exceeding 40,721 (65,535 km) are affected.

Performing the "**Reset inspection service**" test plan in Guided Fault Finding corrects the concern listed above.

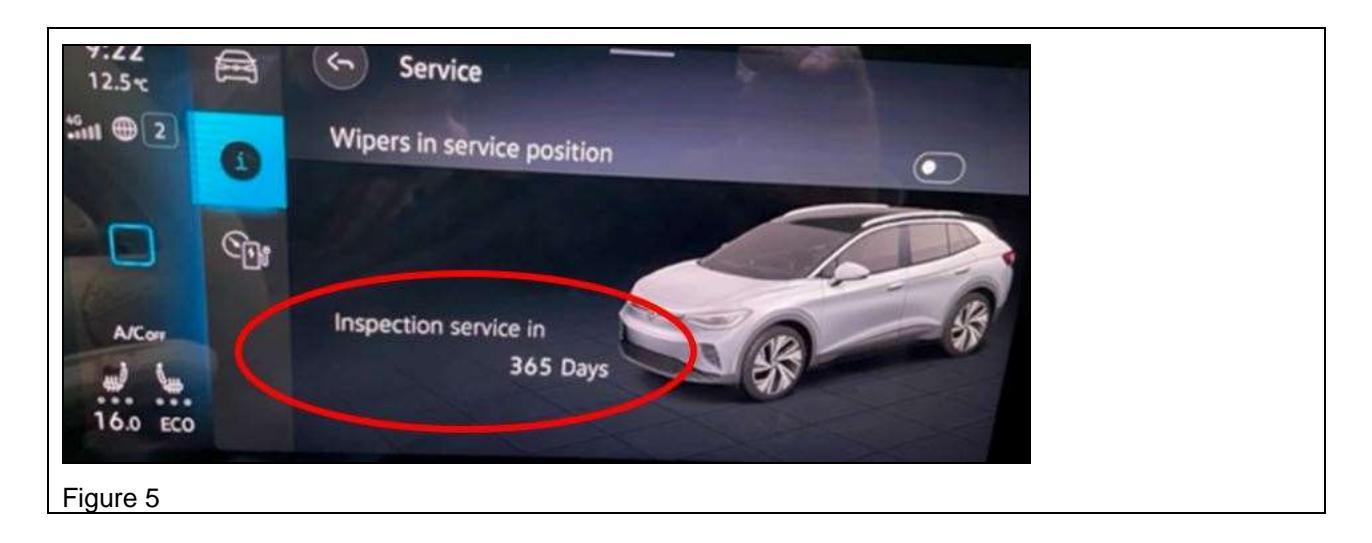
Once the test plan is completed correctly, a mileage value will no longer be present in the Service interval in the MIB display.

9. Once the test plan is completed, exit GFF.
