### Tech Tip L-TT-0323-23

## Lexus Interface (21MM) User Profile Diagnostics and **TAS Precall worksheet**

21MM All Models

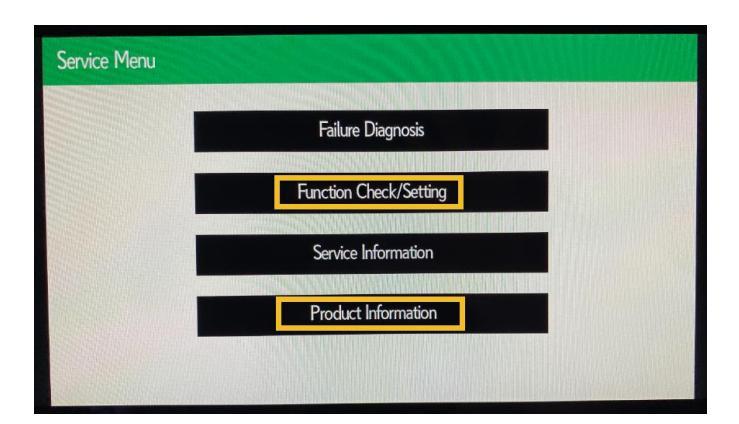
- 2. Start with the vehicle running outside for 5-10 minutes in an area with no overhead obstructions.
  - a. Enter the radio Service Menu (diagnostic mode) using Techstream or GTS+, or the manual swiping method as outlined in the Repair Manual.
  - b. Once the Service Menu is shown, the Function Check/Setting, and Product information buttons will be used.
