Case Number: S2319000004

Release Date: June 2023

**Symptom/Vehicle Issue:** Buzz, Squeak Or Rattle (BSR) From Steering Wheel Area While Turning.

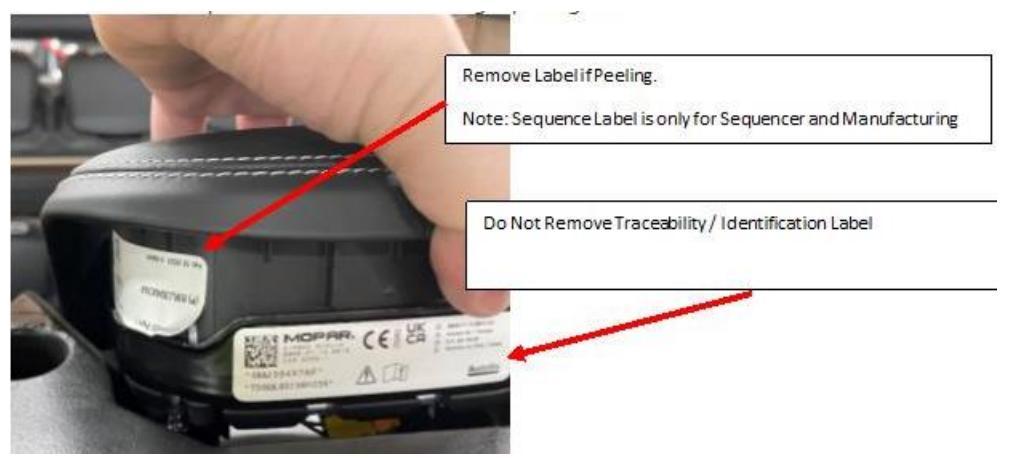
**Discussion**: A possible cause of a noise while turning the steering wheel is the driver airbag sequence label or steering wheel wire harness label. If either label is out of position or has a loss of adhesion they could rub causing a noise. To verify if one of the labels is a cause review the following.

Fig 1. Driver Air Bag Labels.

- a. Sequence label on driver airbag is peeling off (Fig 1). If peeling, remove the sequence label.
- b. Steering Wheel Wire Harness Label and Clip Position. White clip should be fully seated and no label underneath clip (Fig 2.). Remove the harness label. Position and push the harness into the white clip to ensure its fully seated.

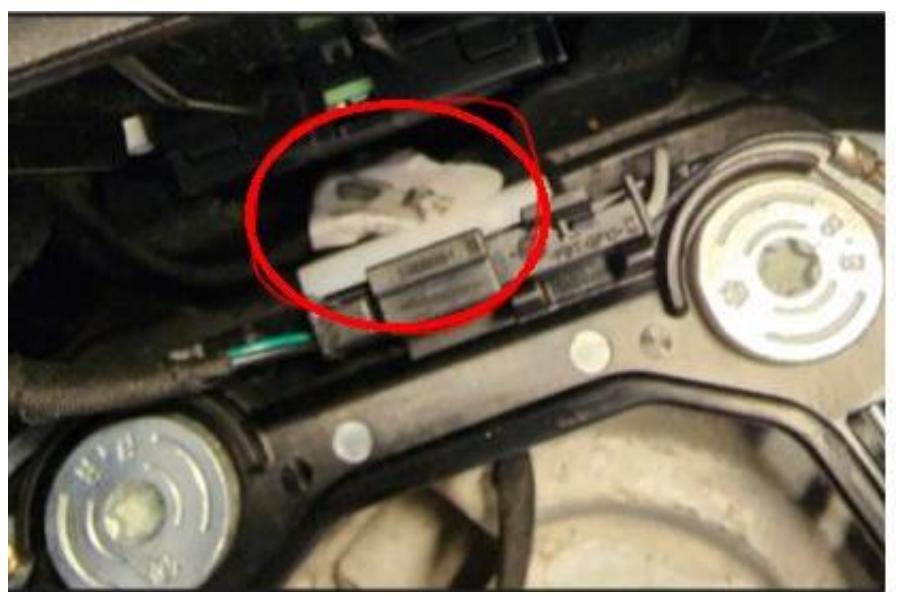
Fig 2. Steering Wheel Harness Label and White Clip.
