Technical Service Bulletin

PSS 90 Audi Virtual cockpit speedometer needle flickers while driving

90 23 36 2071329/1 August 24, 2023.

Model(s)	Year	VIN Range	Vehicle-Specific Equipment
A6, A7, A8, Q7, and Q8	2019	All	Virtual Cockpit

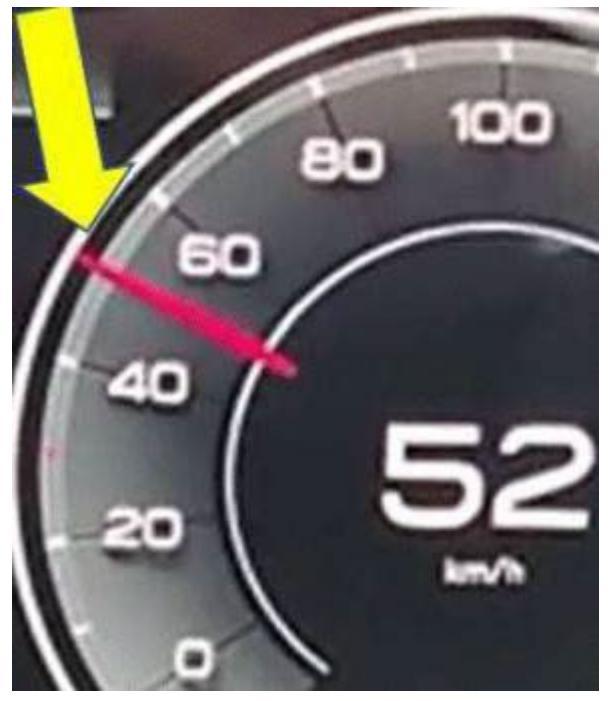
The red needle of the speedometer (Figure 1) flickers while driving.

Figure 1: Red needle of the speedometer flickers while vehicle is in motion.

- Flickering can be seen in standard view (large speedometer).
- Flickering can be seen in extended view (small speedometer).
- Flickering does not occur when stationary.
- The correct speed is displayed.
- The tachometer needle does not flicker.

Software issue in the virtual cockpit.

- 1. Explain to the customer that a solution is expected to be available by the end of the 4th quarter of 2023 (subject to change) and that no repairs are necessary at this point. Do not replace any components for this condition since this will not resolve the customer's concern.
- 2. Create a PSS record in the PSS application through the Pending Service Solutions (PSS) link in AccessAudi (under *Related Links >> Service*).
