**Document ID:** IK0700001  
**Revision:** 4  
**Created:** 8/1/2007  
**Last Modified:** 12/10/2013  
**Author:** Jon Pierce

**Title: Threaded Drain Hole In DPF (Muffler) On Trucks With 2007 Caterpillar Emissions Engines**

**Applies To: All Trucks with CAT 2007 Emission Engines**

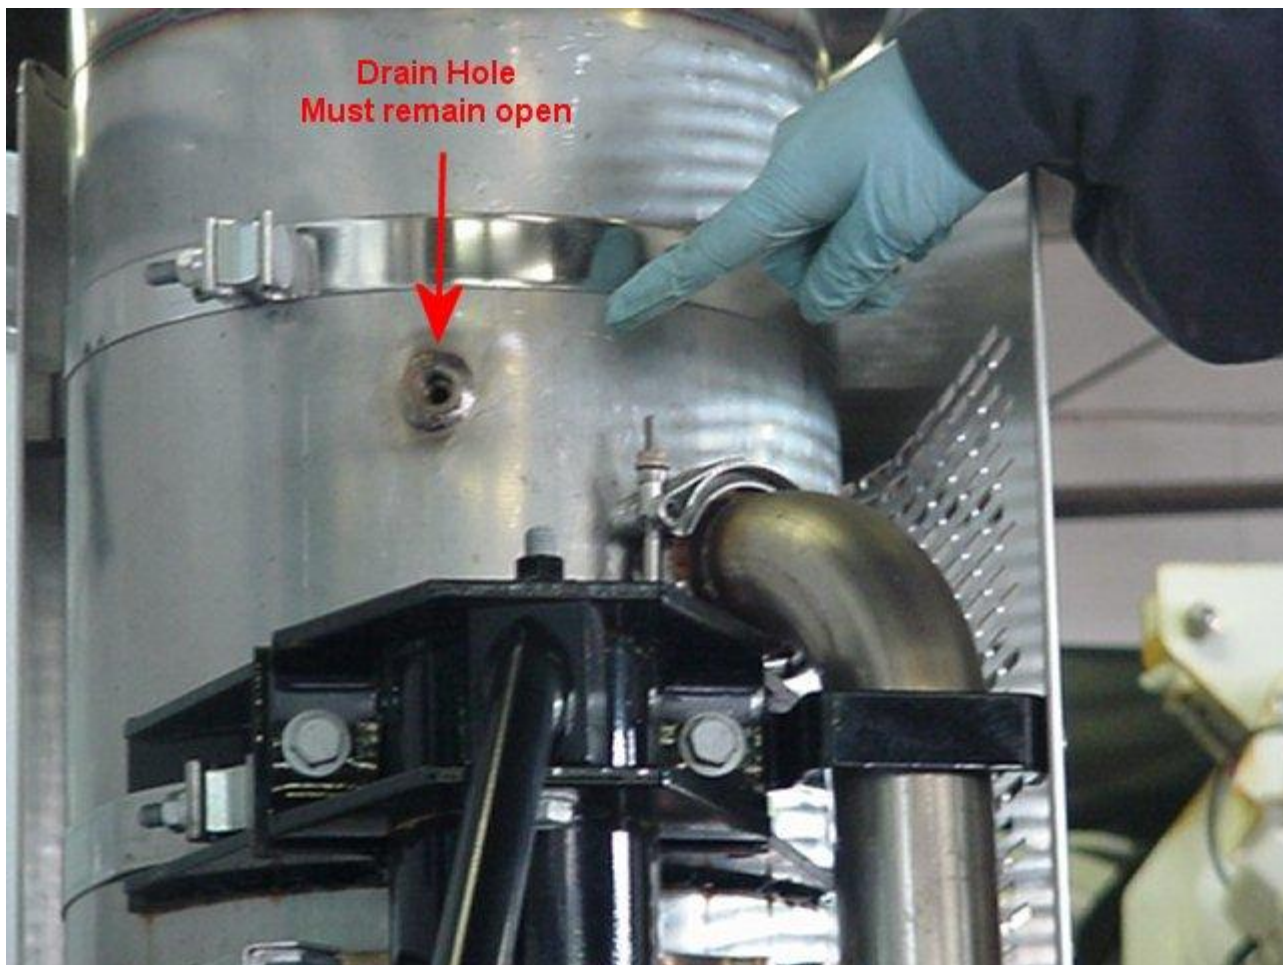
Trucks equipped with 2007 Caterpillar emission engines have a threaded hole in the DPF canister. This is a drain hole and should not have a plug, fitting or sensor installed. Do not plug this hole as water damage to the DPF can occur. This is a water drain hole and must remain open.
