**DOT Auto Safety Hotline**  
**Vehicle Owner's Questionnaire**  
To Report Vehicle Safety Defects  
1-888-DASH-2-DOE  
(1-888-327-4236)  
INTERNET: www.nhtsa.dot.gov/hotline

17 digit Vehicle Identification Number Located at bottom of windshield on driver's side  
4T1BF288X  Make TOYOTA Model AVALON Model Year 2004

**Description of failure:**

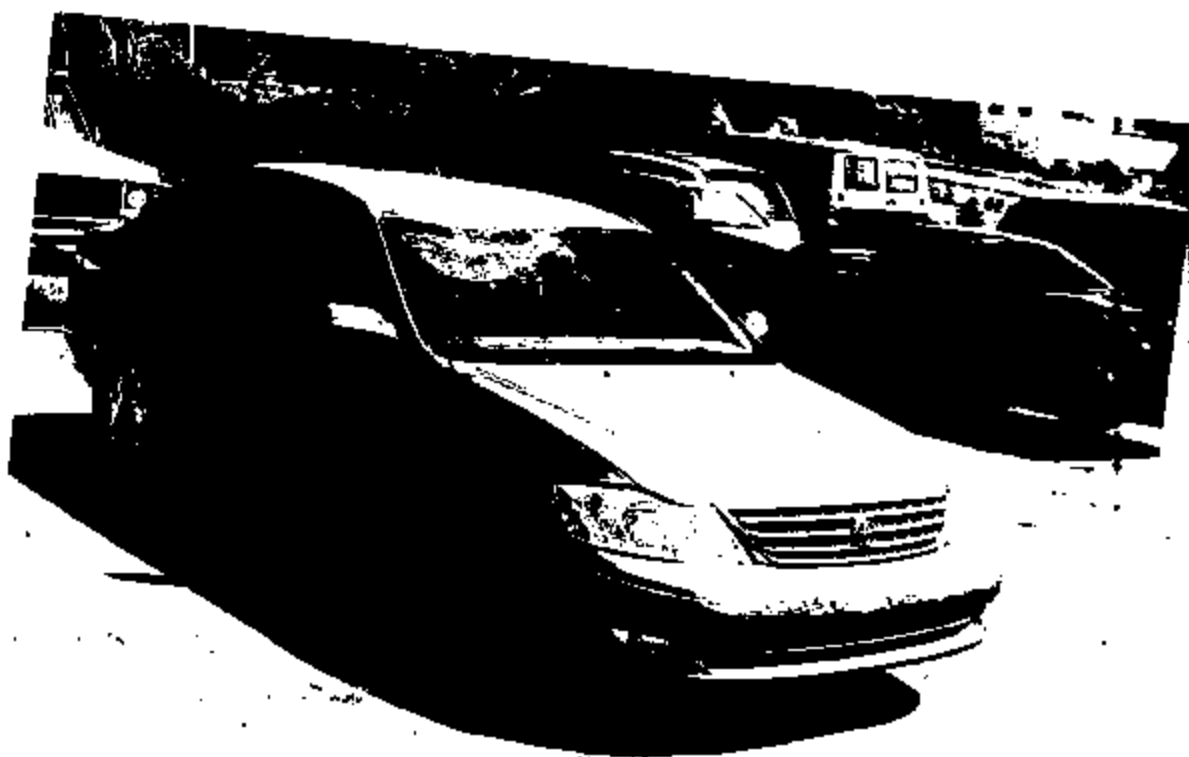
- OVERALL DAMAGE TO CAR :  
BUMPER/HOOD/WINDSHIELD/ROOF

- PHOTO ALSO SHOWS 5 SPOKE  
ALUMINUM ALLOY <sup>WHEEL</sup> REAR OF  
CAR, LIKE THE ONE DAMAGED  
IN THE PHOTOS.
