**From:** [REDACTED]  
**Sent:** Tuesday, March 25, 2008 3:59 PM  
**To:** [REDACTED]  
**Subject:** FW: FW: 2005 Nissan Murano  
**Importance:** High  
**Attachments:** Photo 1.JPG; Photo 2.JPG

The issue with the Front Driver Side Seat of our 2005 Nissan Murano is also covered under a Nissan Technical Service Bulletin which the classification number is BT05-12c and the reference number is NTB05-043c.

The part that caused the issue was not a weld breaking as my wife had explained in her previous e-mail but the actual bracket shearing due to what I believe is a manufactures design flaw. The part in question is Nissan Part Number 87473-CA00A which is listed as the Lifter Link Assembly RR-LH. As you can see in the attached photos the two small tabs where the bracket broke are supposed to hold up the entire left rear portion of the seat. This bracket runs side to side and broke on the left hand side of the bracket.

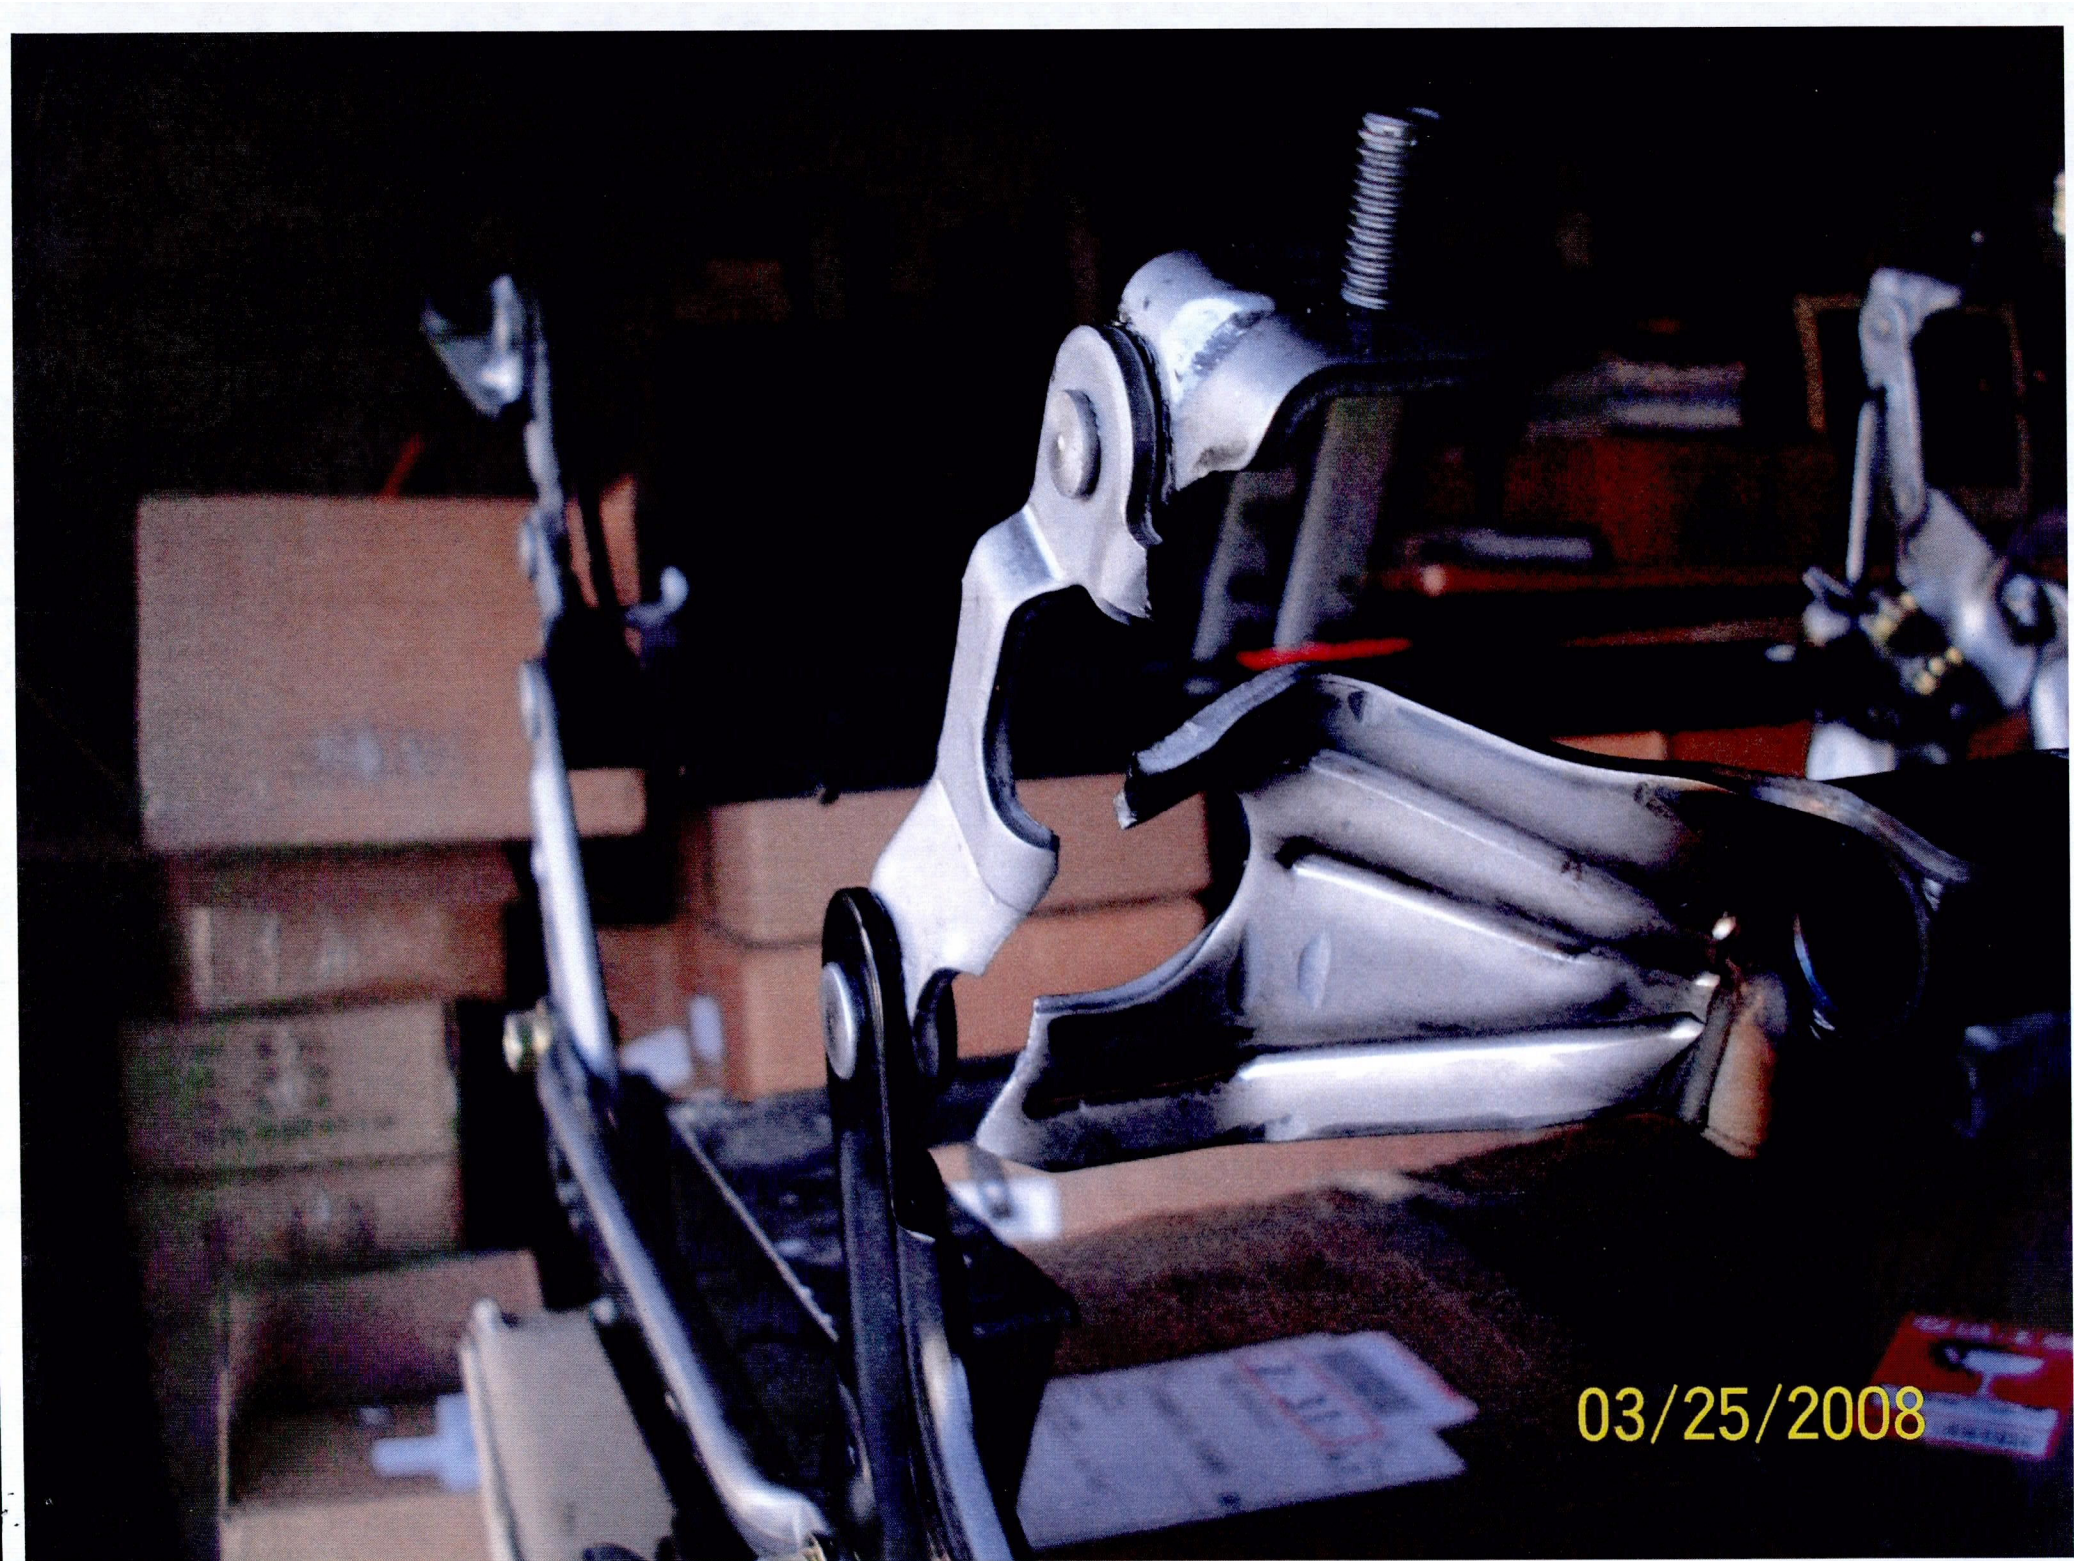
Photo 1 shows the bracket being held in position.

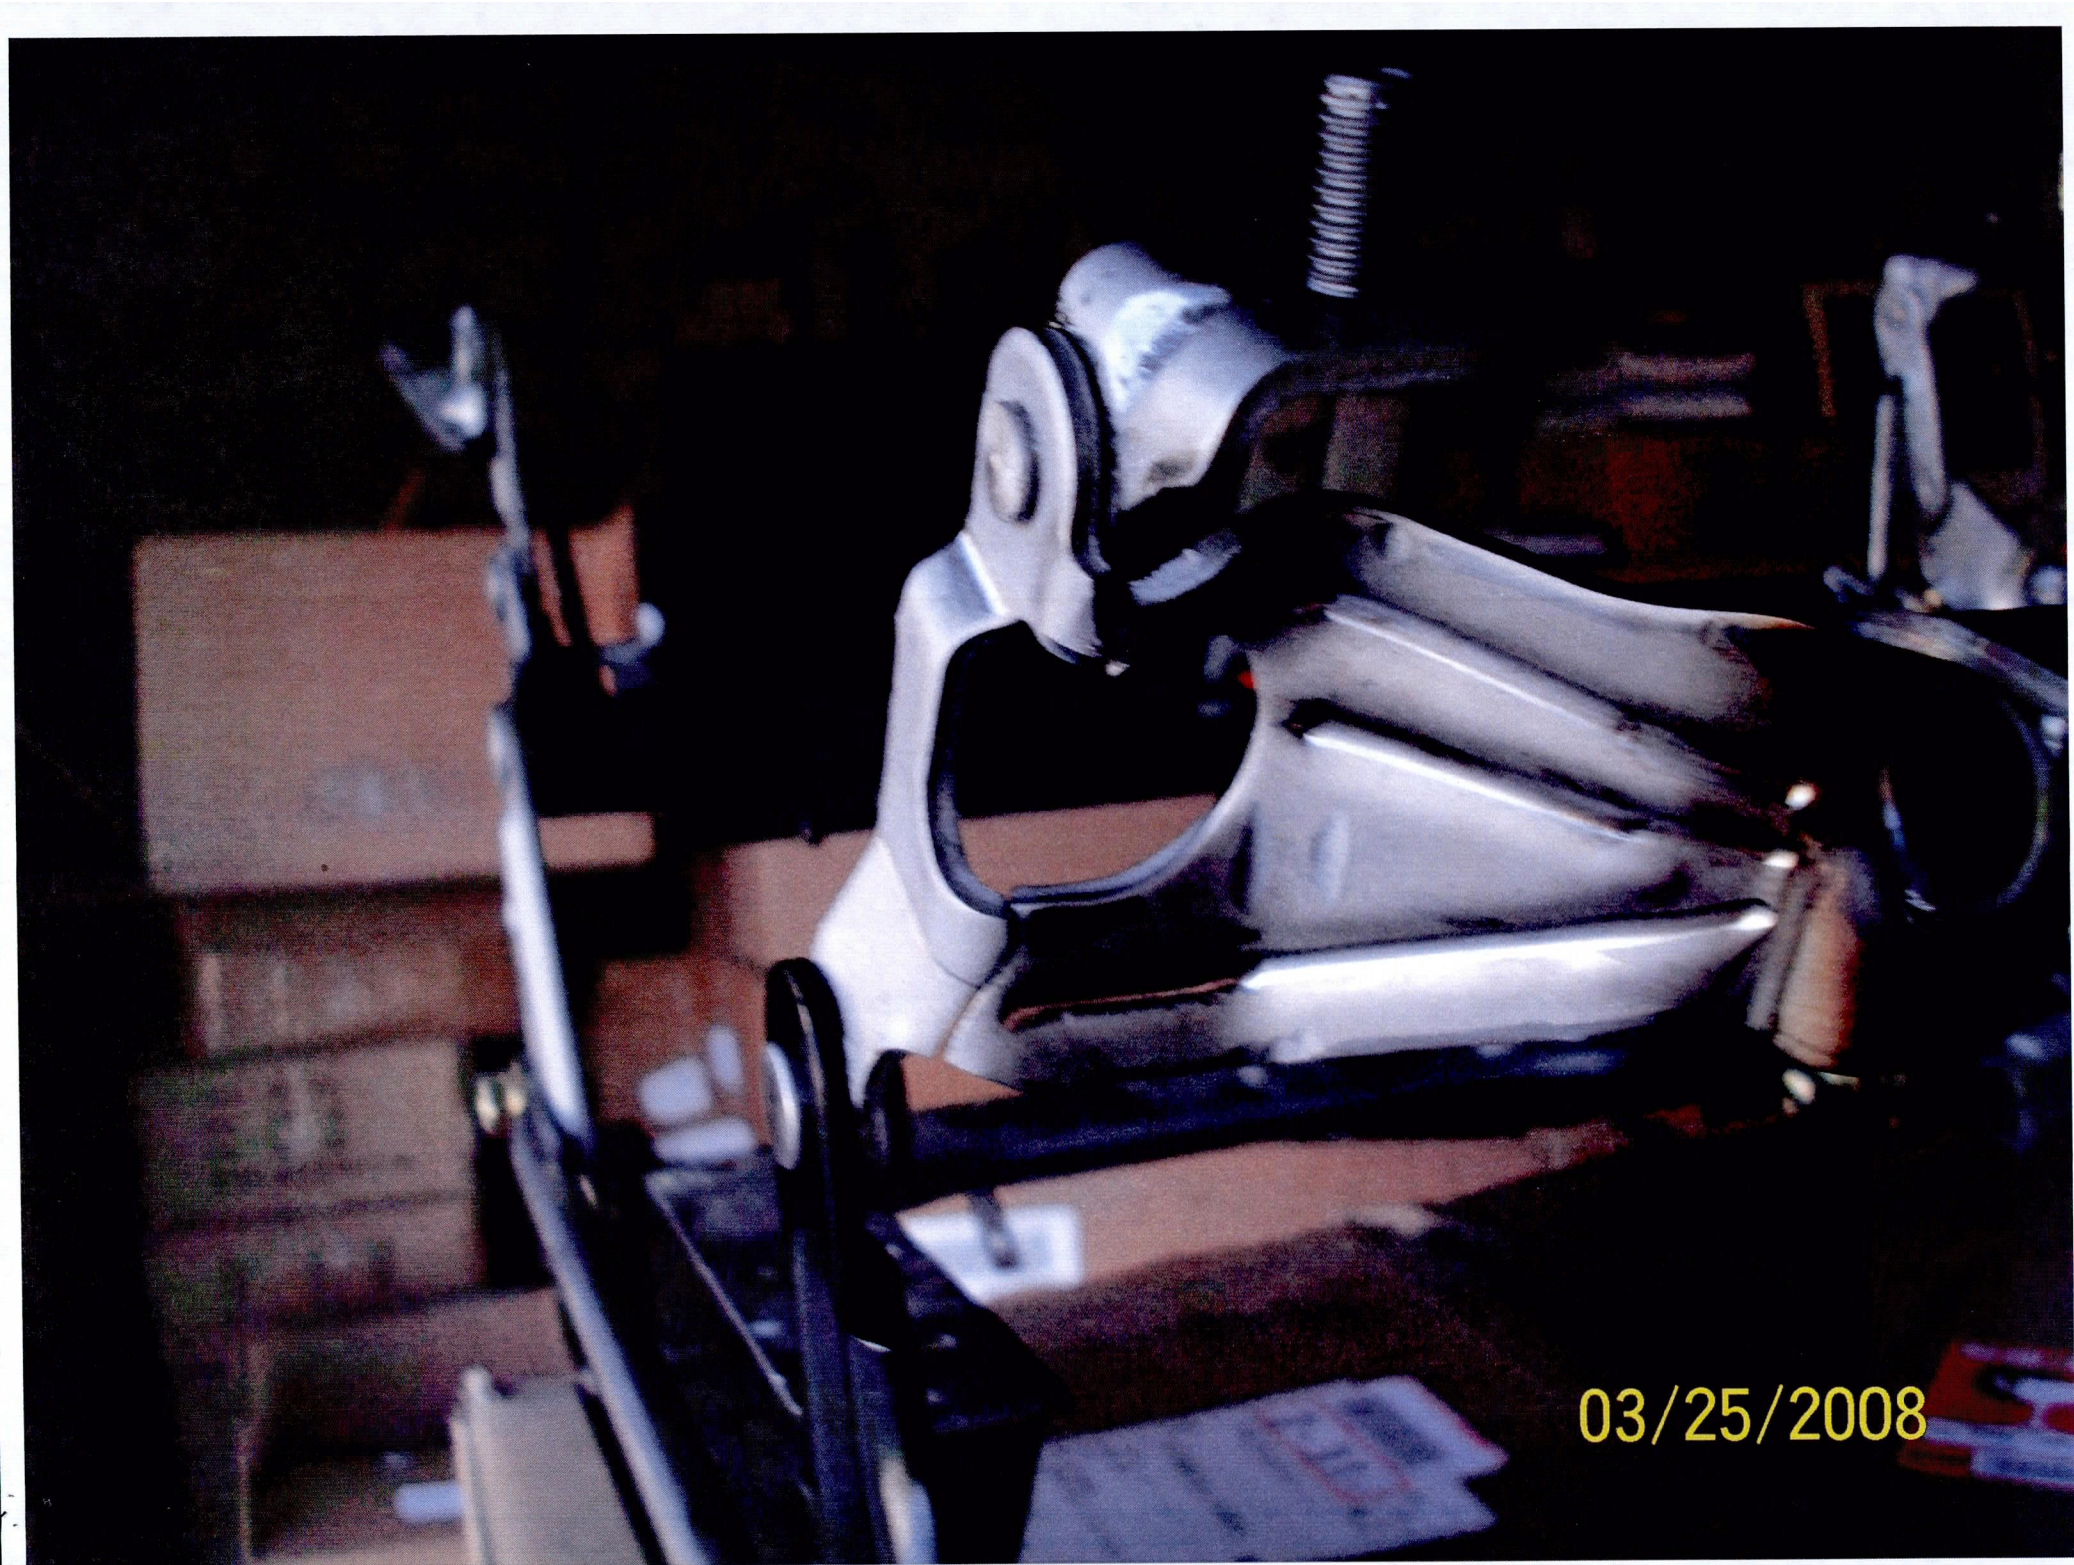
Photo 2 shows the bracket separated at two points.

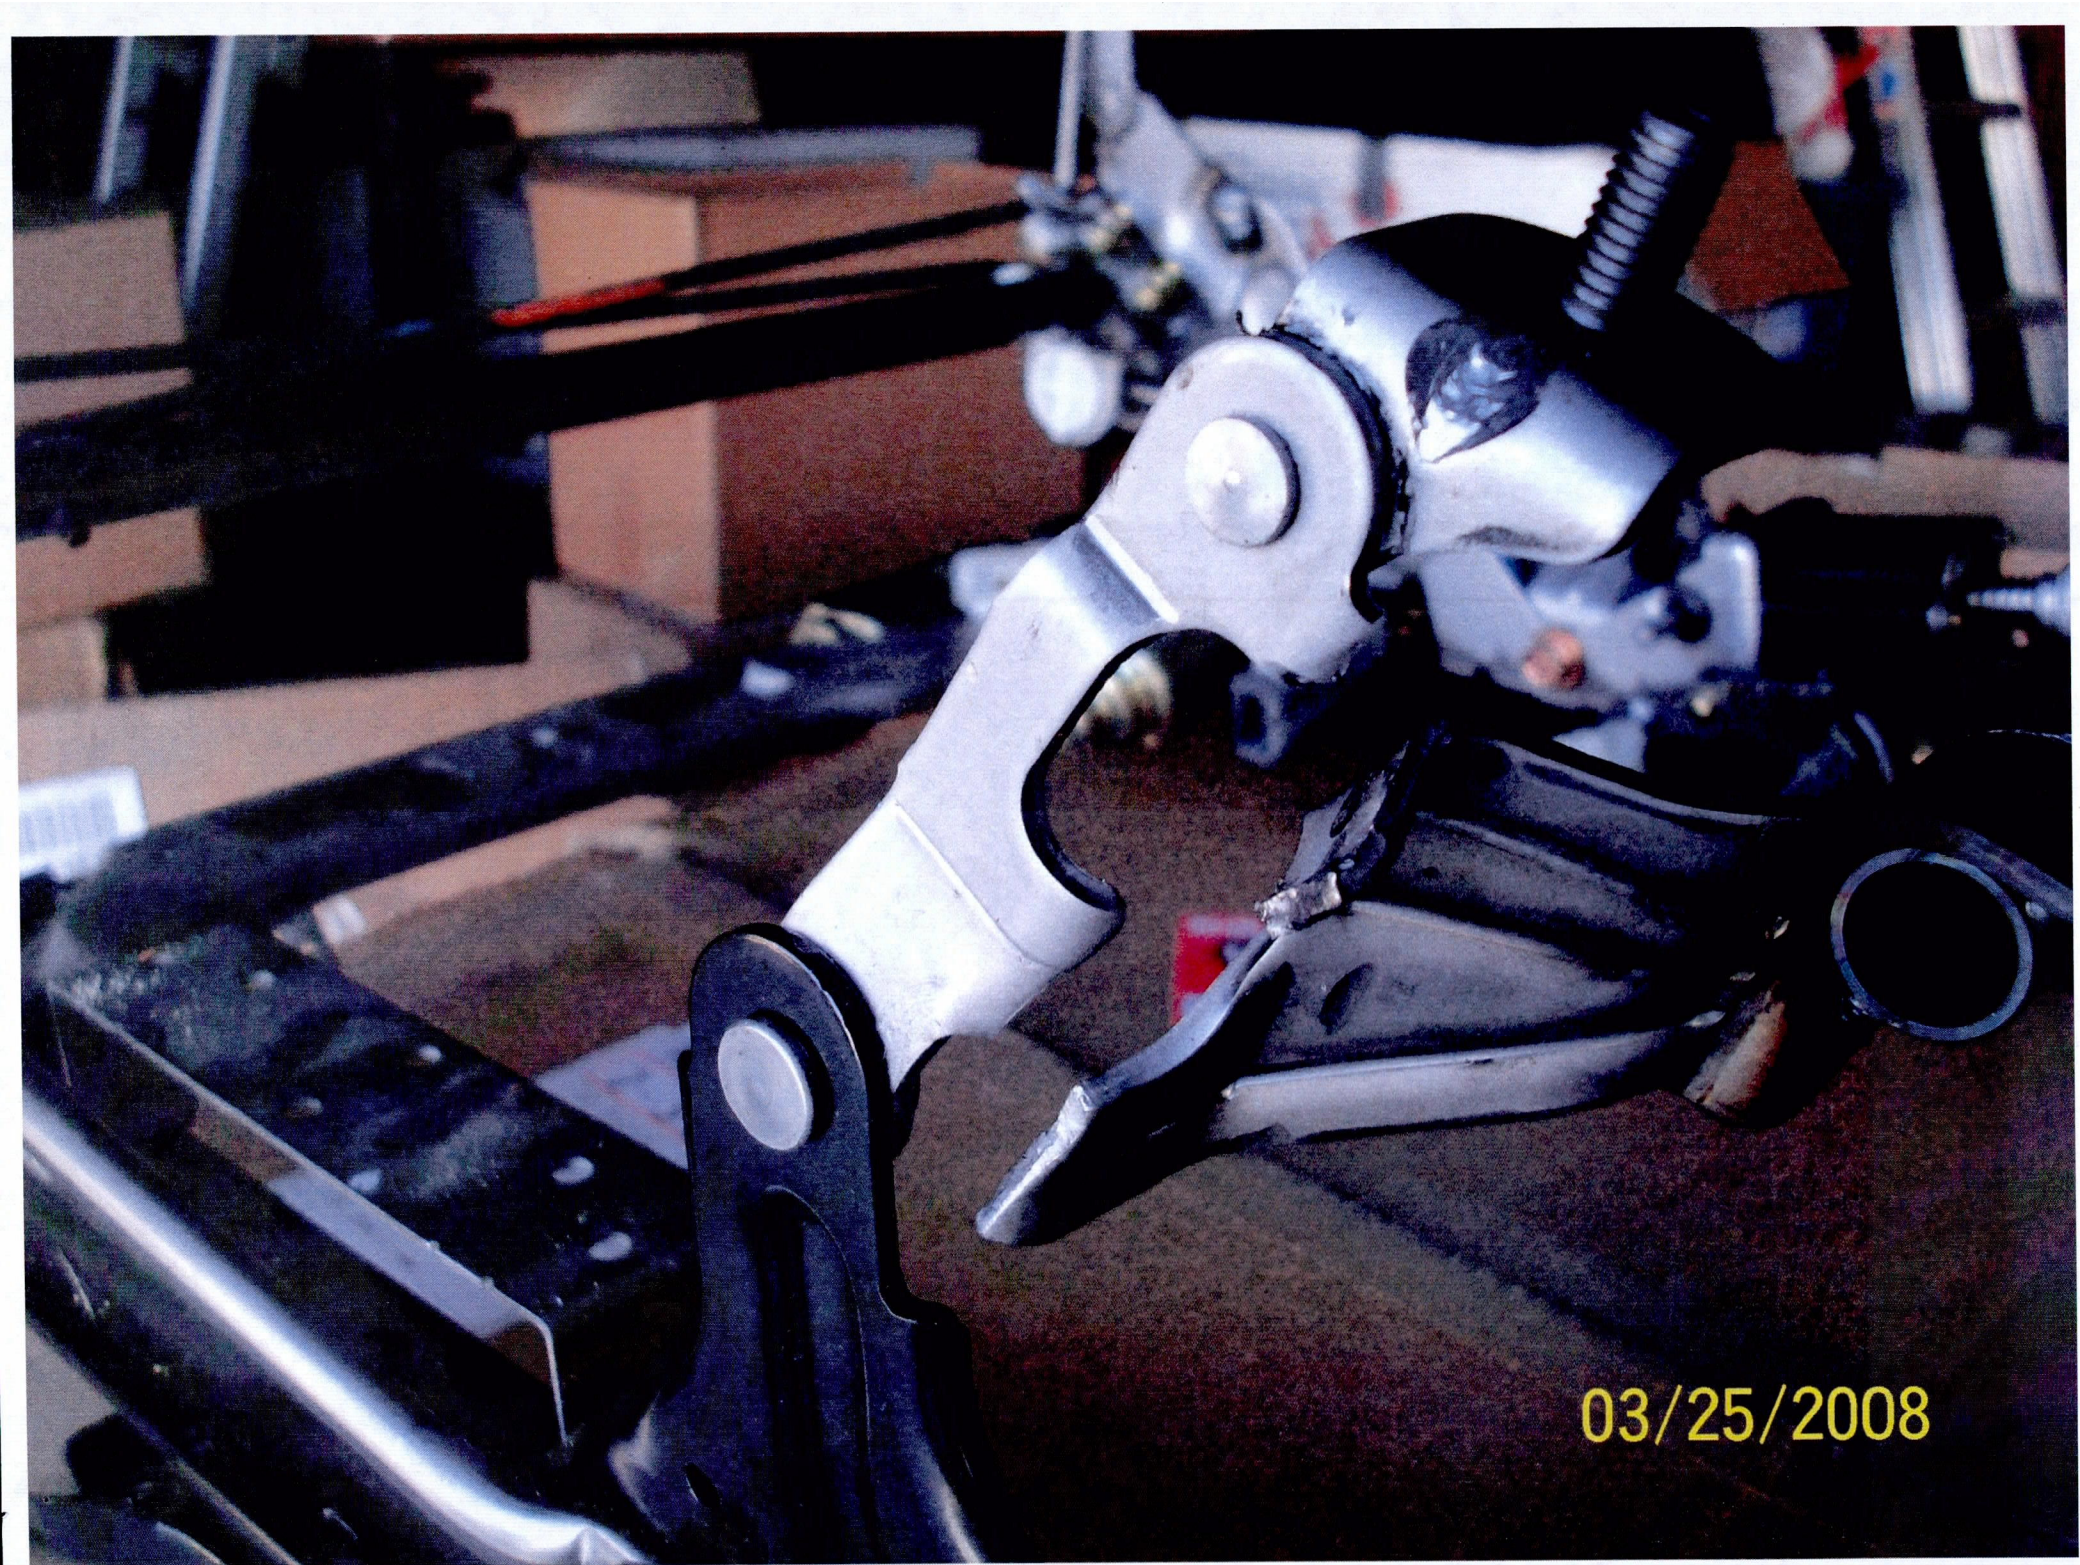
Photo 3 shows same as photo 2.

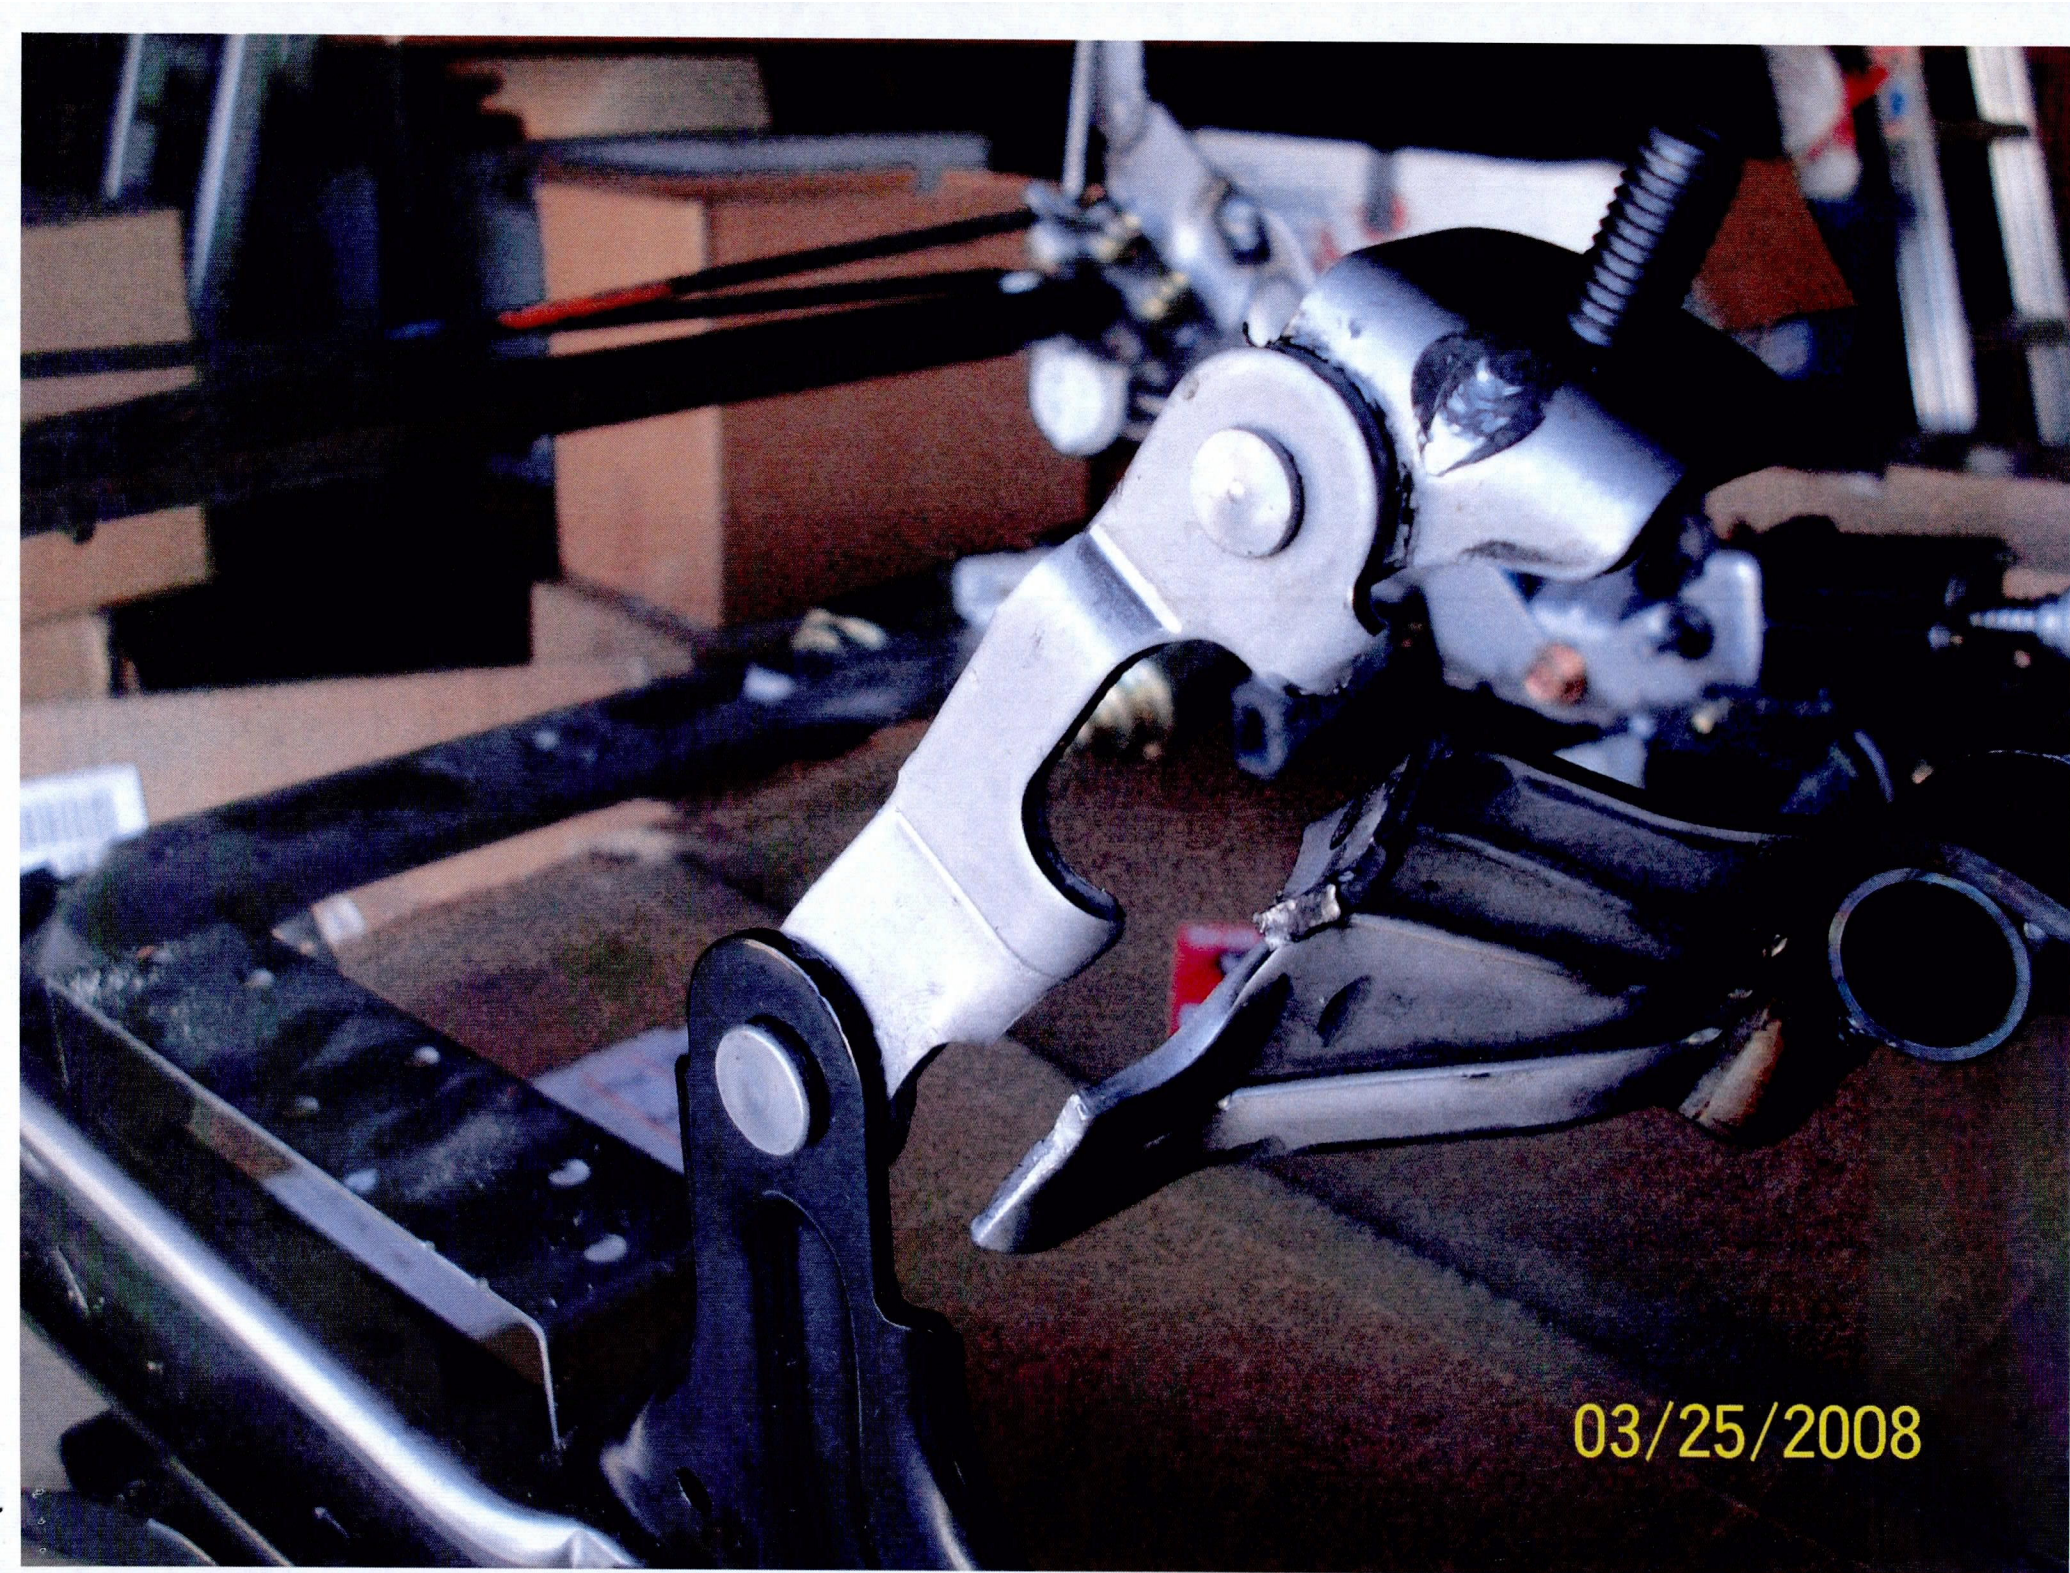
Photo 4 shows how the seat mount pivots to the rear after the breakage allowing the seat to tilt to the left.
