Subject: Chrysler Group, LLC Failure-to-Warn/Comply under 49 CFR § 573.6, et al. <sup>1</sup>

Reference 2: EA12-005 File Update (Chrysler Jeep Fuel Tank System Safety Defect)

Chrysler Jeep Fuel System Defect Investigation EA12-005

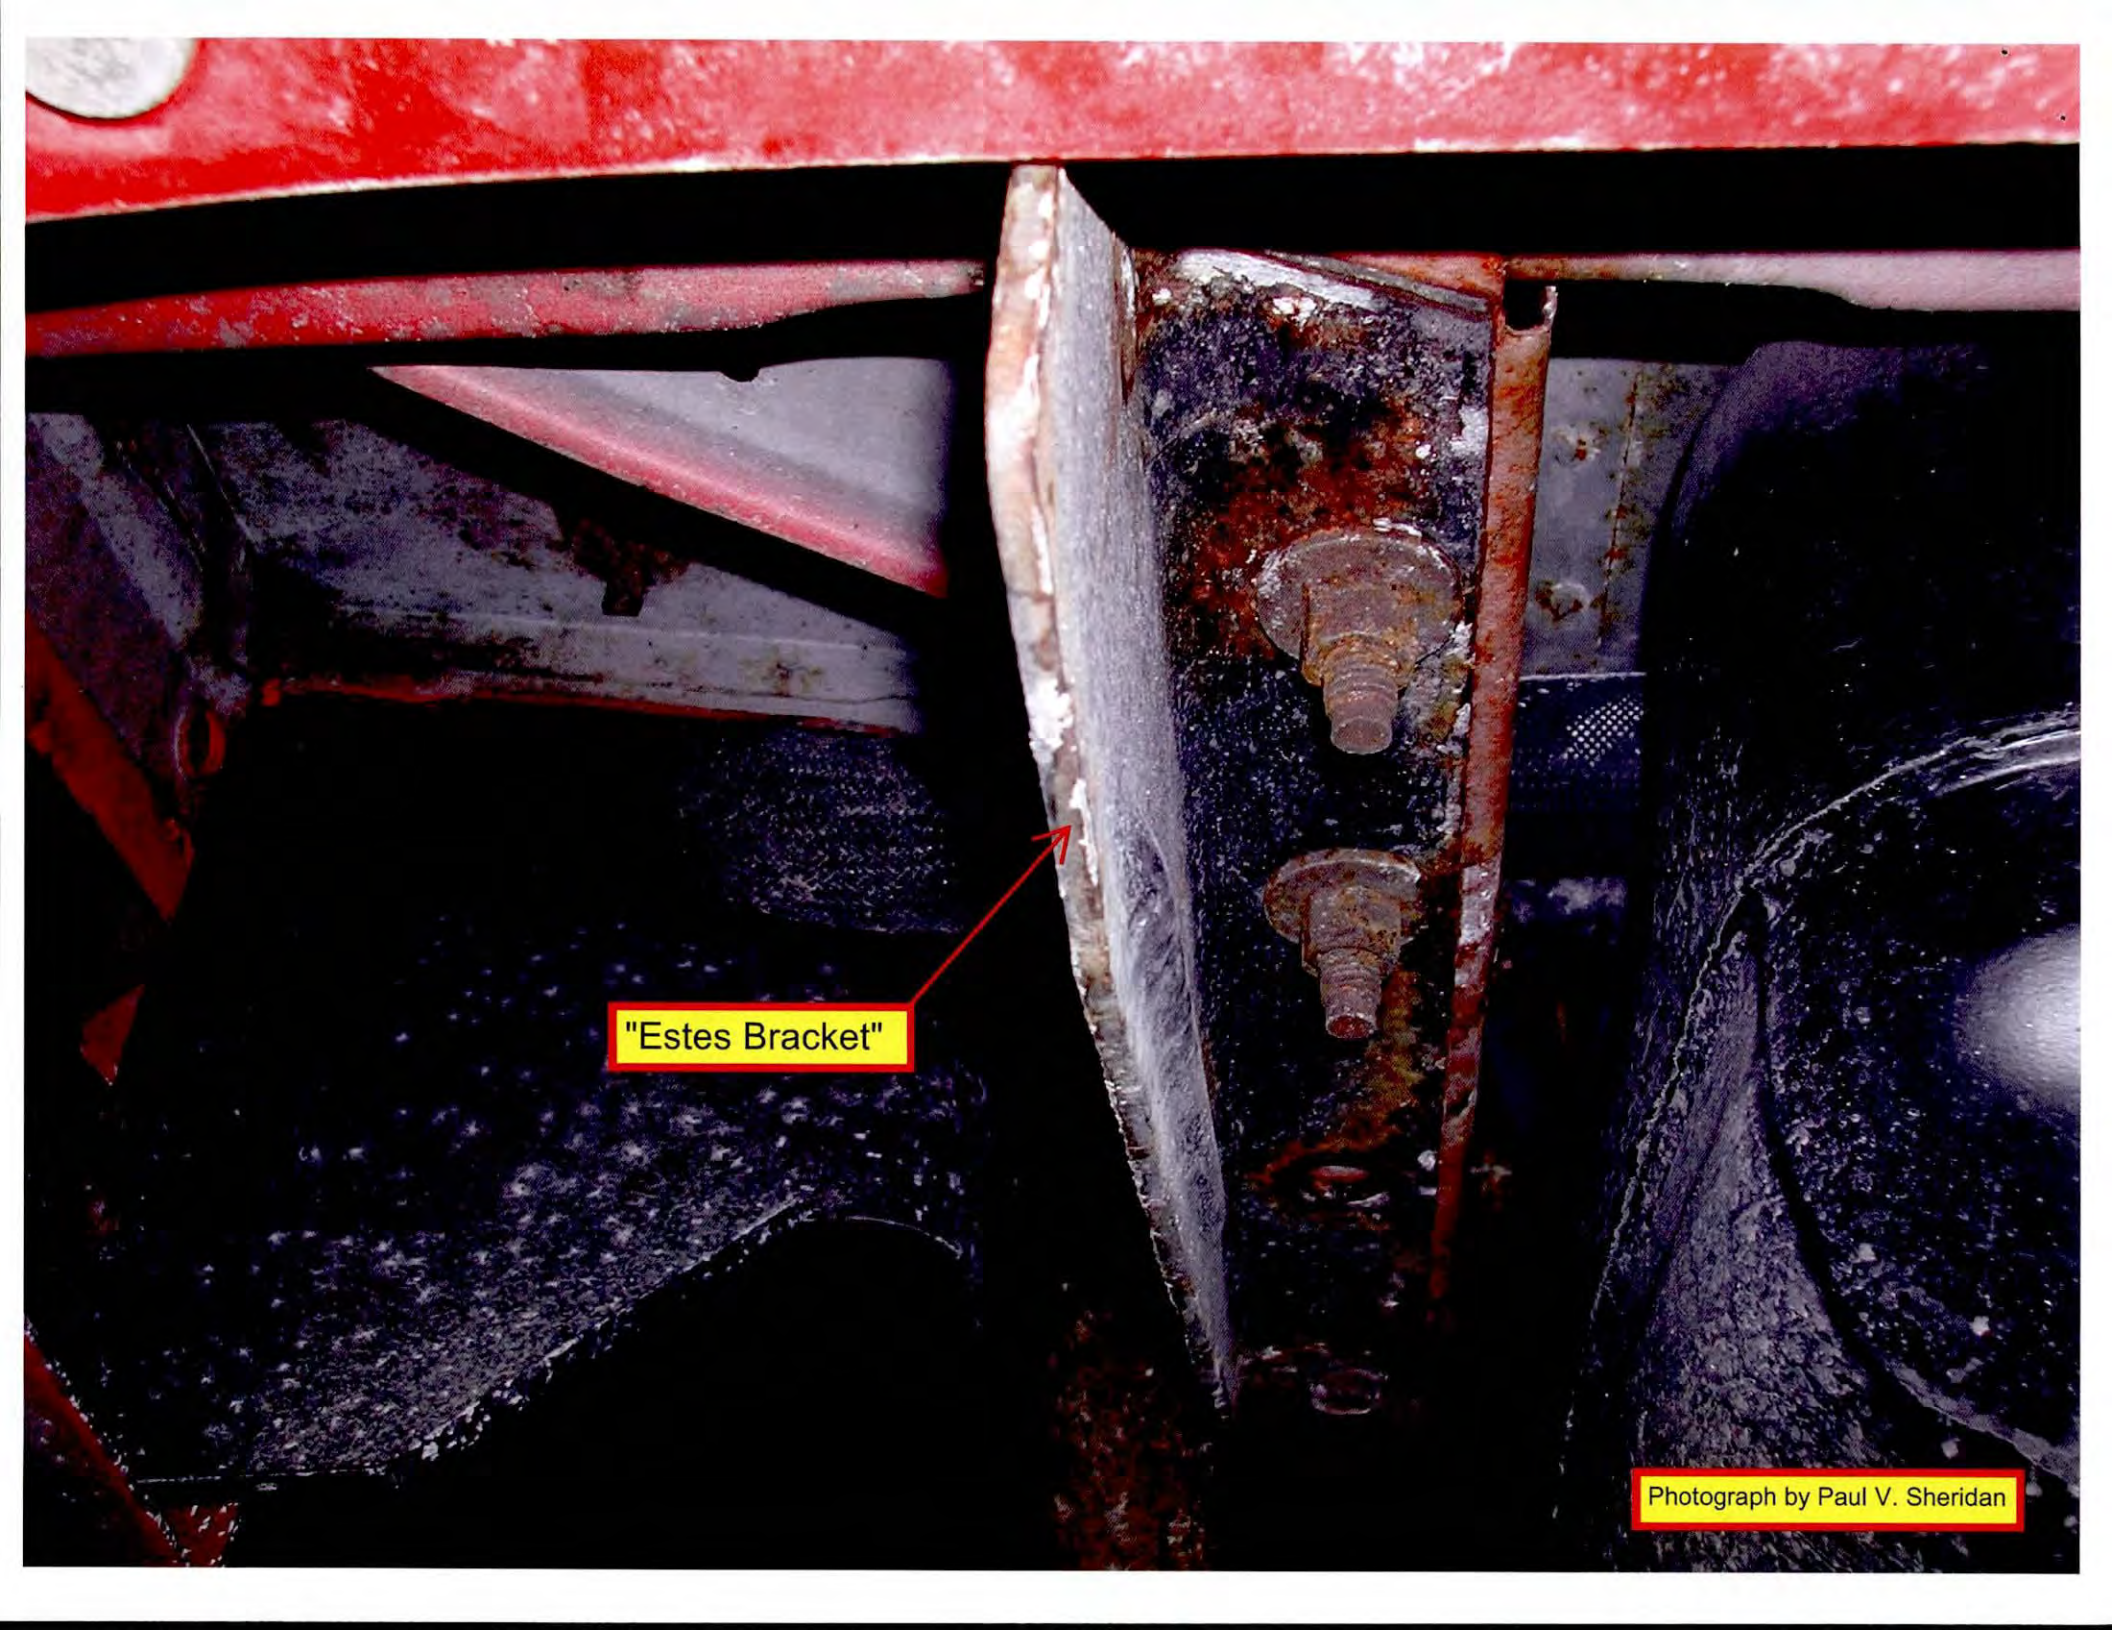
"Estes Bracket"

A close-up photograph of a heavily rusted metal bracket, identified as the "Estes Bracket". The bracket is a vertical, L-shaped piece of metal. It is secured with two large, hexagonal bolts. The surrounding area is dark and appears to be part of a larger mechanical assembly, possibly a vehicle's undercarriage. A red arrow points from the text label to the bracket.

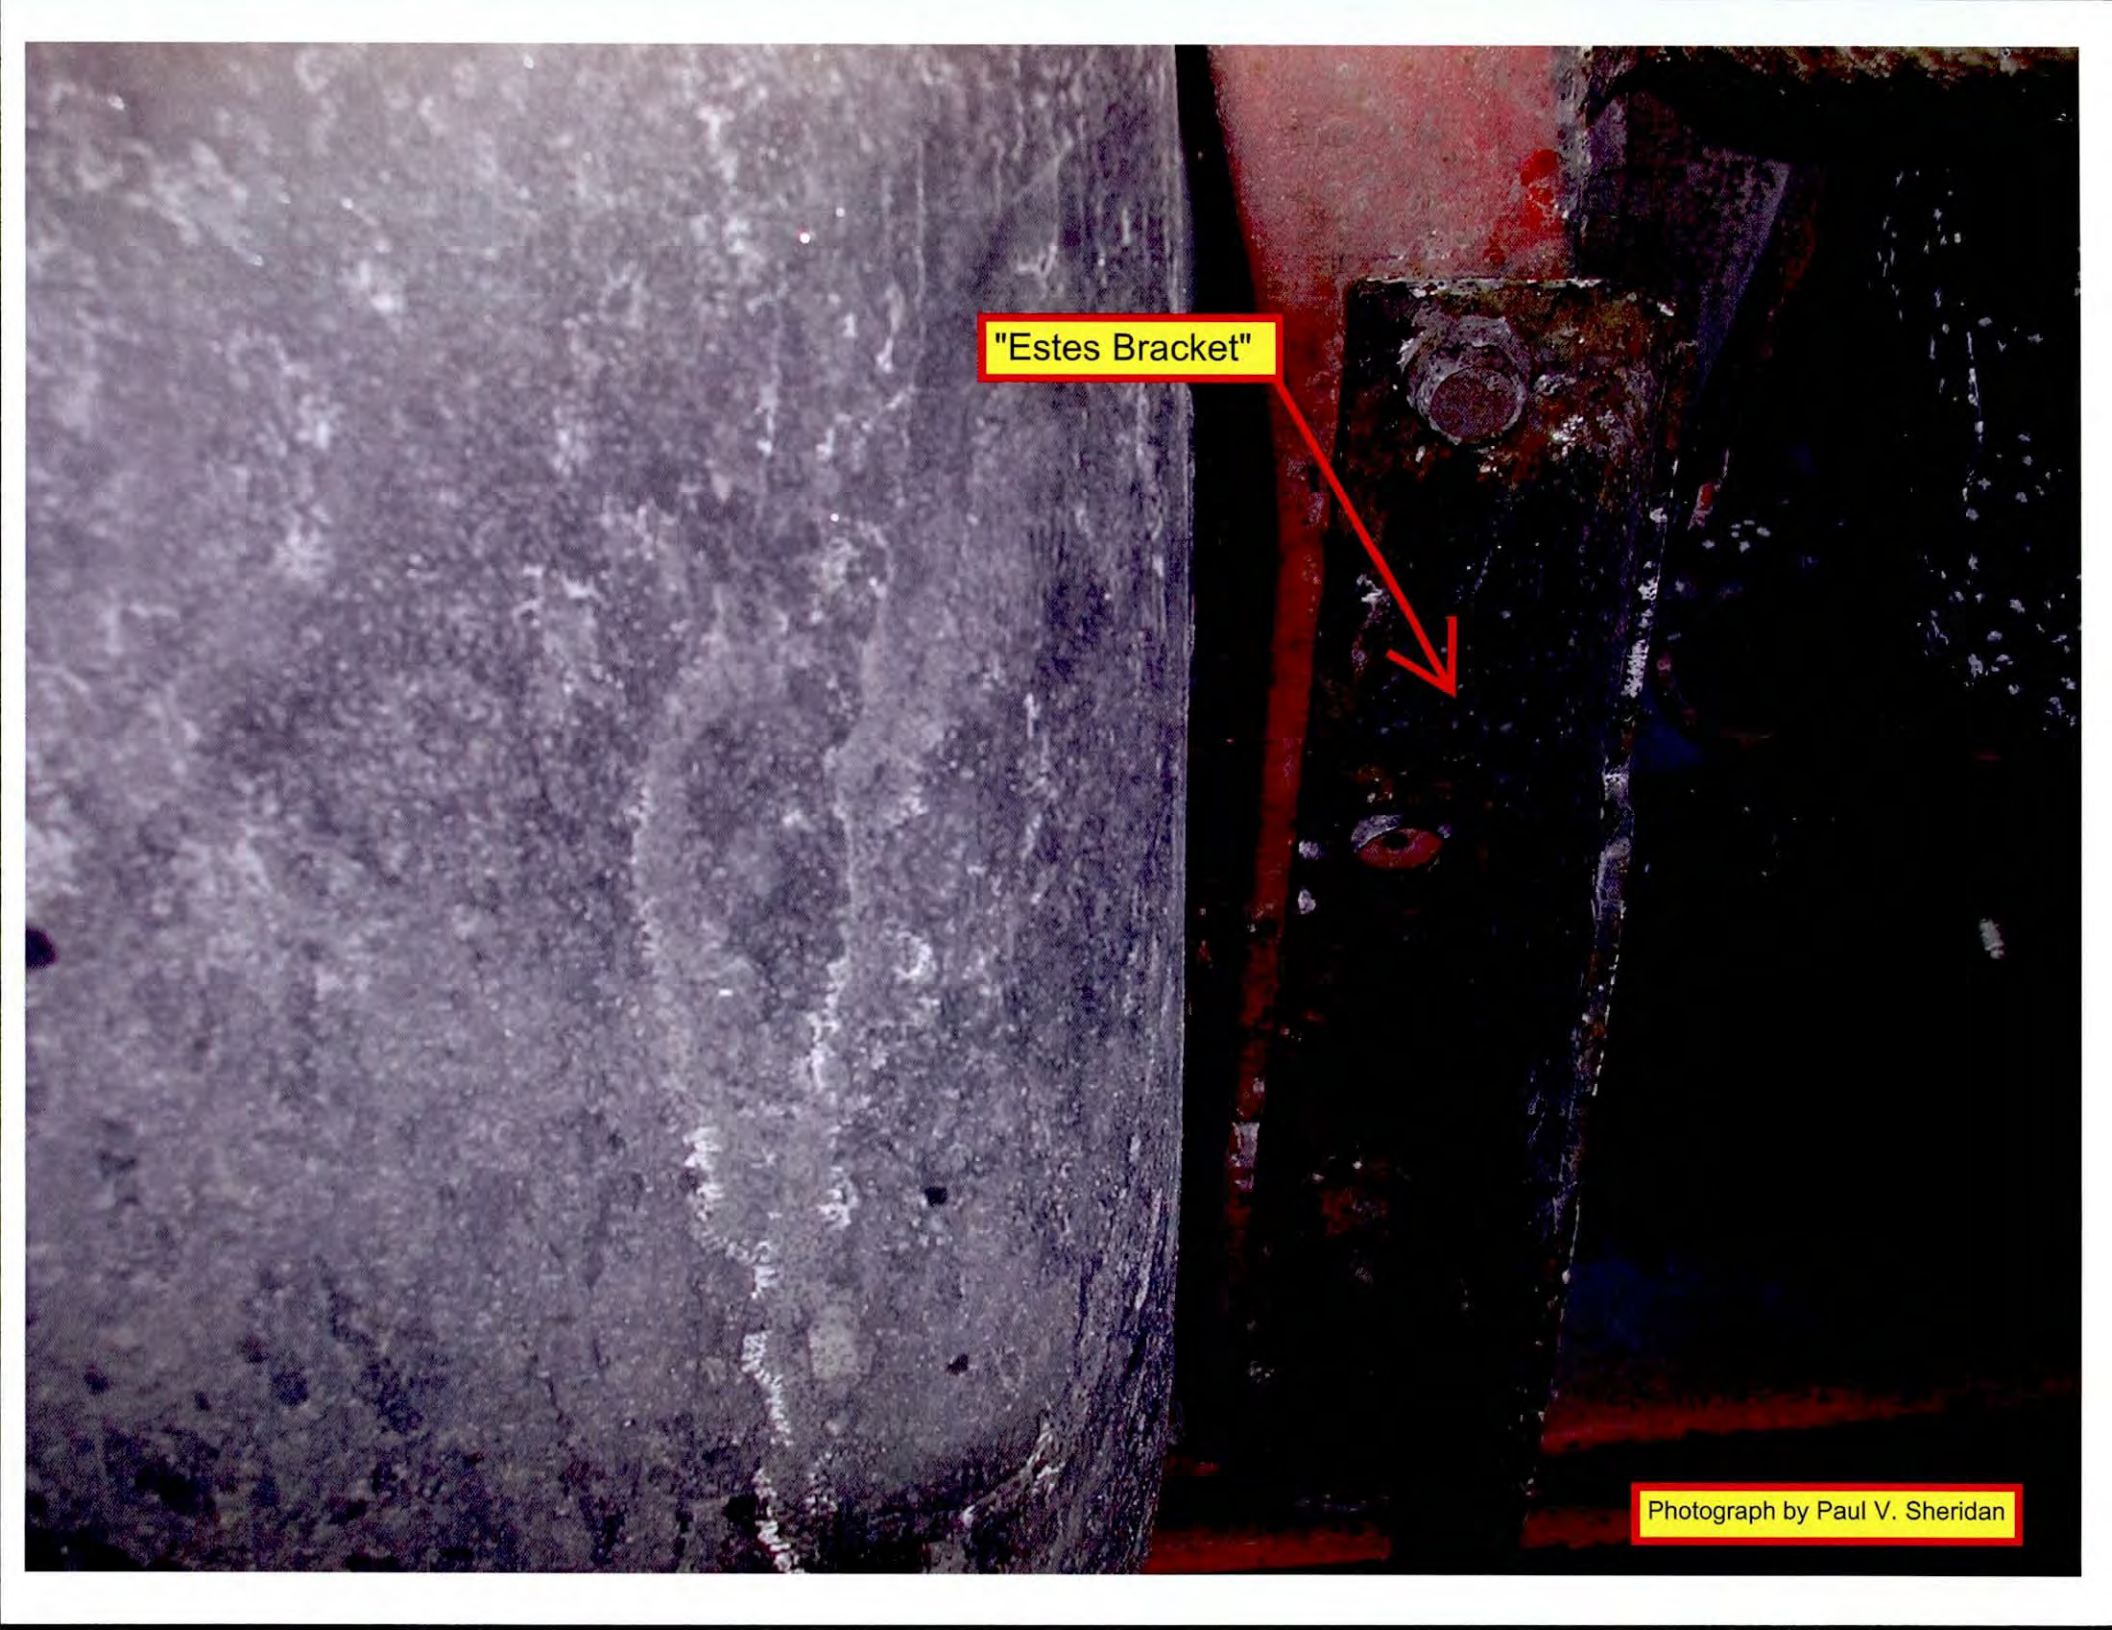
"Estes Bracket"

A close-up photograph of a metal bracket, identified as the "Estes Bracket", mounted on a ship's hull. The bracket is a dark, rectangular metal plate with two visible bolt heads. It is attached to a vertical metal beam. To the left of the bracket is a large, curved, light-colored metal structure, possibly a propeller or a large hatch cover. The background is dark and textured, suggesting the interior or exterior of a ship's hull. A red arrow points from the text label to the bracket.

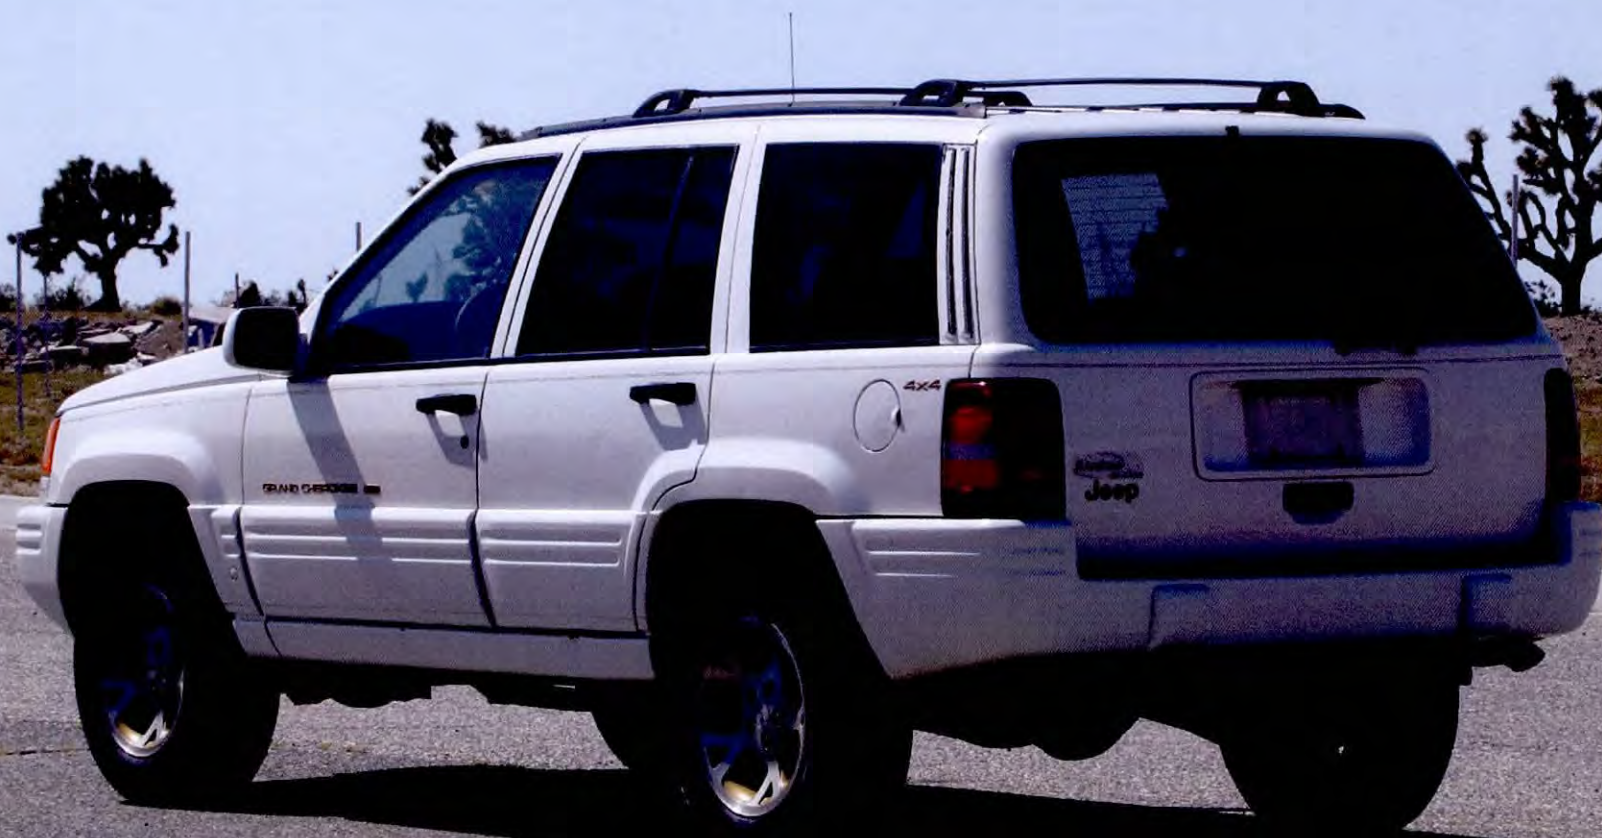
**ZJ-Body Jeep Grand Cherokee:  
Typical Customer View (of Fuel Tank)**

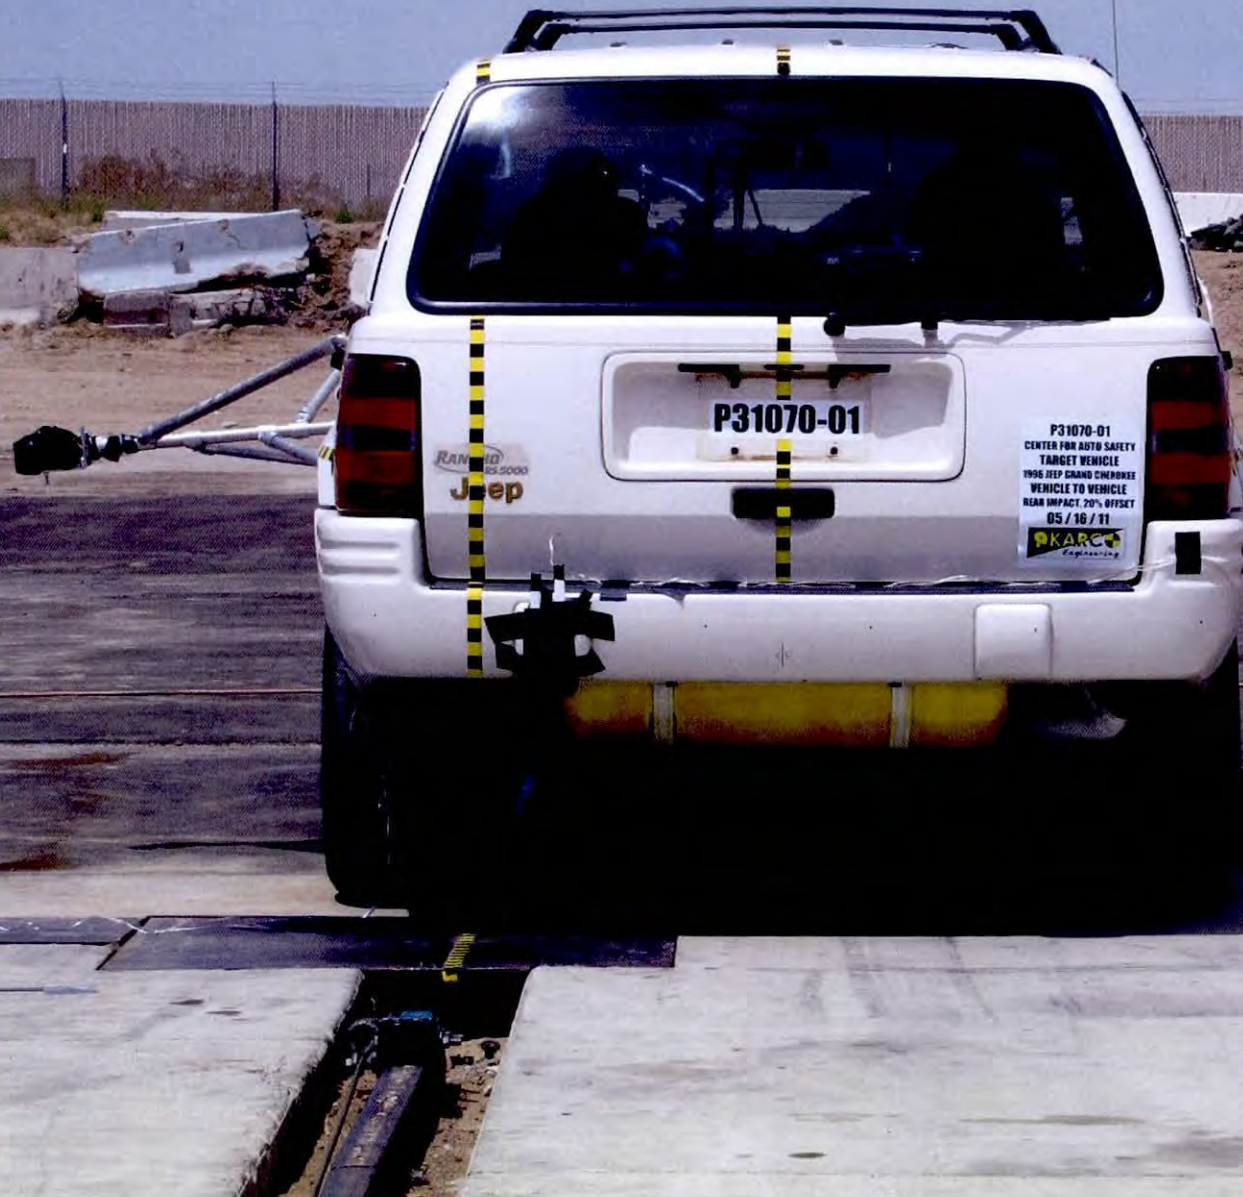
**ZJ-Body Jeep Grand Cherokee:**

**What Showroom Customer Would See if  
Fuel Tank was not color-matched to rear  
underbody / rear suspension components.**
