| <div style="text-align: center;"> <b>DOT Auto Safety Hotline</b><br/> <b>Vehicle Owner's Questionnaire</b><br/> <b>To Report Vehicle Safety Defects</b><br/> <b>1-888-DASH-2-DOT</b><br/> <b>(1-888-327-4236)</b><br/> <b>INTERNET: www.nhtsa.dot.gov/hotline</b> </div> | | | | FOR AGENCY USE ONLY 100148 | |
| WB10439A24Z | | | BMW | R1150 R | 2004 |
| Vehicle Component Code: 070000 FUEL SYSTEM, GASOLINE | | | | Failure Mileage | Failure Speed |

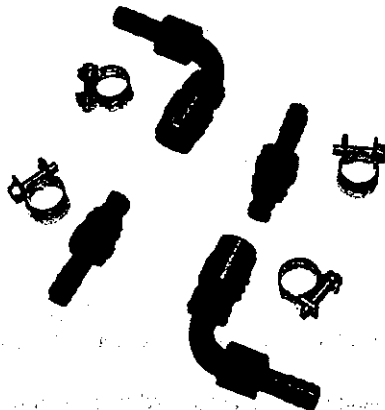
#### Jiffy-tite BMW Quick Disconnect Fuel Line Kit

Jiffy-tite BMW Quick Disconnect Fuel Line Kit. Available with straight or 90 degree fittings.

JIF-QD2 (pictured) is the same but uses the JIF-21505E 90 degree socket for applications where this eases installation.

Note: The bike has subsequently been repaired by the contact with the kit as seen below, The contact felt the repair parts are superior to the OEM parts. This following information is from Racer Parts Wholesale.

This Quick Disconnect kit solves the problematic BMW fuel line quick disconnects that always seem to fail at the worst possible time. These fittings work with 5/16" ID fuel hose.

Jiffy-tite's revolutionary Quick Connect Fluid Fittings provide unsurpassed performance under extreme conditions. Made of lightweight, 6061-T6 aluminum, brass valves, and stainless steel ball bearings, they are corrosion resistant for extra long life. Jiffy-tite's unique, high-flow valve technology in the plug and socket assembly automatically interrupts the flow of fluid when disconnected to protect against hazardous gas leaks. Tested and proven to have a 100% leak proof seal, even at 200 psi. The Jiffy-tite fittings have no serviceable o-rings to replace.

JIF-QD1 includes 2 each of JIF-21505 Jiffy-tite socket and JIF-22505 Jiffy-tite plug, and 4 fuel injection rated hose clamps. These are not cheap worm style clamps that will damage rubber fuel line.
