**From:** [Wells, Cynthia CTR \(NHTSA\)](#)  
**To:** [Fogle, Brenda CTR \(NHTSA\)](#)  
**Subject:** FW: NHTSA: Follow up to ODI Complaint: 10437870  
**Date:** Tuesday, February 21, 2012 9:51:47 AM  
**Attachments:** [Isuzu recall receipt.pdf](#)  
[10437870 \(1\).pdf](#)  
[EVOQ EMAIL RESPONSE \(1\).doc](#)  
[img045.pdf](#)  
[img044.pdf](#)

On November 17, 2011, I had a 1999 ISUZU Rodeo (VIN No. 4S2CM58W8X4 [REDACTED]) repaired at Norman-David Lincoln Mercury Isuzu Suzuki in Westbrook, Maine. The vehicle was repaired under NHTSA campaign I.D. No. 10V436000.

TL\* THE CONTACT OWNS A 1999 ISUZU RODEO. THE CONTACT STATED THAT THE VEHICLE WAS REPAIRED UNDER NHTSA CAMPAIGN I.D. NUMBER: 10V436000 (SUSPENSION:REAR). THE CONTACT DID NOT FEEL THE RECALL REPAIR WAS ADEQUATE BECAUSE A BRACKET WAS BOLTED TO THE FRAME, WHICH EXHIBITED EXCESSIVE RUST. THE CONTACT WAS CONCERNED THAT FRAME WOULD FRACTURE, FRACTURING THE BRACKET AND POSSIBLY CAUSING A CRASH. THE MANUFACTURER WAS NOT CONTACTED. THE FAILURE MILEAGE WAS 100,000.

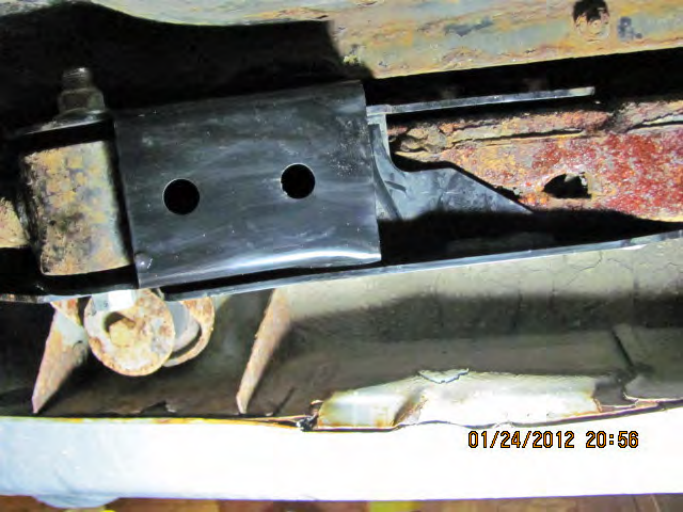
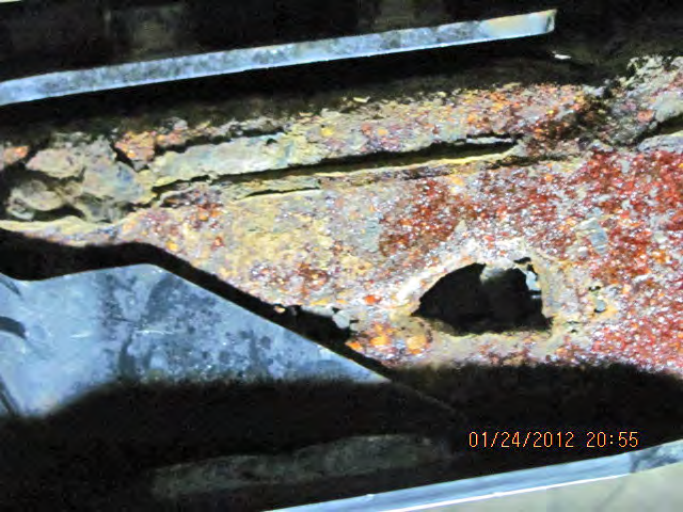
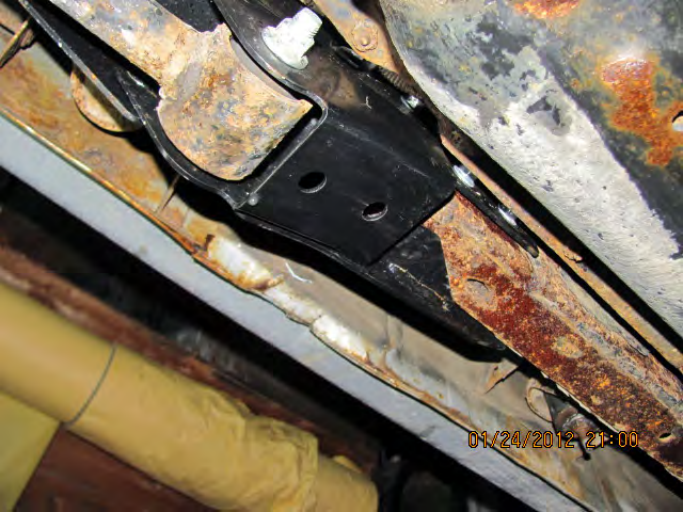
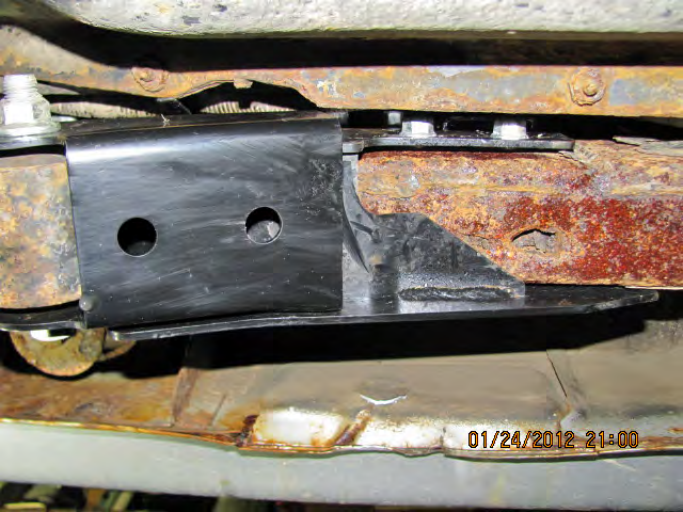
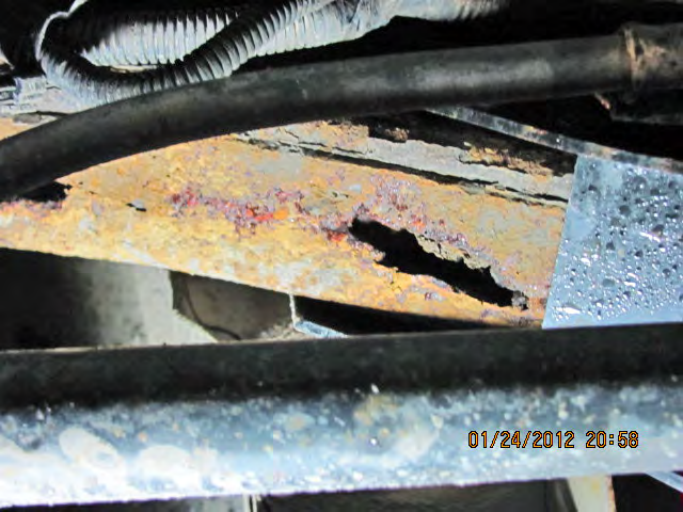
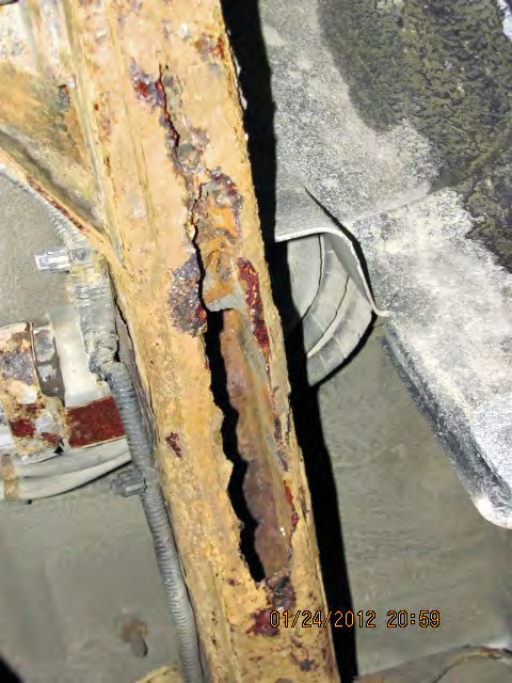
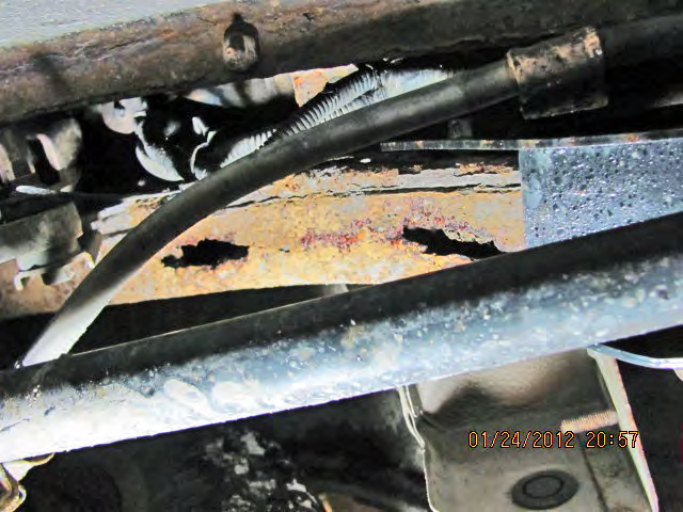
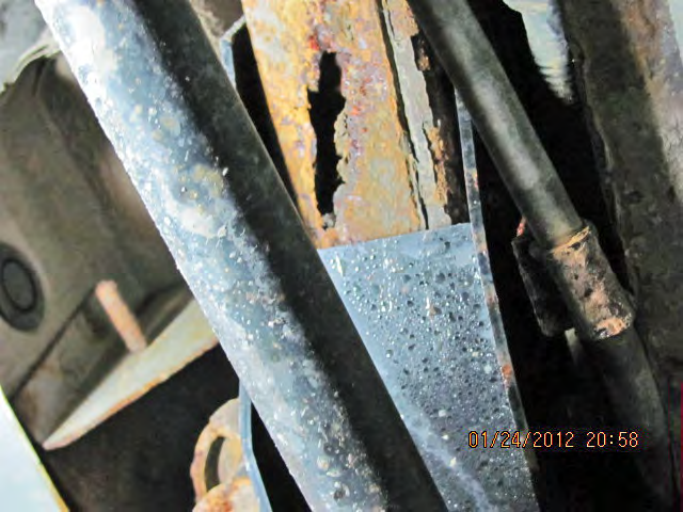
Unfortunately, the recall repair provided was not adequate because the bracket required by the recall was bolted to a portion of the frame that exhibited excessive salt-related rust. I am disappointed because immediately following the repair my vehicle was declined Maine State Motor Vehicle Inspection and, as such, has been declared unsafe to drive in my state. I have contacted the manufacturer in an attempt to fix the problem. The representatives with whom I have spoken, however, have been dismissive.

J# 1 50LIZ RECALL/CAMPAIGN UNITS: TECH(S):73451 WARRANTY  
10V 436 CORROSION INSPECTION  
INSPECTED PER RECALL B KIT NEEDED  
INSTALLED THE B KIT PER RECALL  
HAS RUST IN OTHER AREAS NOT AFFECTED BY THE RECALL
