From: [Wells, Cynthia CTR \(NHTSA\)](#)
To: [Fogle, Brenda CTR \(NHTSA\)](#)
Subject: FW: 10478447
Date: Monday, October 22, 2012 9:01:22 AM

This is reference the report on the tire blow out on the ambulance owned by Lincoln County.

Incident Report

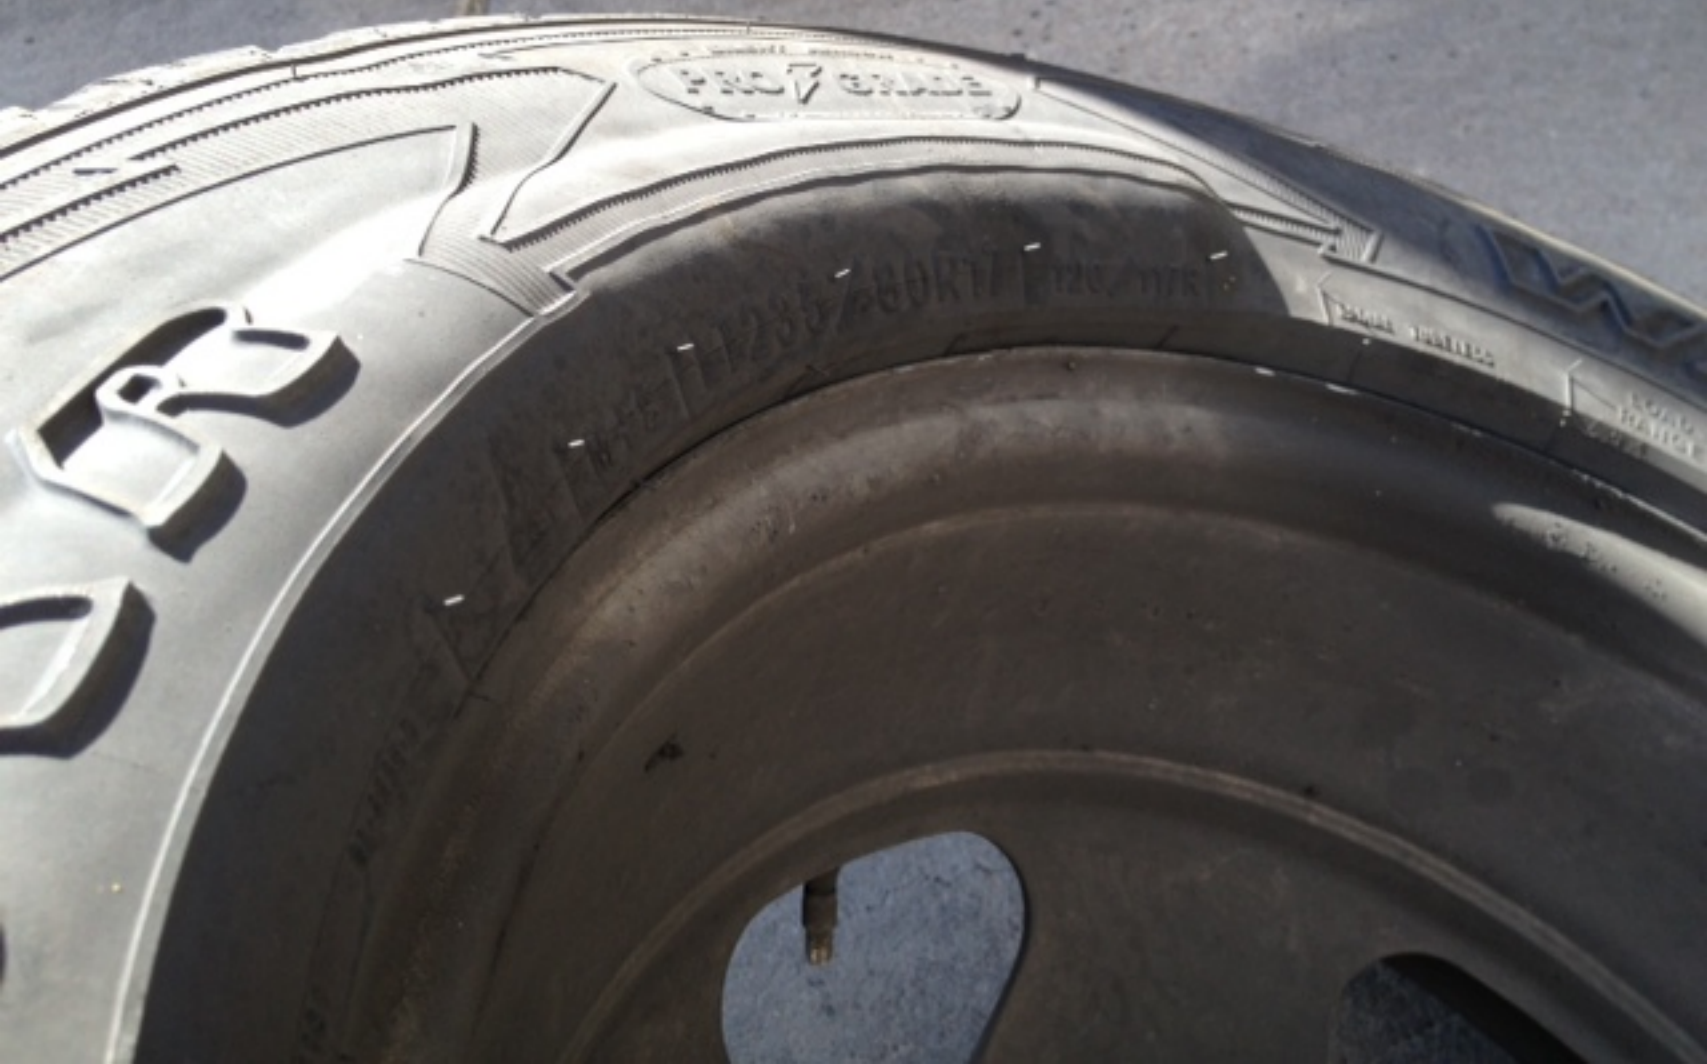
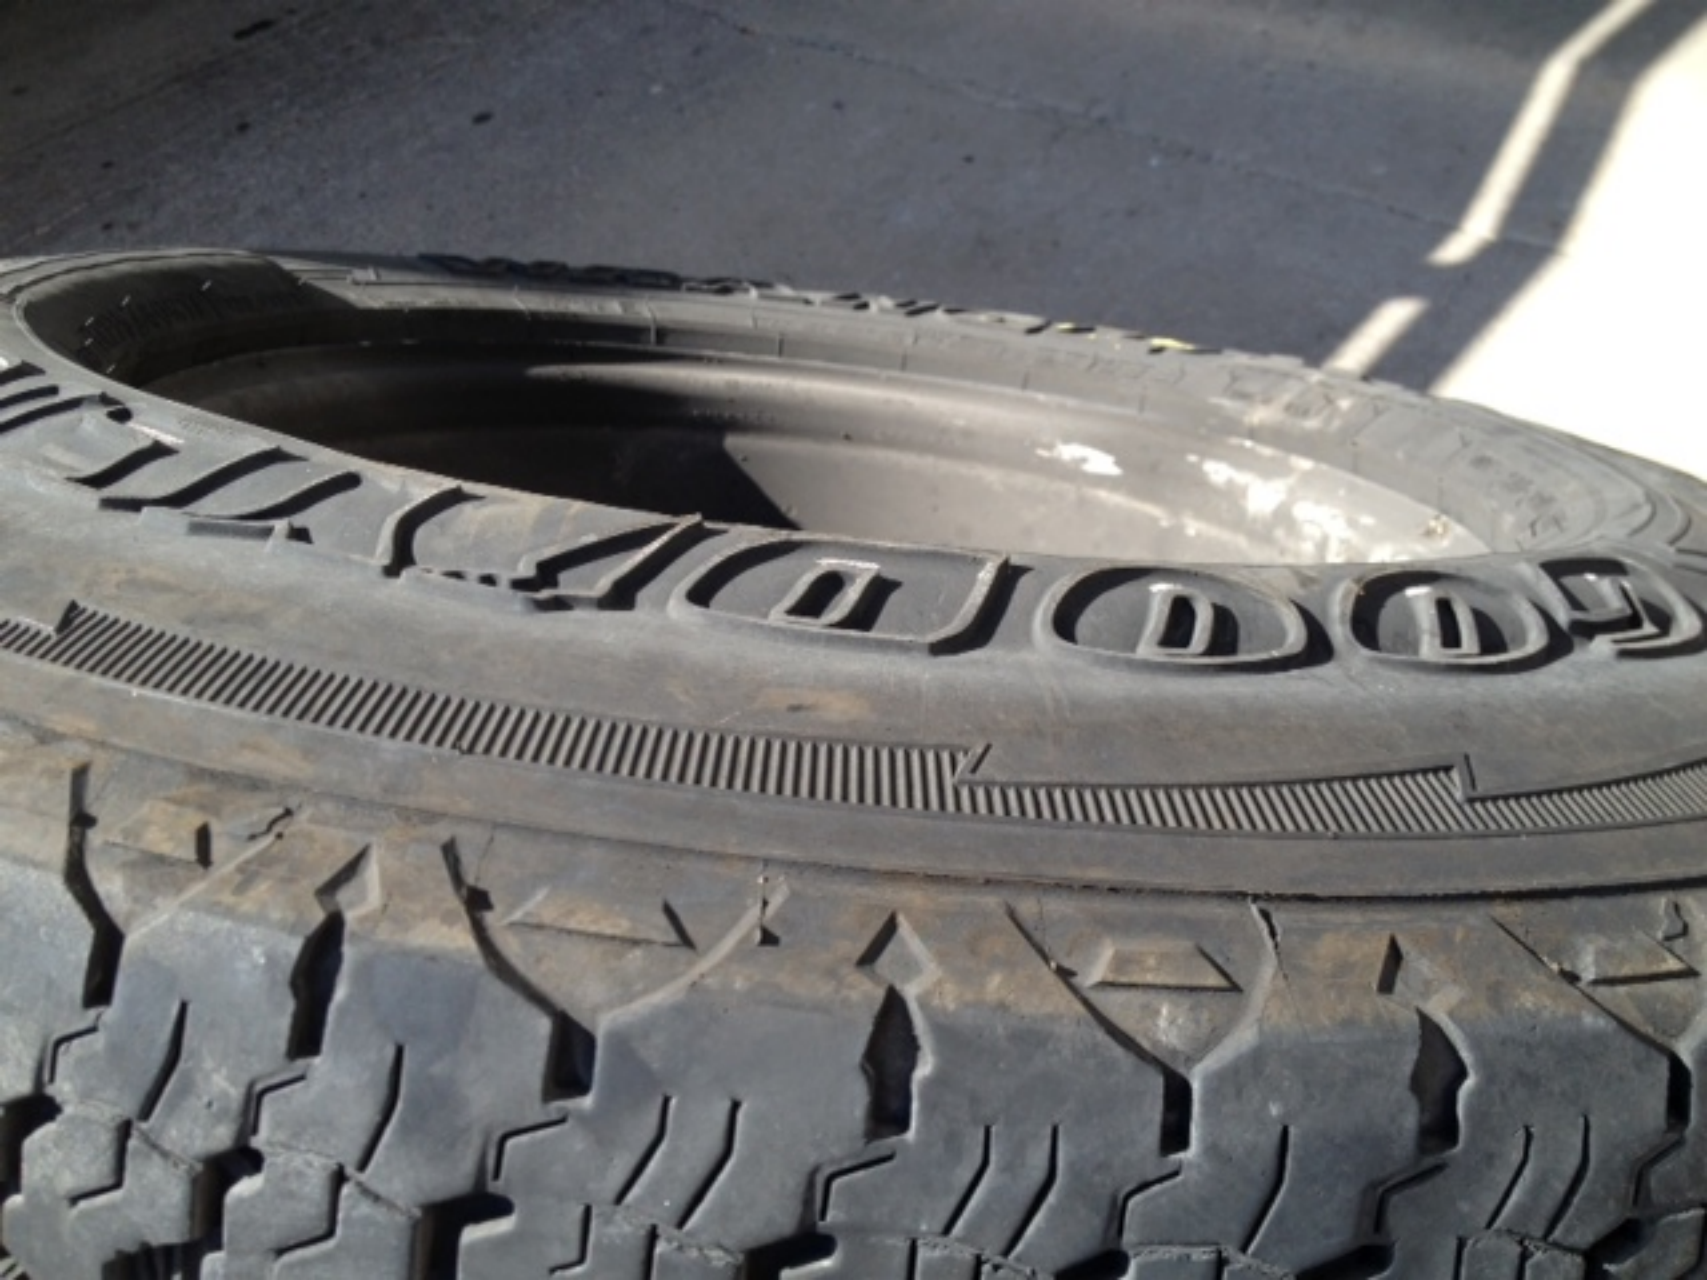
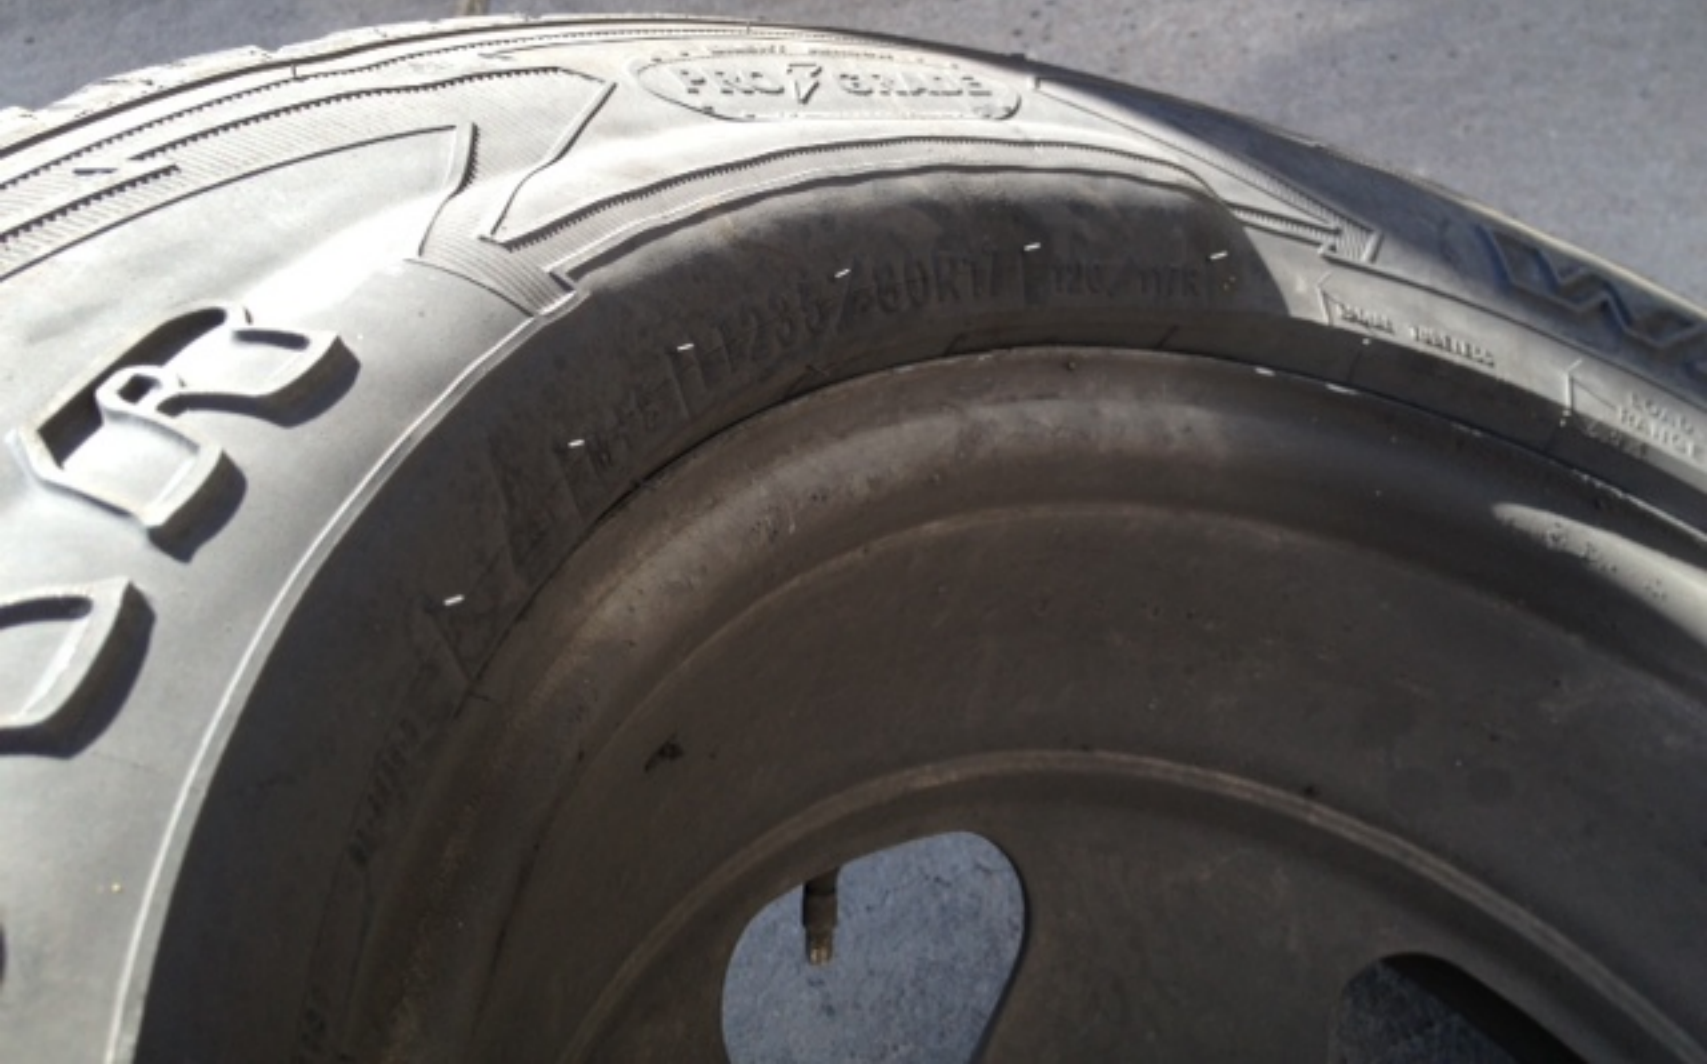
While transporting a patient from LCMC to Albuquerque Presbyterian Hospital on I- 25 just past the exit to Hard Rock Isleta I noticed a vibration in the right rear. Approximate speed at the time was 60-65 mph due to morning inbound traffic to Albuquerque. Posted speed is 75 mph. I asked my partner Arielle Gonzales EMT-P 504 to check out the back door window. While she checked I slowed further and stopped at the side of the road. She reported that pieces of tire were coming from the right rear. I inspected the right rear tires and found that the inside dual had failed. I inspected all other tires and found no abnormalities. I did not want to compromise the vehicle, patient or my partner and requested that Albuquerque Ambulance be dispatched to my location to continue the transfer. Pt was moved to Albuquerque Ambulance's stretcher and transfer was continued to Albuquerque Presbyterian with Arielle Gonzales EMT-P 504. Road side service was called. Tire was removed and placed in the back of the unit for later inspection. Upon arrival at LCEMS in Ruidoso I inspected the tires again and found that the right front and right rear outside dual were preparing to fail. Both tires had bubbles pushing the inside bead from the rim.

Blow out was on RRI tire not as reported and other defective tires on ambulance upon inspection as reported above. Three or the six tires on the ambulance proved to be defective with air bulges on them.
