| <br>U.S. Department of Transportation<br>National Highway Traffic Safety Administration | | <b>DOT Auto Safety Hotline</b><br><b>Vehicle Owner's Questionnaire</b><br>To Report Vehicle Safety Defects<br>1-888-DASH-2-DOT<br>(1-888-327-4236)<br>INTERNET: www.nhtsa.dot.gov/hotline | | FOR AGENCY USE ONLY 100148<br>Date Received<br><b>APR - 5 2013</b><br>24-OCT-2012 | | Repository <input type="checkbox"/><br>Reference No.<br>10482103 | |
| 17 digit Vehicle Identification Number Located at bottom of windshield on driver's side<br>2HGFB2F27CH | | | | Make<br>HONDA | | Model<br>CIVIC DX Sedan | |
| Vehicle Component Codes: 110000 ELECTRICAL SYSTEM, 138000 VISIBILITY: DEFROSTER/DEFOGGER SYSTEM | | | | | | Failure Mileage<br>4000 | |

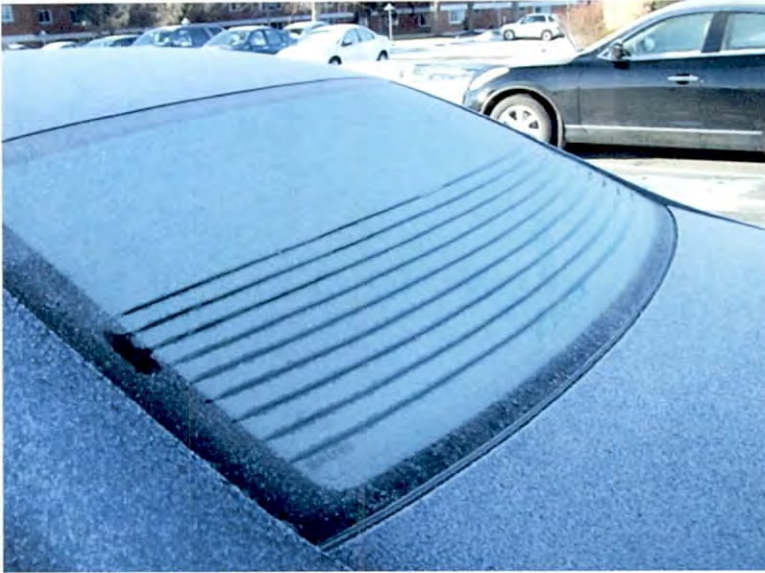
4 min

The rear window defogger of my car, likewise, does not work. The bottom nine coils of the heating element work (twelve inches of the glass). The middle 5 coils have limited effect, and the top six inches have no heating element as they are reserved for the radio antenna. Let it be known my car was delivered with no radio. Because of the slant of the rear window, only about seven bottom inches of visibility are defrosted on a winter day. The other sixty percent is blocked with ice, snow, or frost.

It takes between nine to eleven minutes for the middle five coil elements to defrost the ice or frost. You can see by a visual inspection of the window, that those coils are actually, thinner in width than the others, so obviously do not generate as much heat as the bottom ones.

I have enclosed photos to show you a time lapse of how the coils are not working.
